1984 Corvette: Service Bulletin: Engine Stops Running When Starting with Air Conditioning "On"

Model and Year: 1984 Corvette with Automatic Transmissions

Bulletin No: 84-240

Date: Feb. 1985

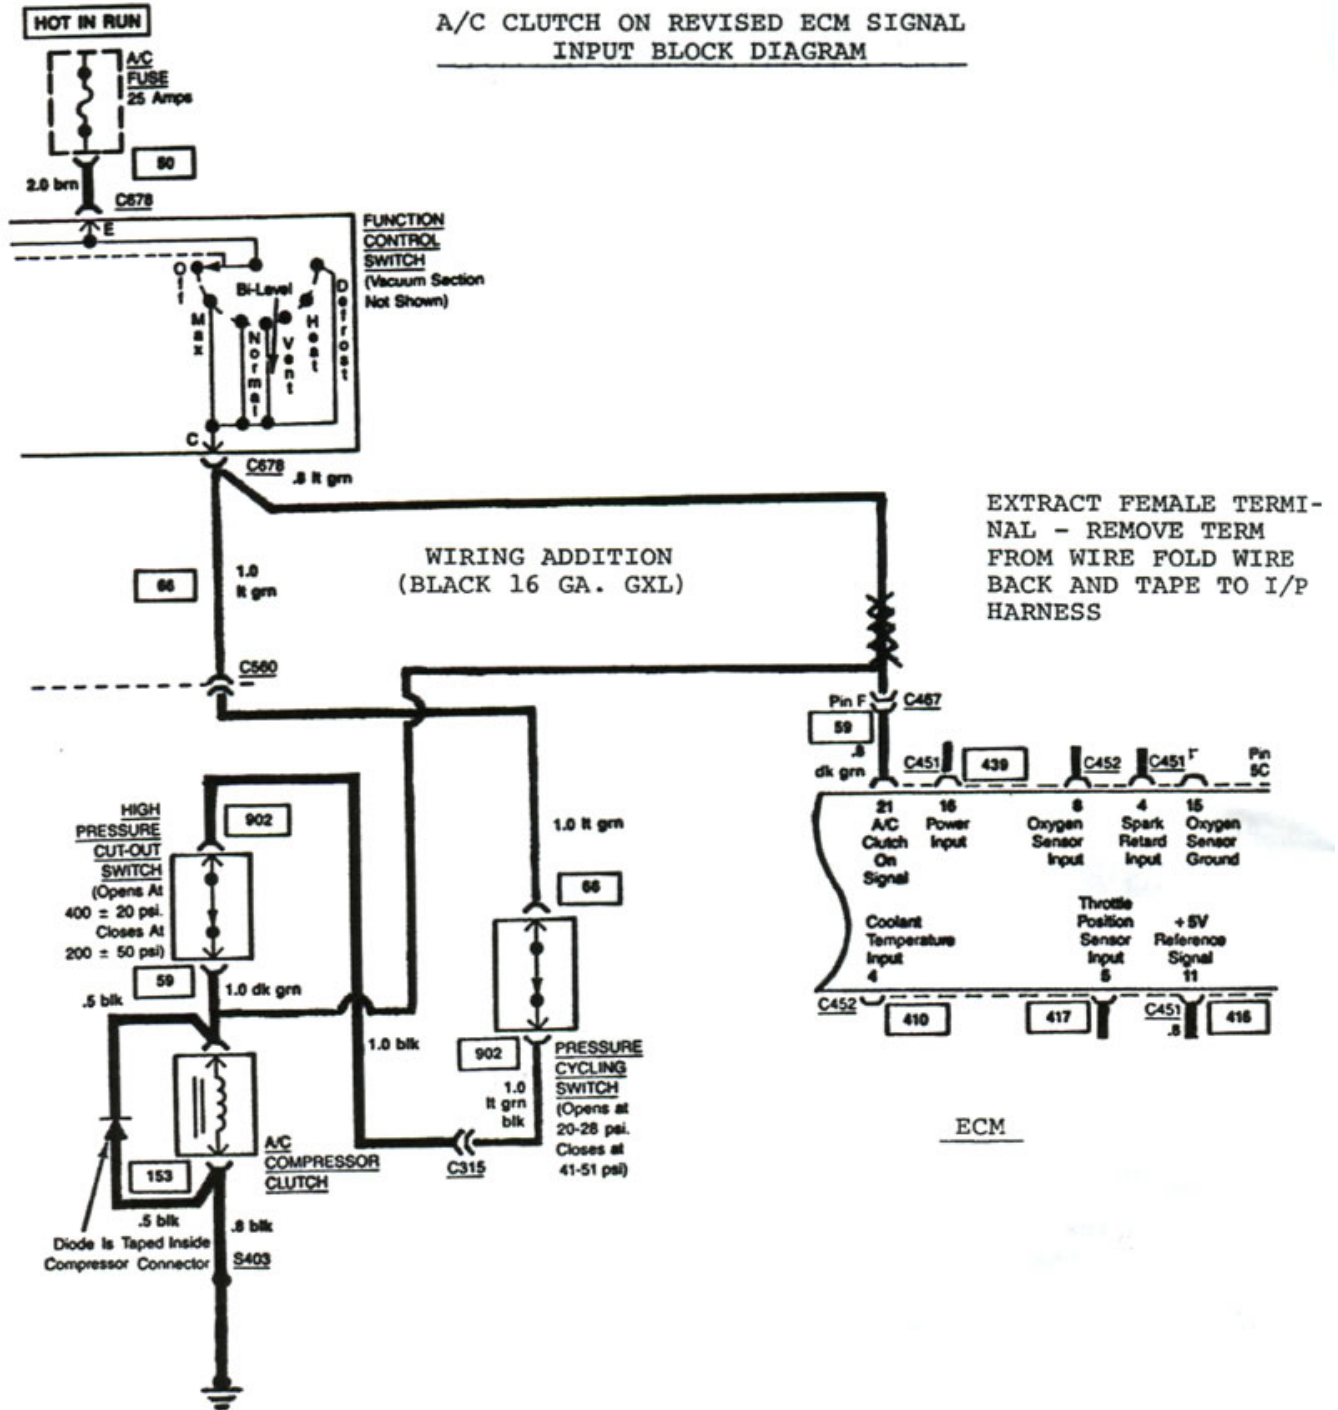
A/C CLUTCH ON REVISED ECM SIGNAL INPUT BLOCK DIAGRAM

This revision requires installing a 16 Ga. wire into the A/C discrete circuit at connector C-467, Pin F of the I/P to ECM harness, routing the wire through the bulk head connector and splicing into the A/C circuit of the engine, between the pressure cycling switch and the compressor clutch (see block diagram).
