# 1955 Corvette: Service Bulletin: Hard Shifting

<b>CHEVROLET—CENTRAL OFFICE</b> DIVISION OF GENERAL MOTORS CORPORATION DETROIT 2, MICHIGAN	
<b>TECHNICAL SERVICE BULLETIN</b> Service and Mechanical Department	
<b>SUBJECT:</b> HARD SHIFTING - 1955 MODEL PASSENGER CAR 3-SPEED TRANSMISSION	<b>BULLETIN No.</b> DR #236  <b>SECTION</b> VII
<b>TO:</b> ALL CHEVROLET DEALERS	January 9, 1956
<p>In cases where hard shifting on 1955 Passenger Models with 3-Speed Transmission is experienced in high frequency shifting operations due to malfunction and/or wear of gearshift controls and butting of transmission gears, the condition may be reduced by installation of a Transmission Control Conversion Kit and three new type transmission gears.</p> <p>The new transmission gears which have more tooth chamfer entered production about July 5, 1955.</p> <p>The revised transmission controls entered production beginning with 1956 Model and the Control Conversion Kit has modified parts for use on 1955 Models.</p>

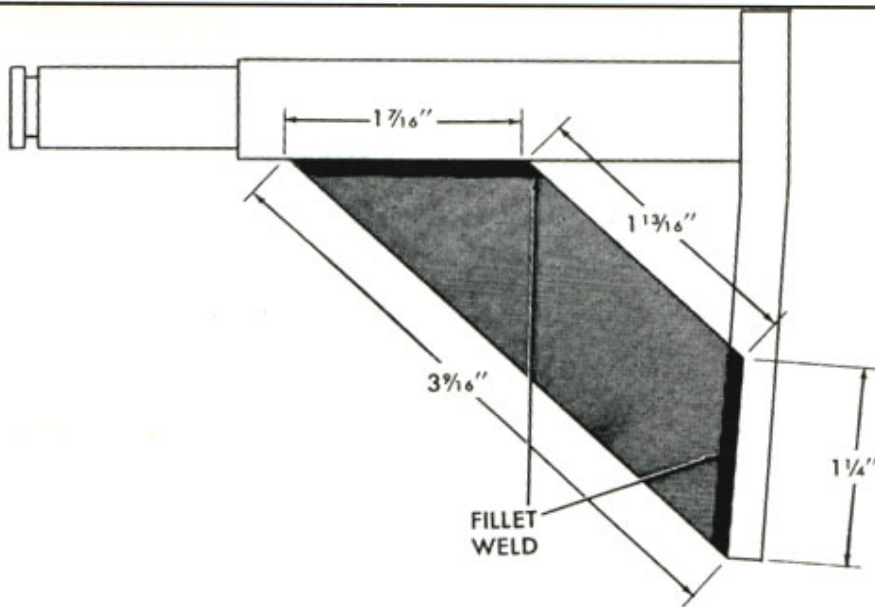
FIGURE 3

TRANSMISSION CONTROL ROD IDLER LEVER SUPPORT

Further improvement of shifting can be made by reinforcement of transmission control rod idler lever support located on left frame rail under toe pan to reduce its deflection. See figure 3.
