# 1970 - 1973 Corvette: Service Bulletin: Engine Overheat

**Source:** Chevrolet Dealer Service Technical Bulletin

**Bulletin Number:** 73-T-28, Section VI

**Date:** May 14, 1973

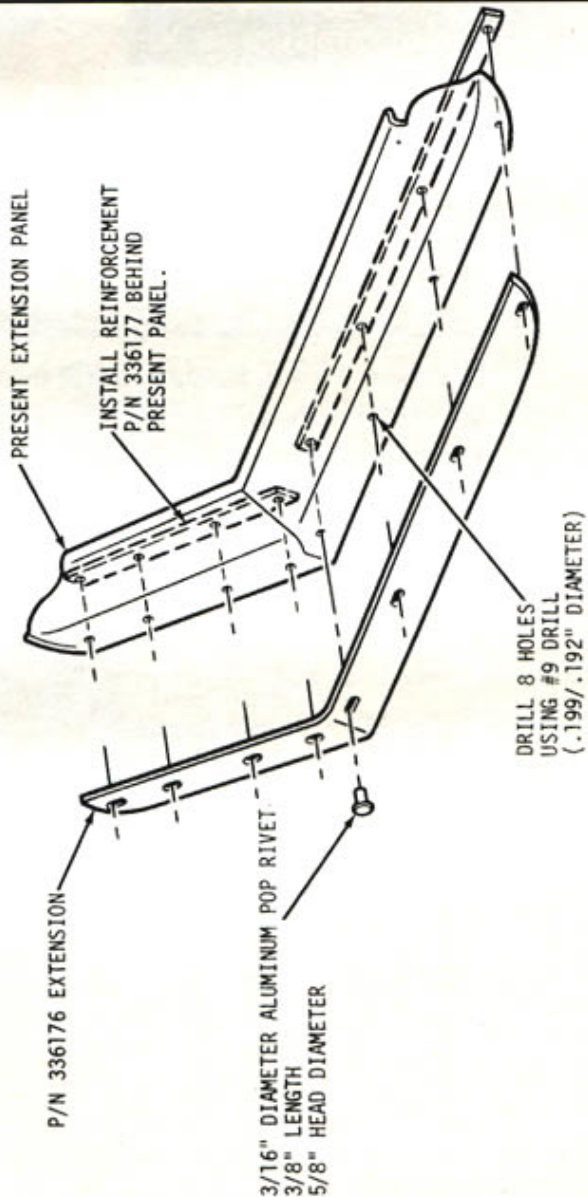
Engine overheat may be encountered on some 1970-1973 Corvettes equipped with the 454 cu. in. engine and air conditioning during high ambient temperatures when operated in heavy traffic. This condition is due to the limited amount of air flowing through the radiator at low vehicle speeds or during periods of extended idle.

To improve low speed cooling, an additional grille panel lower extension was installed in 1973 Corvettes produced after Vehicle Identification Number 1Z37Z3S410722. This extension, Part Number 336176, may be installed as illustrated on page 2 of this bulletin on early 1973 Corvettes only .
