1970 - 1973 Corvette: Service Bulletin: Engine Overheat

Subject: Engine Overheat

Model and Year: 1970 - 1973 Corvettes with 454 Cu. In. Engines and Air Conditioning

Bulletin Number: 73-T-28, Section VI

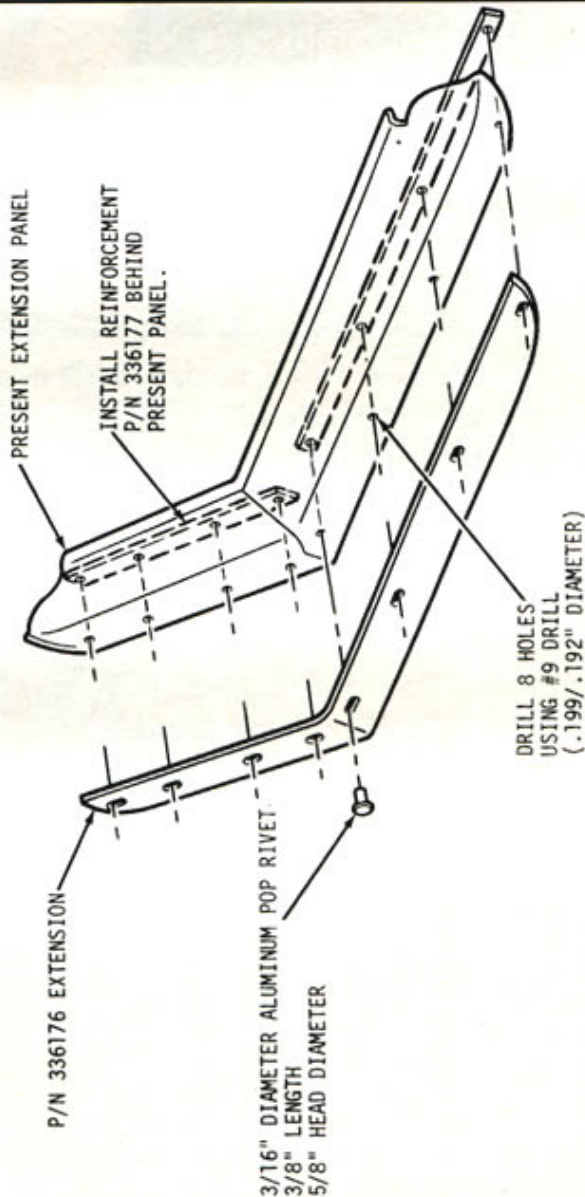
Engine overheat may be encountered on some 1970-1973 Corvettes equipped with the 454 cu. in. engine and air conditioning during high ambient temperatures when operated in heavy traffic. This condition is due to the limited amount of air flowing through the radiator at low vehicle speeds or during periods of extended idle.

To improve low speed cooling, an additional grille panel lower extension was installed in 1973 Corvettes produced after Vehicle Identification Number 1Z37Z3S410722. This extension, Part Number 336176, may be installed as illustrated on page 2 of this bulletin on early 1973 Corvettes only .
