# 1968 Corvette: Chevrolet Engineering Memo: Window Service Update

**Subject:** Window Service Update  
**Model and Year:** 1968 Corvette  
**Source:** Chevrolet Engineering Memo - Mr. G. H. Tyler of Chevrolet Engineering  
**Page Number:** NA  
**Date:** March 1968

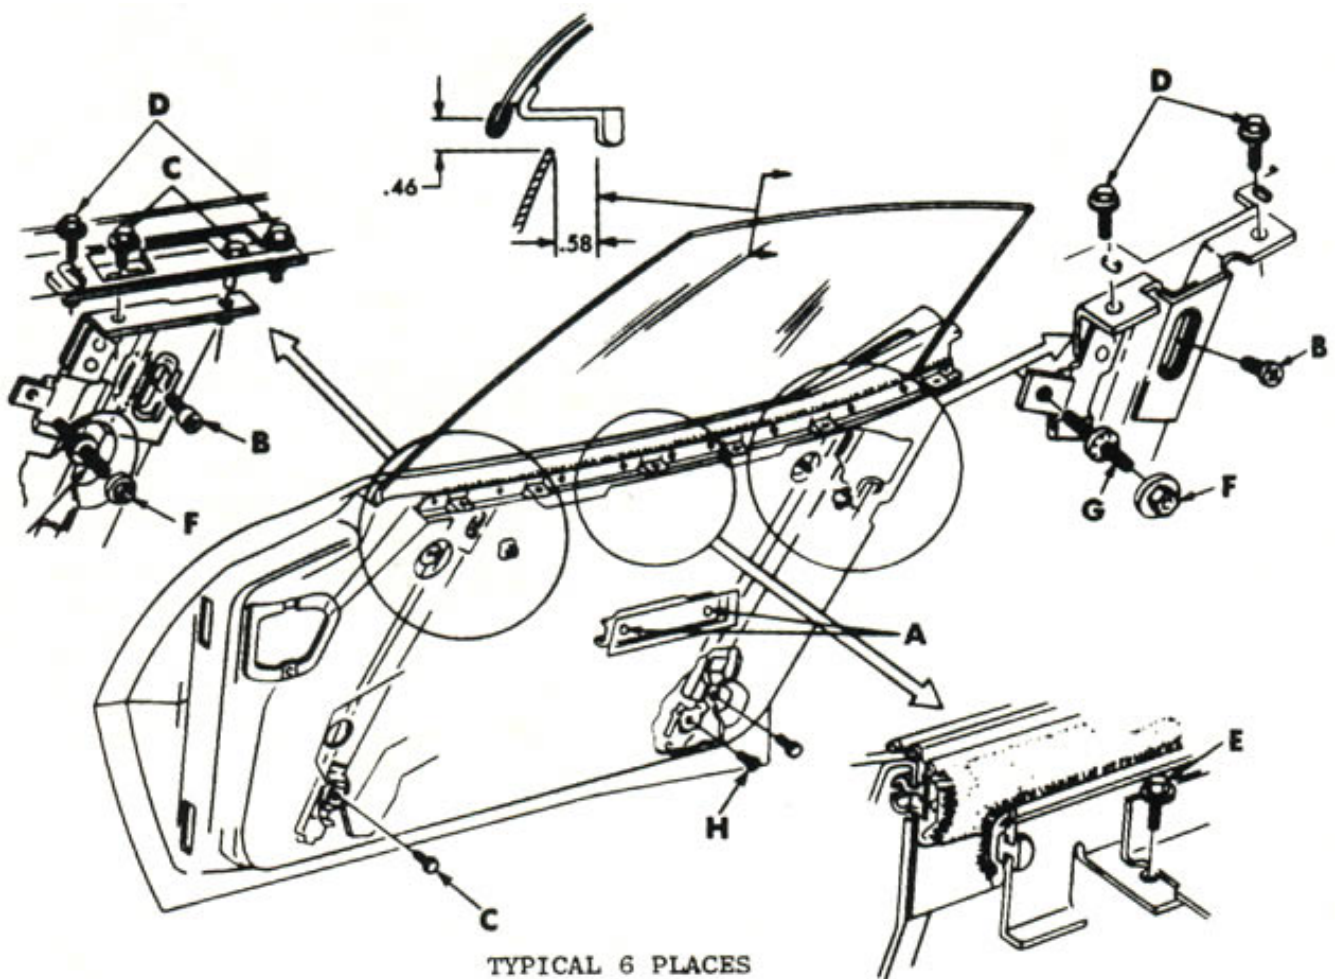
The adjustment procedure for 1968 Corvette door window glass has been revised as of this date. Items No. 3 and 4 have been revised.

1. Loosen bolts (A) and adjust the fore and aft tilt of the door window glass by rotating until a constant gap, or relationship, is obtained between the front edge of glass and the windshield pillar. Retighten bolts (A).
2. Loosen the front and rear stop screws (B) and roll glass up until top edge is .46 below roof rail. Move front and rear stops to contact the window rollers. Retighten screws (B).
3. Loosen the 3 bolts (C) and front nut (F) and slide door glass forward so that the front edge is .44 from and parallel to the windshield pillar. Retighten bolts (C).
4. Loosen bolts (D), (E) and rear nut (F). move bailey weatherstrip outboard so outer nylon pads are in contact with door outer panel reinforcement. Retighten bolts (E). move glass run channel so the top

of the glass is .58 from the vertical flange of the roof rail (move the glass run channel outboard to move the upper edge of glass inboard, move the glass run channel inboard to move the upper edge of glass outboard.) Retighten bolts (D).

5. Turn adjusting screw (G) so the front and rear inner nylon pads are in light contact with the wedges. Tighten nuts (F).
6. Loosen screw (H) and roll glass down until top edge is flush with door outer panel. Move stop to contact the window roller. Retighten screw (H).
7. Install and adjust windshield pillar weatherstrip, front rail weatherstrip, center rail weatherstrip, and rear rail weatherstrip to seal on glass.

Above procedure pertains to Assembly Plant operation. For Service, remove weatherstrip, weatherstrip retainer and door trim panel prior to glass adjustment.
