1974 Corvette: Product Safety Campaign: Fuel Tank Return Line Tube Fitting Leakage

1974 Corvette built within serial range number 15,309 through 18,652 had a possibility of a fuel tank return line breaking.

Subject: Product Safety Campaign No. 74C13 - Fuel Tank Return Line
Tube Fitting Leakage - 1974 Corvette
Model and Year: 1974 Corvette
Source: Chevrolet Dealer Product Campaign Bulletin
Bulletin Number: 74-C-13, Section VIII
Date: March, 1974

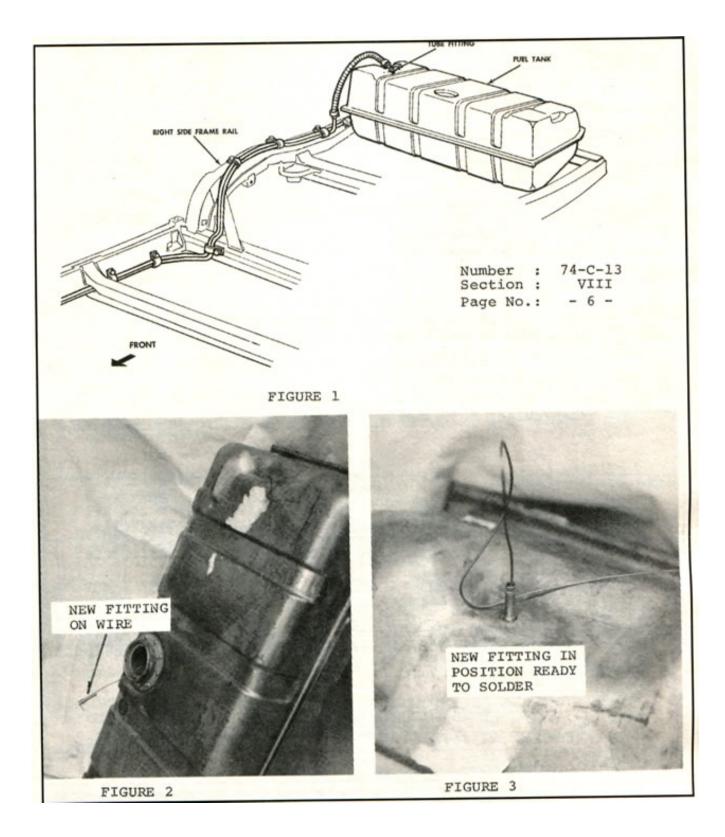
Owners, at the time of campaign initiation, were advised that the fuel tank return line fitting in some of these vehicles may have a thin wall section that could break under operating conditions. If this should occur, fuel being returned to the gasoline tank will be spilled around the tail pipe outlet as long as the engine continues to run. If, under these conditions the vehicle backfires or sparks are emitted from the exhaust system, the fuel vapor can be ignited. The resultant fire may cause damage to the vehicle and any occupant remaining in the vehicle may receive burn injuries.

1)	Prop upwa:	tank on left end so that fuel re	eturn fitting poir	nts				
2)	Thread a piece of "coat hanger" wire, approximately three feet in length, through the return line fitting and reaching through the filler neck opening, pull the end of the wire through the opening. Bend the wire at the fitting end to retain in position. See Figure 1.

5)	Using emery cloth also lightly clean up area to be soldere on the replacement fitting.							
6)	Insert the replacement fitting (small end first) on the wire at the filler neck opening end, and bend the wire at the filler neck end 90° to retain the fitting on the wire. See Figure 2.

7)	Pull the wire and fittings through the fitting hole until the tube is properly seated in place. A "popping" noise will most often be heard when fitting is properly seated, but in all cases the larger diameter section of the fitting will be visible as shown in Figure 3.

Number : 74-C-13 Section : VIII Page No .: - 5 -SERVICE PROCEDURE - (Cont'd.) REPLACEMENT OF DEFECTIVE TUBE FITTING - (Cont'd.) Place end of wire in vise or bend it in such a manner that 8) fitting will be held firmly in place. See Figure 3. Solder the fitting in place using a rosin-core solder. 9) Do not use acid-core solder. Allow solder joint to cool at least one minute and visually 10) inspect to insure that a proper solder joint has been obtained. Remove wire and clean up joint area as necessary. 11) 12) Install fuel gauge unit. Test for leaks around joint area by performing a fuel tank 13) leak test as outlined in the 1974 Passenger Car Service Manual (Page 8-11). Reinstall fuel tank assembly in vehicle again referring to 14) procedure in the 1974 Passenger Car Service Manual (Page 8-6). Check fuel line connections for proper installation. PARTS INFORMATION Fuel tank return line fittings and 8oz. containers of "Product Sol 913" have been furnished to each Chevrolet Zone Service Manager based on only the number of vehicles on the Vehicle Identification Number computer list, furnished by Chevrolet. Parts are to be requested by the dealer from the Zone for only those vehicles appearing on his computer list. Dealers who receive Campaign Bulletins without a computer list attached, are not involved. Parts are furnished by Chevrolet at no charge to involved dealers. Parts are not available from General Motors Parts Distribution Centers.
