# 1984 Corvette: Service Bulletin: Generator Noise (Moan) at Idle with Air Conditioning On

**Model and Year:** 1984 Corvette

**Source:** Chevrolet Dealer Service Bulletin

**Bulletin Number:** 84-151, Section 6D (VIy)

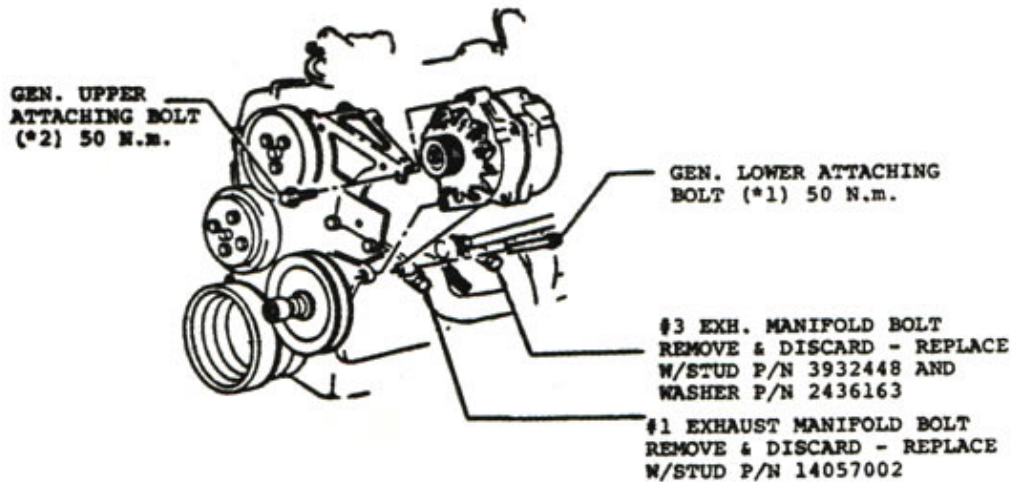
FIGURE 1

Some 1984 Corvettes may exhibit the subject noise, which is commonly defined as a "moan". This noise is induced into the generator by belt excitation when the air conditioning compressor is "on".

The following service procedure has been developed to reduce this noise by using three (3) new tubular braces and fasteners to replace the generator vibration period, which is the primary noise source.

1. Remove the generator rear support brace. Discard the support brace, attaching nut and attaching bolt.
  2. Remove and discard #1 and #3 L.H. exhaust manifold to cylinder head attaching bolts (see Figure 1).

3. Install stud, P/N 14057002, in place of discarded #1 bolt and torque to 35 N.m.
  4. Install stud, P/N 3932448, and washer, P/N 2436163, in place of discarded #3 bolt and torque to 35 N.m.

- NOTICE: Washer is to be installed on stud between stud hex and exhaust manifold.
5. Remove the serpentine belt from the generator pulley.
  6. Loosen generator attaching bolts (2). (See Figure 1).

9. Mandatory torque sequence (Figures 1 and 2):

- Generator lower attaching bolt 50 N.m.
- Generator upper attaching bolt 50 N.m.
- Long tubular support brace to generator, attaching bolt 35 N.m.
- Two (2) short tubular support braces to generator, attaching bolt 50 N.m.
- Three (2) tubular support braces to three (3) exhaust manifold studs, 25 N.m. three (3) attaching nuts.
