2016 Corvette: Service Bulletin: Delayed Engagement After Sitting With Engine Off

#16-NA-014: Delayed Engagement After Sitting With Engine Off - (Jan 21, 2016)

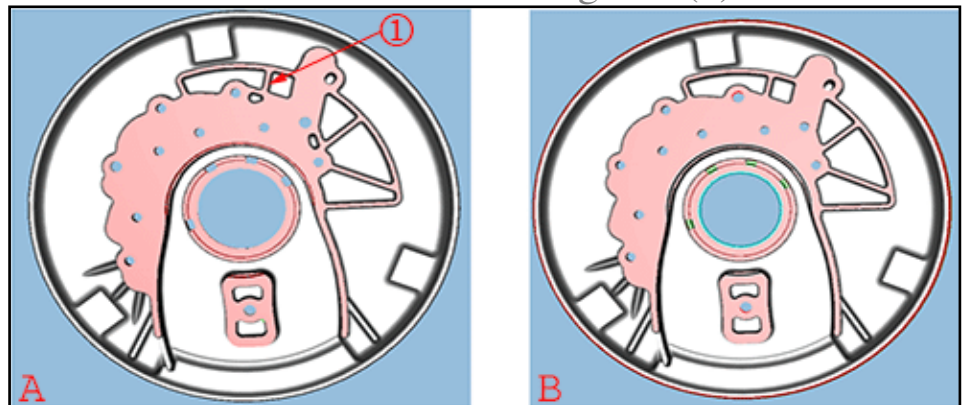
(A)

Old cover 24272660

(B)

New cover 24277964

Note: The casting void has been eliminated from the underside of the cover (see illustration).
