2016 Corvette: Service Bulletin: Delayed Engagement After Sitting With Engine Off

#16-NA-014: Delayed Engagement After Sitting With Engine Off - (Jan 21, 2016)

Subject: Delayed Engagement After Sitting With Engine Off

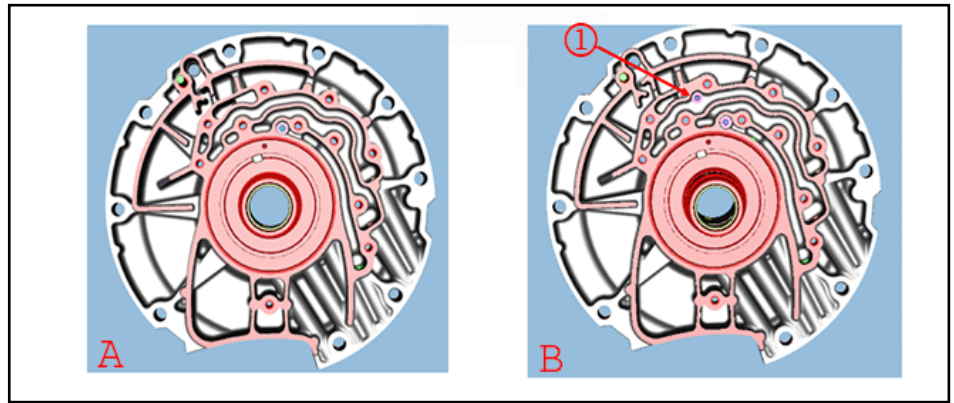
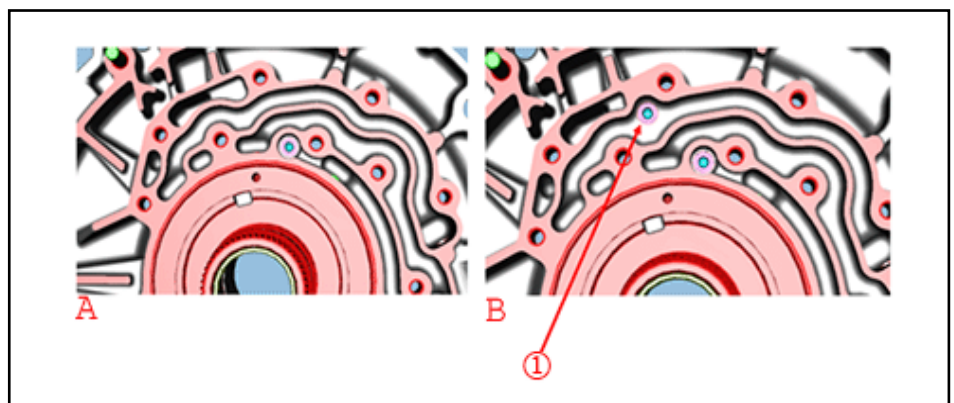
- (A) Old stator support asm 242
74636/24275106/2427265
6
- (B) New stator support asm
24277234

Note: The new stator shaft support assembly has a second check ball (1) added (see illustrations).

Install a new stator shaft support assembly that includes an additional check ball. Follow the instructions below to replace the stator shaft support assembly.
