GMC	Sierra	2014	2016			L83, L86, LV1, LV3	
	Yukon	2015	2016			L83, L86	
	Yukon Denali	2015	2016				
	Yukon XL	2015	2016				
	Yukon XL Denali	2015	2016

<i>Condition</i>	<p>Some customers may comment that the Malfunction Indicator Light (MIL) is illuminated.</p> <p>Technician may find DTC P0420 and P0430 set.</p>
<i>Cause</i>

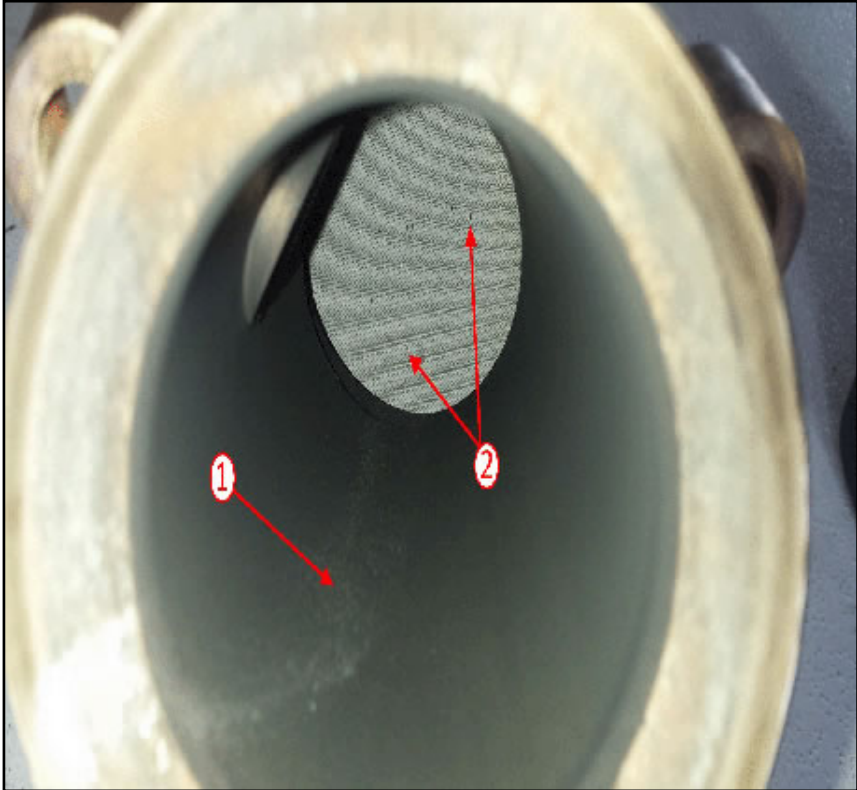
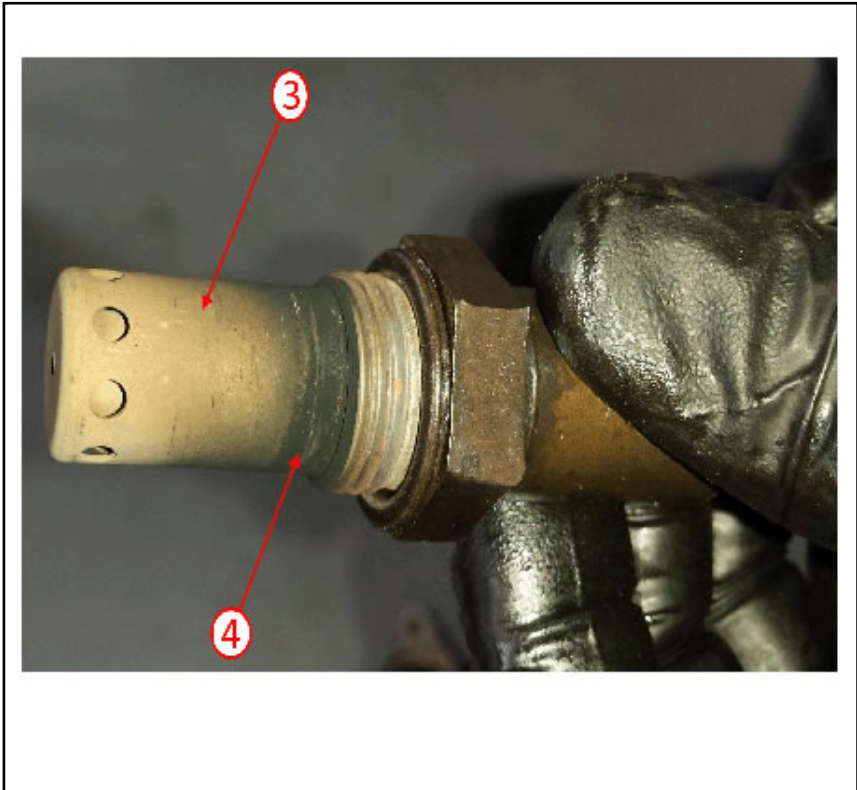
This may be caused by excessive sand and/or debris entering the air filter box and bypassing the seal of the air filter, due to not properly sealing, causing damage to the HO2 sensor element (3) and the catalytic converter to become blocked with sand and debris particles (1, 2).

*Do not* replace any of the parts until the air filter housing has been validated to be completely sealed.

If the condition is evident, inspection of the air box and air filter seal must be done.

Follow the Service Procedure steps in order to verify the sealing of the air filter to housing surface.

After validating the air box has been sealed, repair the P0420 and the P0430 codes *as needed*.
