# 2015 - 2016 Corvette: Service Bulletin: #16-NA-014: Delayed Engagement After Sitting With Engine Off

## #16-NA-014: Delayed Engagement After Sitting With Engine Off - (Jun 28, 2016)

**Subject:** Delayed Engagement After Sitting With Engine Off

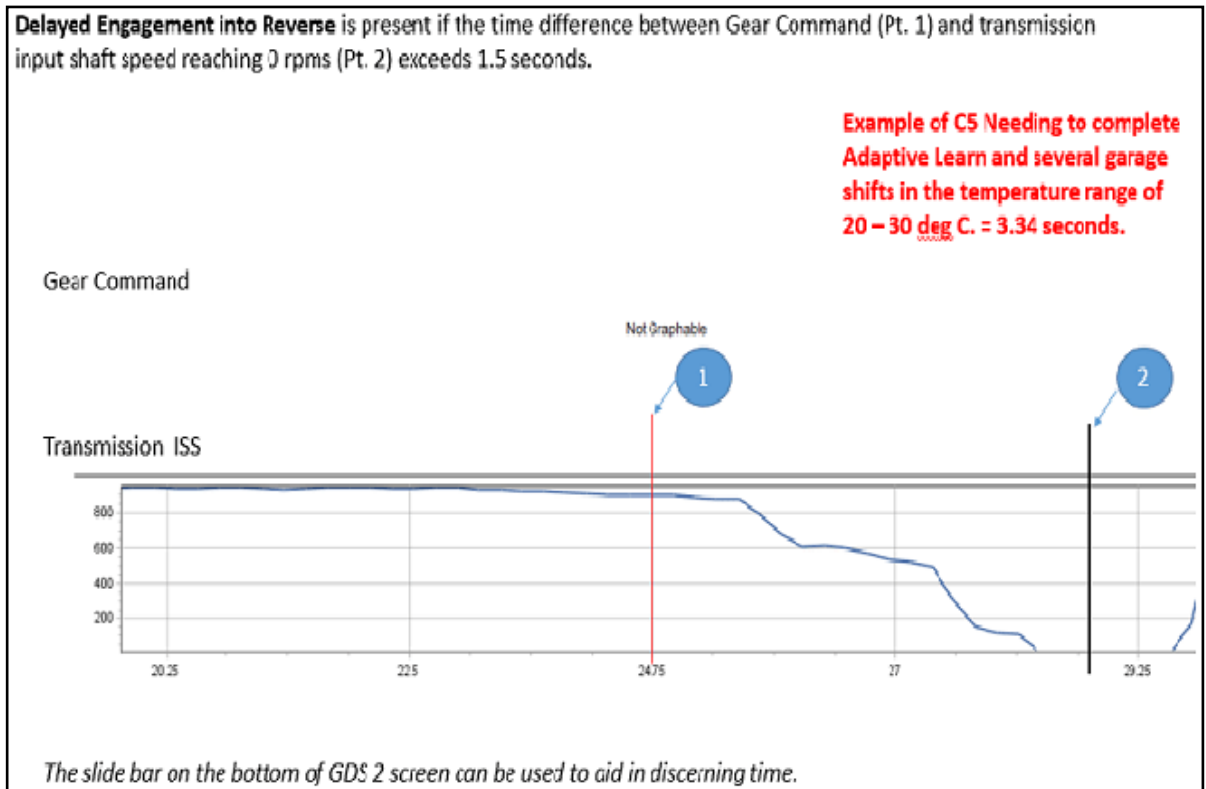
## Delayed Harsh Engagement - Clutch Slow to Fill

If the customer describes the condition as a long engagement time with a harsh or bump engagement feel when shifting the vehicle from park to drive or reverse. Using GDS and monitor engine RPM and transmission Input Speed Sensor (ISS) prior to starting the engine. Start the engine with the engine in park. ISS should equal engine RPM in 3 seconds or less. If ISS takes more than 3 seconds to equal engine RPM than follow the procedure for replacing the stator shaft support. If the ISS is equal to engine RPM in 3 seconds or less shift the vehicle from park to drive or reverse leaving the service brake applied. ISS should drop to zero “0” within 2 seconds, this is clutch

engagement time. Recording a GDS session log can be useful in diagnosing this condition.

For 2015 MY vehicles Contact GM TAC for review and additional instructions. Prior to contacting TAC record a GDS2 Session log of the delayed engagement.

For 2016 MY vehicle attempt to learn the C5 Clutch using the following procedure:

1. Allow the transmission sump temperature to rise between 20 and 30 degrees C (68 and 86 degrees F).

2. Perform 20 Park to Reverse shifts releasing the brake with each shift.

If the learn procedure does not correct the condition contact GM TAC for review and additional instructions. Prior to contacting TAC record a GDS2 Session log of the delayed engagement.
