2015 - 2016 Corvette: Service Bulletin:

#16-NA-014: Delayed Engagement After Sitting

#16-NA-014: Delayed Engagement After Sitting With Engine Off - (Jun 28, 2016)

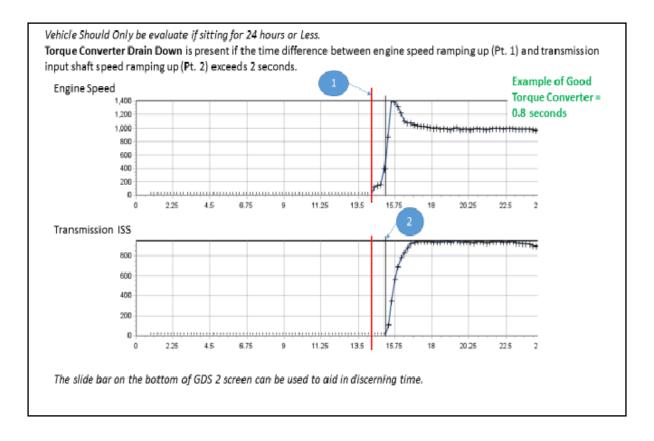
Not Wanting to Move or Slips - Torque Converter Drain Back

If the customer describes the condition as a long engagement with a slip/soft engagement feel and/or the vehicle not wanting to move, the condition should be considered drain back and the following procedure should be followed.

- 1. Using GDS and monitor engine RPM and transmission Input Speed Sensor (ISS) prior to starting the engine.
- 2. Start the engine with the transmission in park.
- ISS should be equal to engine RPM in 3 seconds or less.
- If ISS takes more than 3 seconds to equal engine RPM than follow the procedure for replacing the stator shaft support described in the service procedure below.

• *DO NOT* replace the stator shaft support on vehicles taking 3 seconds or less for turbine shaft speed to equal engine RPM.

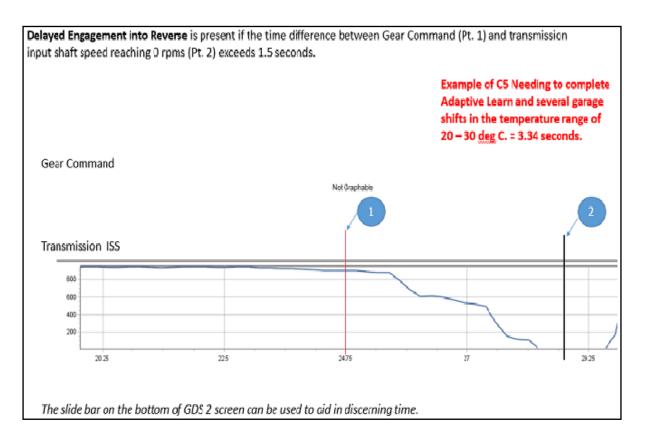
Delayed Harsh Engagement - Clutch Slow to Fill

If the customer describes the condition as a long engagement time with a harsh or bump engagement feel when shifting the vehicle from park to drive or reverse. Using GDS and monitor engine RPM and transmission Input Speed Sensor (ISS) prior to starting the engine. Start the engine with the engine in park. ISS should equal engine RPM in 3 seconds or less. If ISS takes more than 3 seconds to equal engine RPM than follow the procedure for replacing the stator shaft support. If the ISS is equal to engine RPM in 3 seconds or less shift the vehicle from park to drive or reverse leaving the service brake applied. ISS should drop to zero "0' within 2 seconds, this is clutch

engagement time. Recording a GDS session log can be useful in diagnosing this condition.

For 2015 MY vehicles Contact GM TAC for review and additional instructions. Prior to contacting TAC record a GDS2 Session log of the delayed engagement.

For 2016 MY vehicle attempt to learn the C5 Clutch using the following procedure:

1. Allow the transmission sump temperature to rise between 20 and 30 degrees C (68 and 86 degrees F).

2. Perform 20 Park to Reverse shifts releasing the brake with each shift.

If the learn procedure does not correct the condition contact GM TAC for review and additional instructions. Prior to contacting TAC record a GDS2 Session log of the delayed engagement.

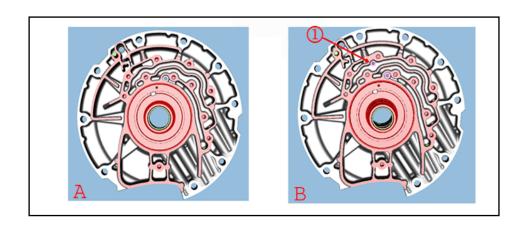
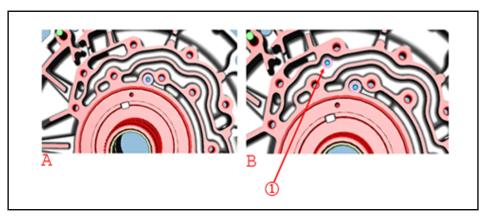
Old stator support asm New stator support asm

Note: The new stator shaft support assembly has a second check ball (1) added (see illustrations).

Install a new stator shaft support assembly that includes an additional check ball. Follow the instructions below to replace the stator shaft

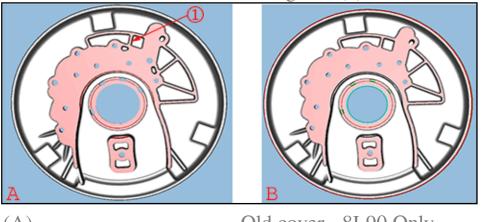
Old cover - 8L90 Only New cover - 8L90 Only

Note: The casting void has been eliminated from the underside of the cover for the 8L90 only (see illustration). The 8L45 is not required.
