# 2014 - 2016 Corvette: Service Bulletin: #16-NA-250: Slow Cranking, Dead Battery and/or No Start

## #16-NA-250: Slow Cranking, Dead Battery and/or No Start - (Aug 8, 2016)

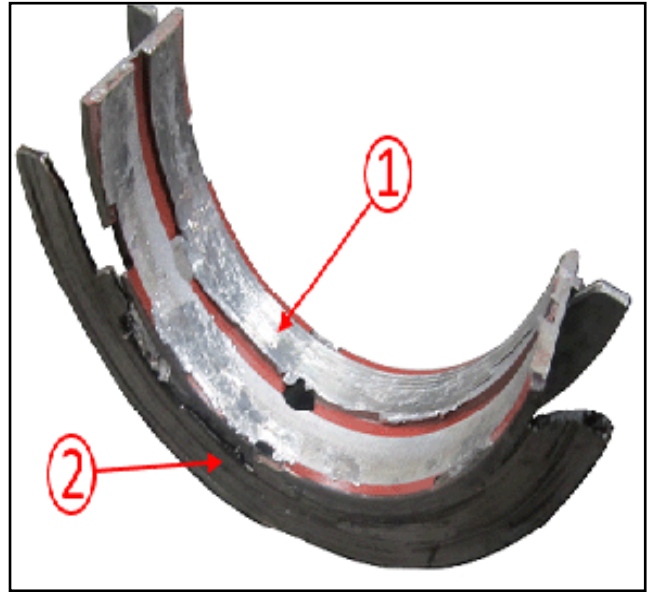
This may be caused by excessive pressure to the engine crankshaft thrust bearing (1), by forward pressure from a mis-aligned driveline support assembly.

If the driveline support assembly has been removed from a previous vehicle repair, it is required that the propeller shaft hub clamp (Automatic Transmission) or input shaft front bearing (Manual Transmission) be realigned. Follow the procedures outlined in SI.
