**2015 - 2016 Corvette: Service Bulletin:  
 #16-NA-107: DTC U0184 Set, Radio Inoperative,  
 Blue Screen, AM Clipping Noise, HD On/Off  
 Status Not Retained in Stations, Time Lag on  
 Transitions, No Audio with Internal Amp, Park  
 Assist Symbol Position Wrong i**

**#16-NA-107: DTC U0184 Set, Radio Inoperative, Blue Screen, AM Clipping Noise, HD On/Off Status Not Retained in Stations, Time Lag on Transitions, No Audio with Internal Amp, Park Assist Symbol Position Wrong in Rear View Camera - (Sep 8, 2016)**

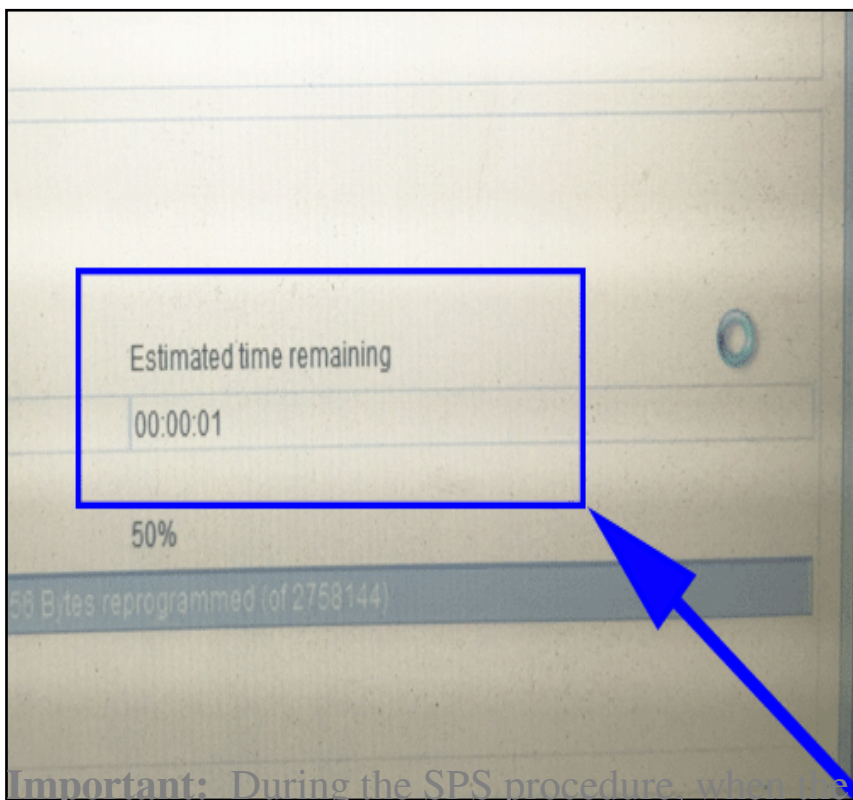
<i>Involved Region or Country</i>	North America and N.A. Export Regions
<i>Condition</i>	<p>Some customers may comment on one or more of the following conditions based on the RPOs:</p> <ul style="list-style-type: none"> <li>• Radio is inoperative (IO3 or IO6)</li> <li>• Screen is blue (IO3)</li> <li>• AM clipping noise in talk stations (All RPO's)</li> <li>• Watchdog timer implementation against blank display, GMLAN lost communication DTC U0184 (IO3 or IO6)</li> <li>• HD on/off status not retained when HD station is selected (All RPO's)</li> <li>• GPS compass is pointed to North only (IO6)</li> <li>• No audio with internal amp due to amp IC erroneously staying in sleep state (UQ3)</li> <li>• Time lag on transition</li> </ul>

<p>between Rear View Camera and normal display (IO3)</p> <ul style="list-style-type: none"> <li>• Park Assist symbol position is wrong in Rear View Camera (IO3)</li> </ul>
<i>Cause</i>	This may be caused by a software calibration within the radio.
<i>Additional Options</i>	Equipped with radio RPOs IO3, IO5 or IO6

If you encounter a vehicle with the above concern, reprogram the radio with the latest calibrations. Refer to the proper SPS radio reprogramming procedure in SI.

**Important:** During the SPS procedure, when the estimated time remaining reaches 00:00:01, it may take a few minutes to complete the reprogramming. Be sure to wait until the reprogramming is completed.

**Important:** You may have U0184 set in multiple modules and no communication with the radio. Please cycle power to the radio and recheck for communication. Update radio software if radio now communicates.
