2014 - 2016 Corvette: Service Bulletin: #PI1116A: Door Rattle Noise from Outside of Vehicle During High Radio Volume or High Bass Levels - (Sep 14, 2016)

Subject:	Door Rattle Noise from Outside of Vehicle During High Radio Volume or High Bass Levels
Models:	2014-2016 Chevrolet Corvette
Attention:	This PI also applies to any of the above models that may be Export from North America vehicles.

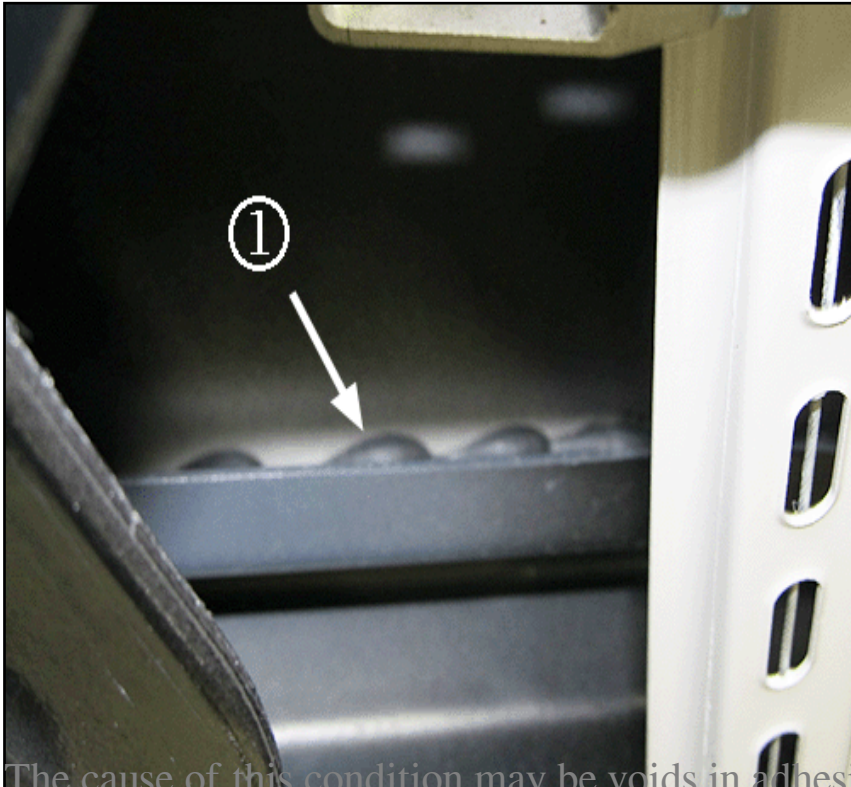
The cause of this condition may be voids in adhesive (1), leaving gaps between the inner door beam and the door skin.

Inspect the front side door beam and door skin gap for voids and add a bead of butyl ribbon sealer in those areas following the steps below:
