2016 - 2017 Corvette: Service Bulletin: #17-NA-025: Repeated Radio/display Resets, Volume Control Inoperative, Waiting for Update Media Message, Voice Command For Calling Bluetooth Phone Contacts Inoperative, Service Rear Vision System Message, Radi

#17-NA-025: Repeated Radio/display Resets, Volume Control Inoperative, Waiting for Update Media Message, Voice Command For Calling Bluetooth Phone Contacts Inoperative, Service Rear Vision System Message, Radio Turns On Unwanted At Startup, and/or Navigation Radio Destination State Defaults To WV - (Mar 3, 2017)

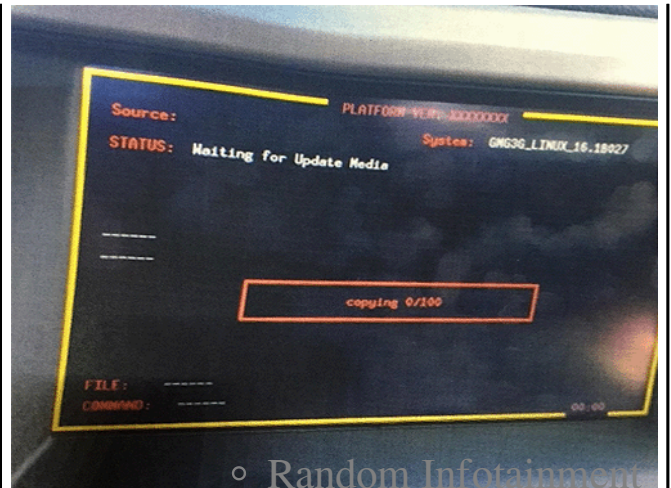
- Random Infotainment

system display resets while driving, screen temporarily goes blank and then returns after approximately 5 seconds.

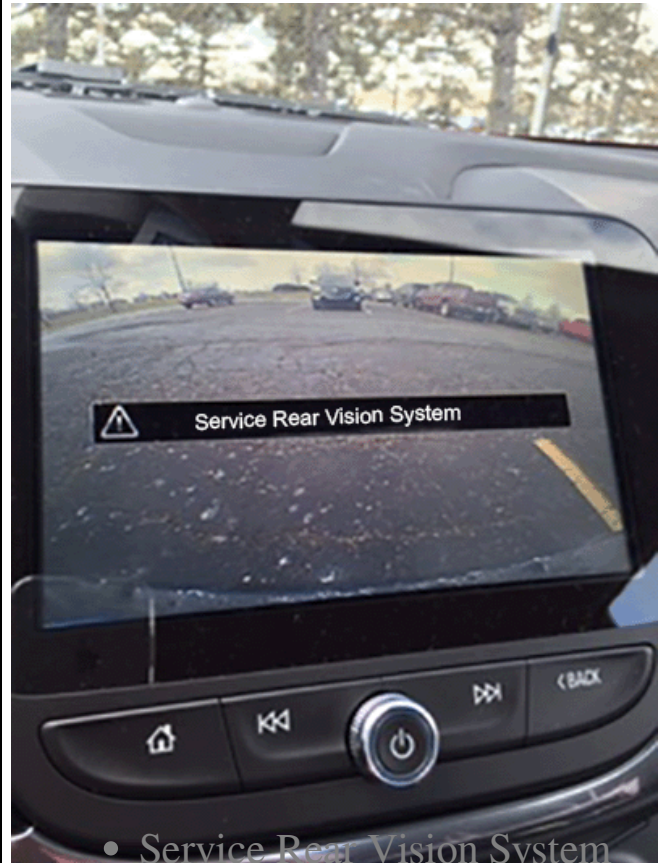
- Service Rear Vision System

Message displayed.

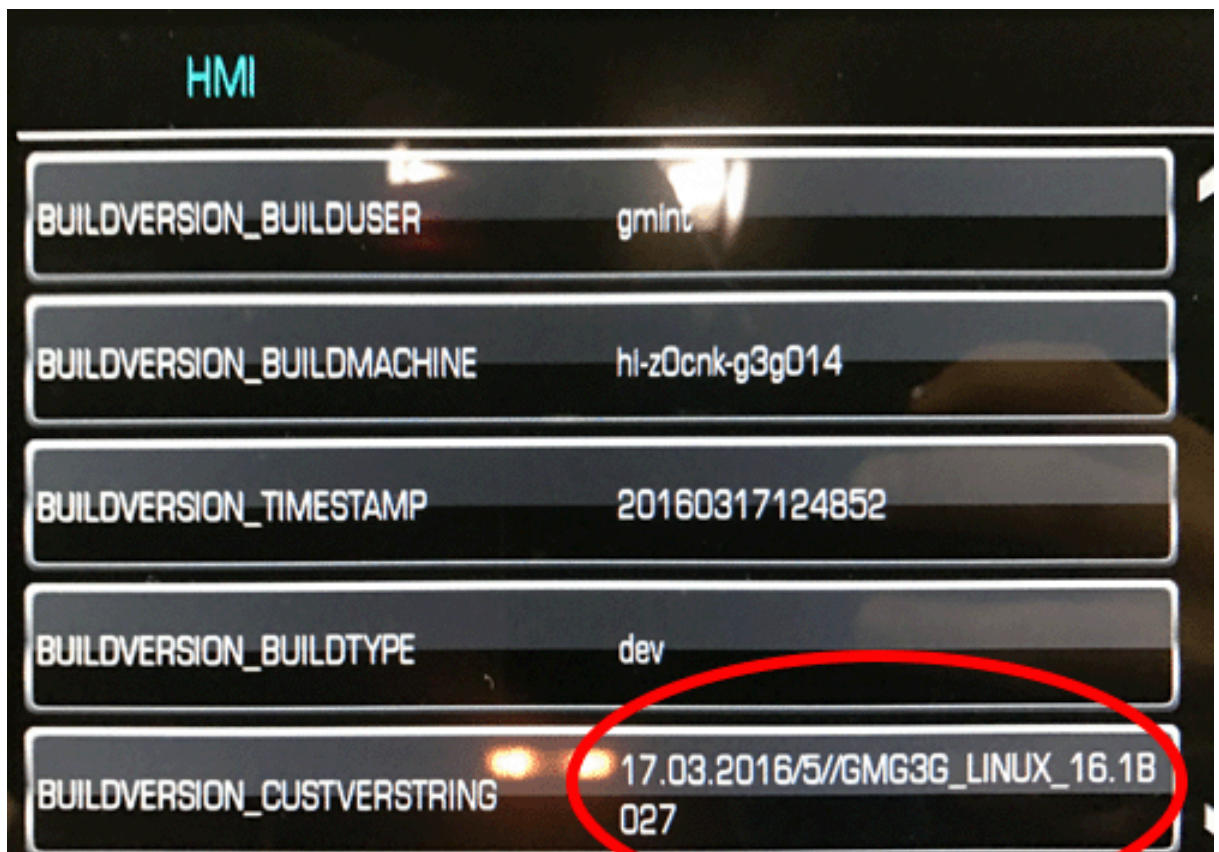
Once in Development Screen press HMI and document the Buildversion-Custverstring

If the software is one of the following, reprogram the Human Machine Interface Control Module. Refer to *Human Machine Interface Control Module Programming and Setup* in SI.

- 2016 Models - 15.1A044
- 2016 Models - 15.1A052
- 2016 Models - 15.2B033
- 2017 Models - 16.1B027
