1970 - 1973 Corvette: Service Bulletin: Overheating - 454 Cu.In. Engine with Air Conditioning

73-T-28

Subject: ENGINE OVERHEAT - 1970-1973
 CORVETTES WITH 454 CU. IN.
 ENGINES AND AIR CONDITIONING

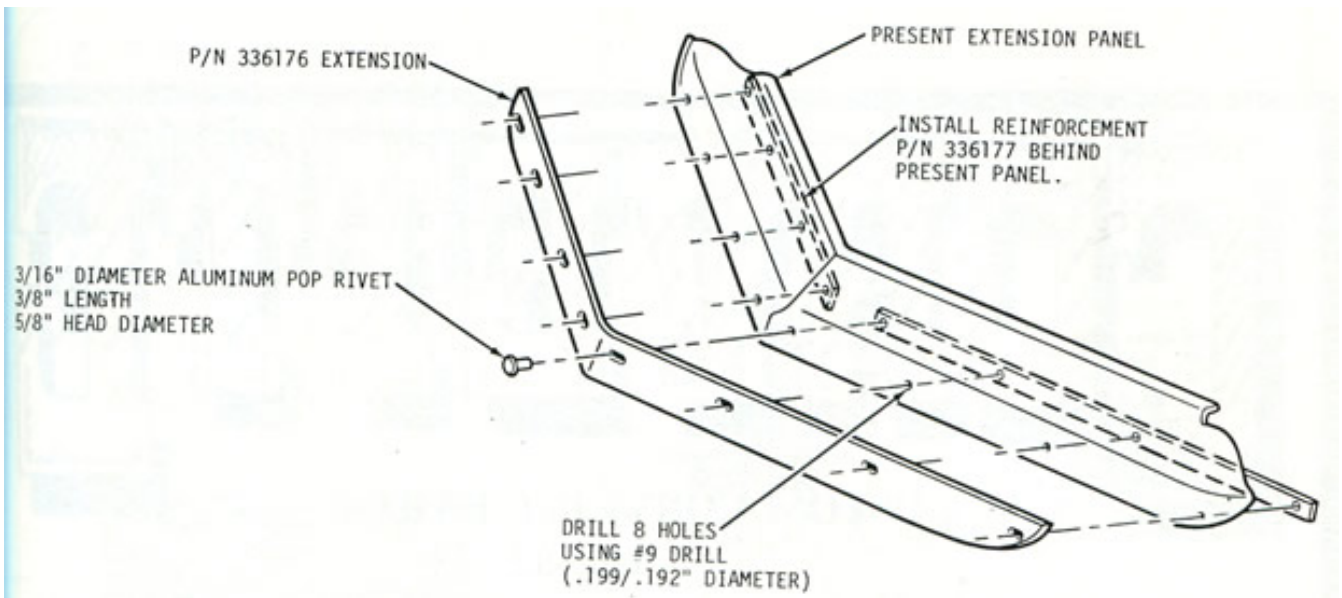
Engine overheat may be encountered on some 1970-1973 Corvettes equipped with the 454 cu. in. engine and air conditioning during high ambient temperatures when operated in heavy traffic. This condition is due to the limited amount of air flowing through the radiator at low vehicle speeds or during periods of extended idle.

To improve low speed cooling, an additional grille panel lower extension was installed in 1973 Corvettes produced after Vehicle Identification Number 1Z37Z3S410722. This extension, Part Number 336176, may be installed as illustrated on page 2 of this bulletin on early 1973 Corvettes only.
