2015 - 2017 Corvette: Service Bulletin: #15-NA-002: Information on Fuel Odor and/or Fuel Leaks from Underhood SIDI Pipes Between High Pressure Pump and Fuel Rails

#15-NA-002: Information on Fuel Odor and/or Fuel Leaks from Underhood SIDI Pipes Between High Pressure Pump and Fuel Rails - (Jul 11, 2017)

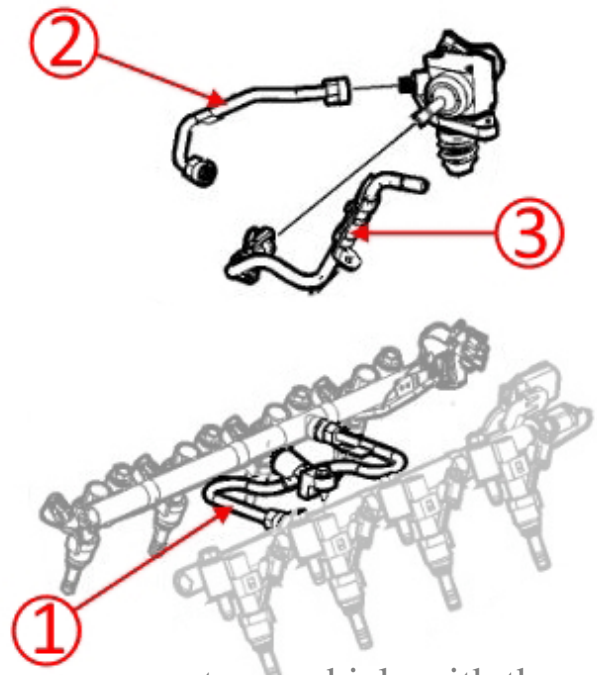
<i>Involved Region or Country</i>	North America and N. A. Export Regions
<i>Condition</i>	<p>Some customers may comment on one or more of the following conditions:</p> <ul style="list-style-type: none"> • Fuel odor smelled • Fuel leak in front of vehicle • Low/poor fuel economy • Vehicle hard start or engine stumble • Vehicle no start • Wet foam insulator on engine <p>The technician may find fuel leaking around the bellhousing or VL0M.</p>

<p>Note: The conditions listed may occur with or without the Malfunction Indicator Lamp (MIL) illuminating.</p>
<p>Important: It is required to replace the engine fuel feed intermediate pipes during any service repairs that required one or more of the pipes to be loosened or removed.</p>	
<p><i>Cause</i></p>	<p>This condition may be caused by the result of a fuel leak at one of the high pressure fuel rail pipe connections that was installed incorrectly during service of another engine component, that required the fuel system to be opened. (i.e. fuel rail, lifter, head gasket, High pressure pump, injector, etc.)</p>
<p><i>Correction</i></p>	<p>Important: If any damage occurred due to leaking fuel, be sure to replace as necessary. (i.e. Fuel Pump Insulator)</p>

1. Install Dye (p/n 88861206) into the fuel system via the filler neck
2. Start Engine and let idle for 15 minutes
3. Remove intake manifold
4. Inspect for any leaks.

1. If a leak is found at any nut location, change as denoted below.

- If a leak in pipe 2 is found, change *only* pipe 2 (Int pipe 2), ensuring the interfaces for this tube are clean and free of debris.
- If a leak in pipe 1 is found, change pipe 1 *and* pipe 2 (Int pipe 1 and 2), ensuring the interfaces for this tube are clean and free of debris.
- If a leak in pipe 3 is found, change pipe 3 only (Fuel feed). Ensure the interfaces for this tube are clean and free of debris.
