2014 - 2018 Corvette: Service Bulletin: #PIP5248D: Stalling Shudder And/or Hard shifting Into 1st Gear Or Reverse Vibration On launch

#PIP5248D: Stalling Shudder And/or Hard shifting Into 1st Gear Or Reverse Vibration On launch (With Excessive Crankshaft End Play) - (Aug 10, 2017)

Subject: Stalling Shudder And/or Hard shifting
Into 1st Gear Or Reverse Vibration On
launch (With Excessive Crankshaft
End Play)

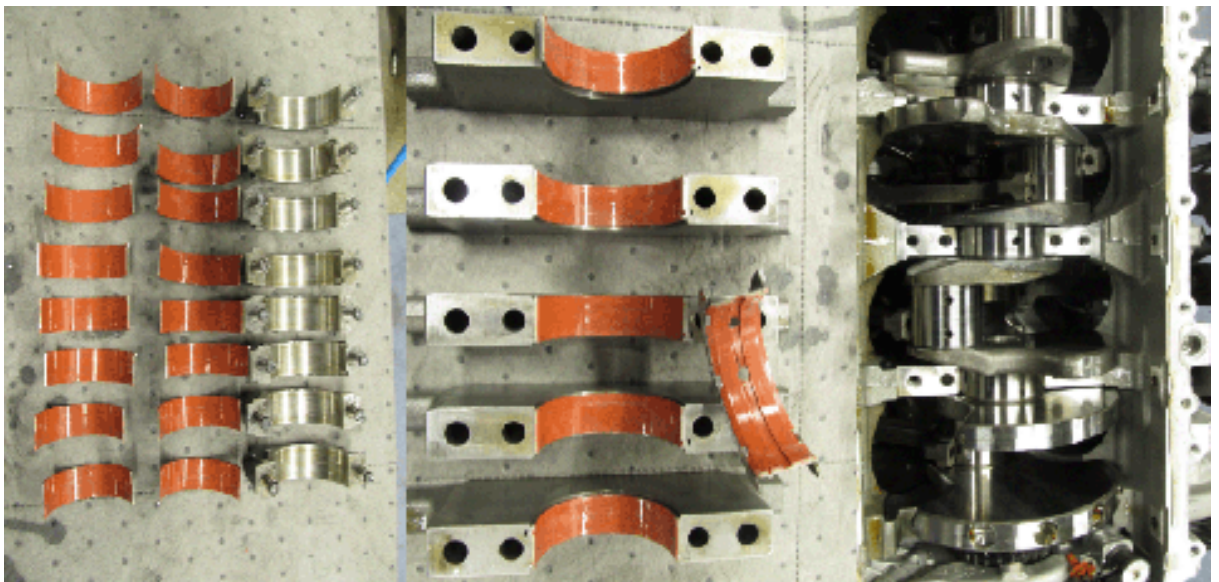
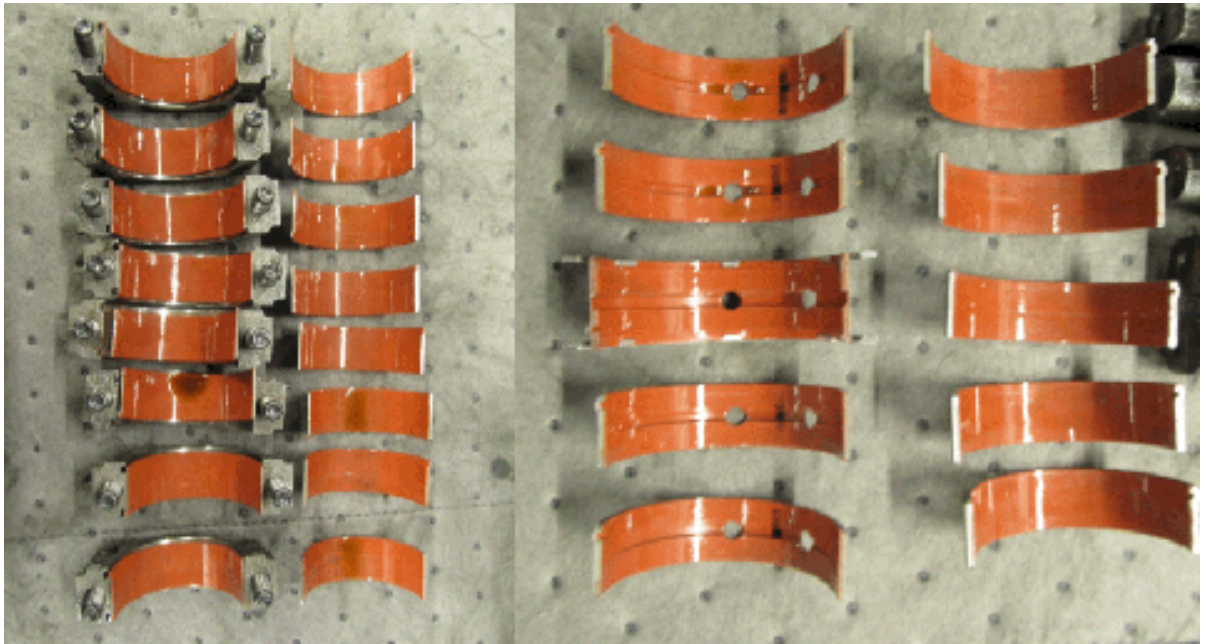
This concern could be caused by excessive crankshaft end play.

Note: If bearings and crankshaft look like components in attached picture, damage has not occurred.

Inspect thrust bearing for wear on one side and crankshaft on that “mating” surface.

If wear is evident (3 vertical channels worn off) replace connecting rod bearings, main bearings, thrust bearing and crankshaft.
