# 2016 - 2017 Corvette: Service Bulletin: #PIP5498B: SES Lamp P050D P0300 Setting On A Cold Start And/Or a Run Rough Warm with No codes

## #PIP5498B: SES Lamp P050D P0300 Setting On A Cold Start And/Or a Run Rough Warm with No codes - (Aug 8, 2017)

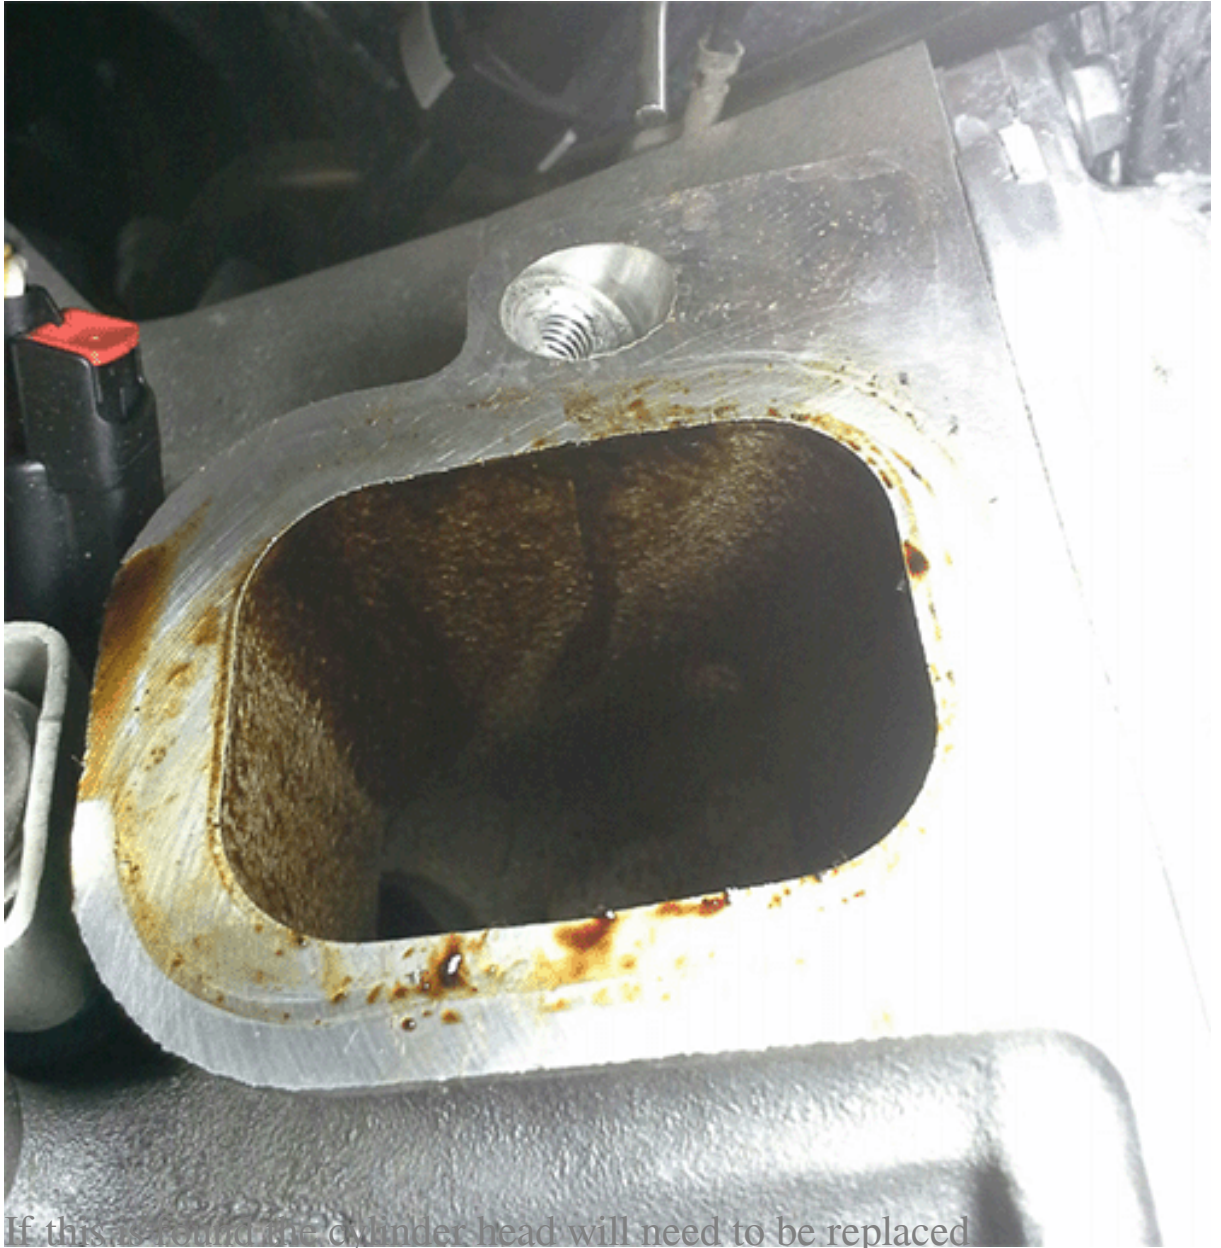
If the head casting line is the concern the intake port will be wet with a coolant oil mix.

This could be the cause of a running rough warn concern with or without codes.

The location of where the coolant is running down in the port will also look washed down.

If this is found the cylinder head will need to be replaced

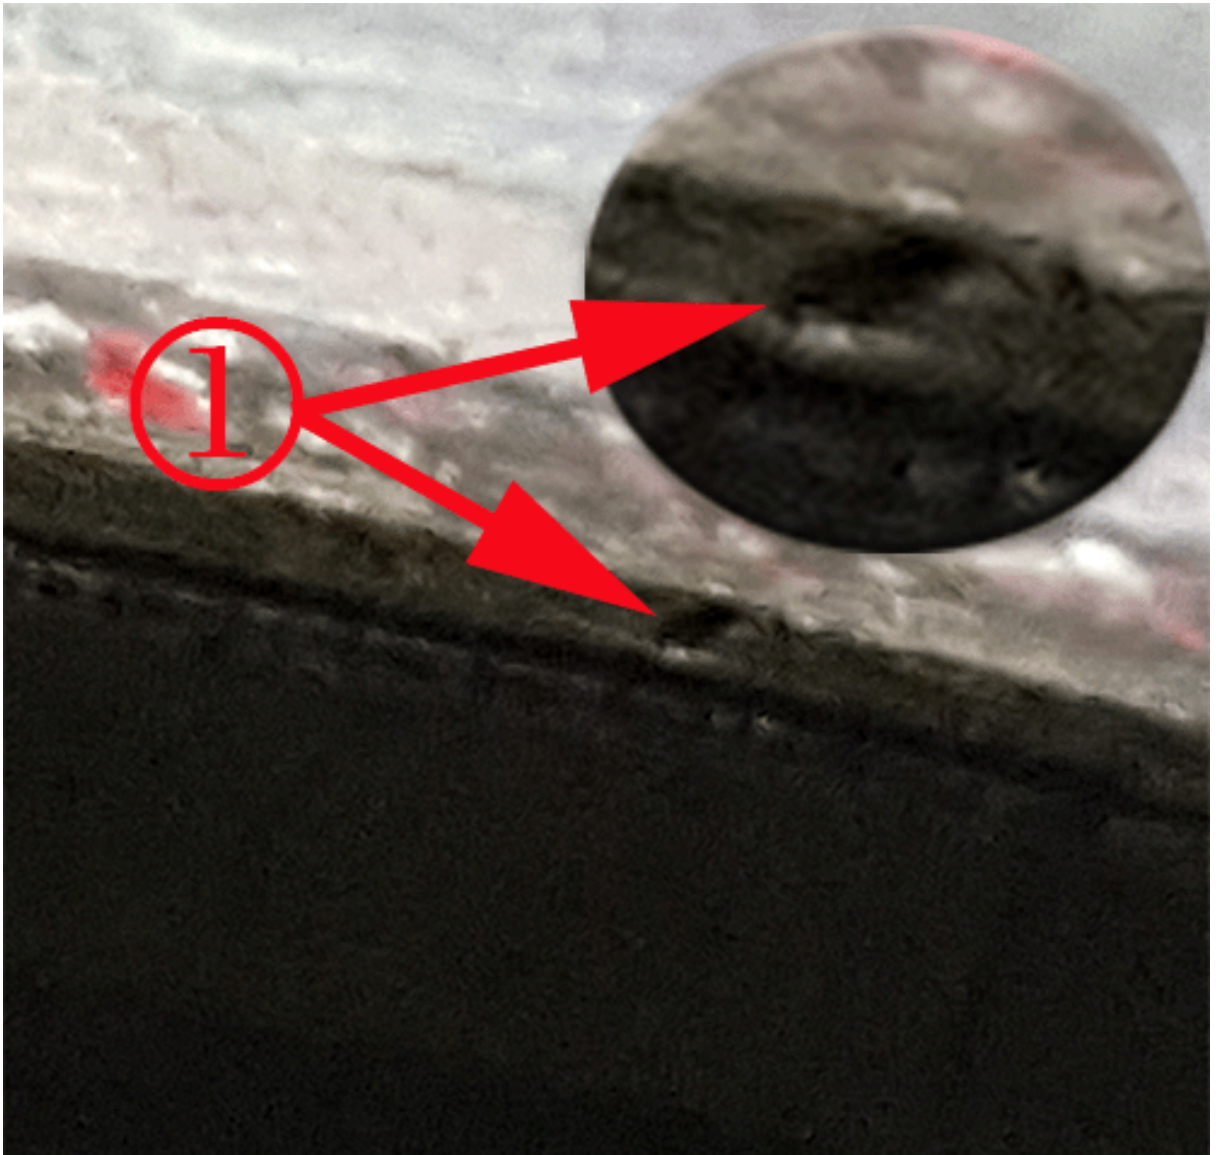
For coolant entry at the liner to deck face casting of the cylinder bore.

It is hard to see the actual source (pin hole) but it usually streams down the liner so that you can see it with a borescope. (Sometimes) The top of the piston will be steam cleaned.

Do not confuse residual fuel on the piston crown / surface as coolant. Some fuel residue may be present and can be mistaken as coolant (reason for the cooling system Dye to be added). Use black light to confirm the liquid is coolant. If this concern is present, do not replace the cylinder head because that will not repair this concern. Call PQC per the latest version of 16-NA-338, if required, reference this PI and replace the engine.
