2015 - 2017 Corvette: GM TechLink: Diagnostic Tips for Harsh Shifting Transmission Conditions

Diagnostic Tips for Harsh Shifting Transmission Conditions

June 10, 2017

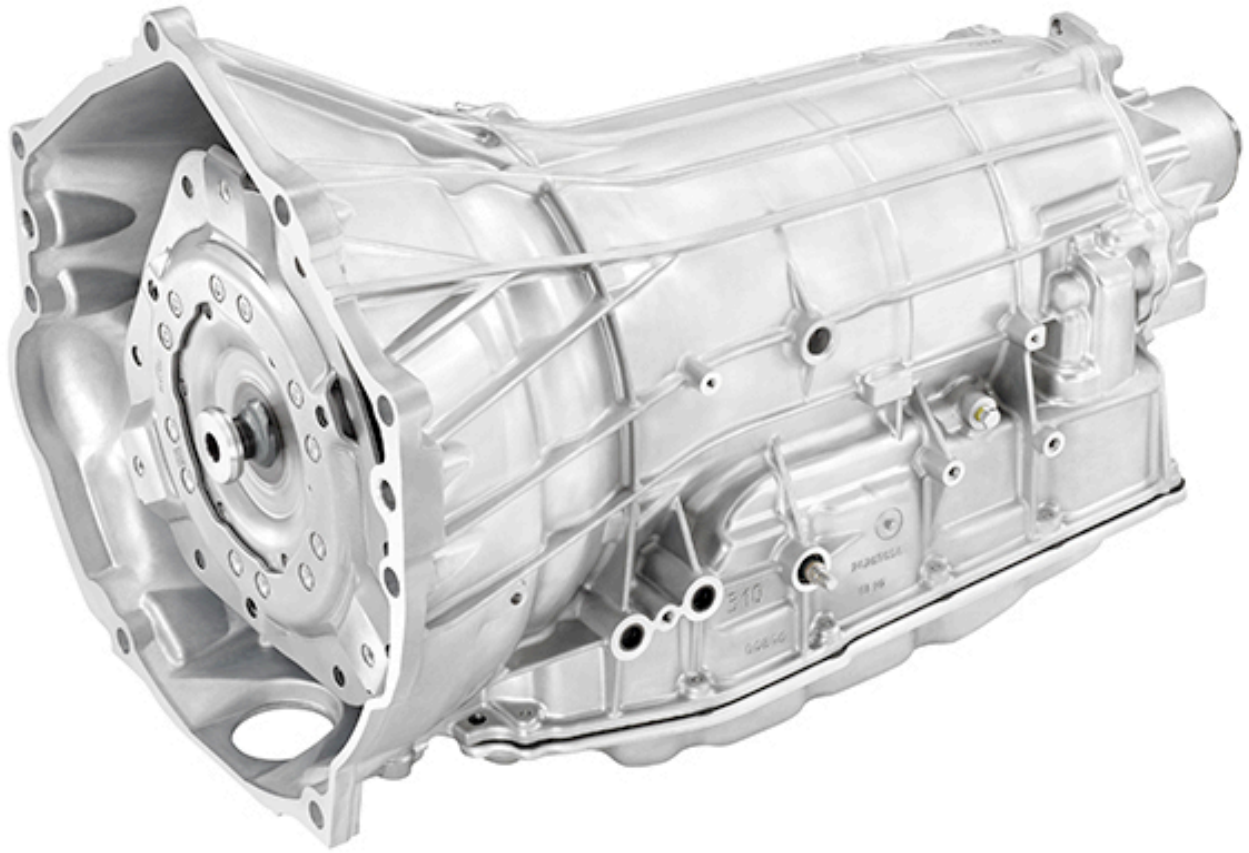
Fig. 12

Harsh shifting conditions and delayed garage shift engagements may be noticed on some 2017 Colorado, Canyon, Express, Savana; 2016-2017 ATS, CT6, CTS, Camaro; 2015 - 2017 Escalade, Silverado, Sierra, Yukon Denali, and Corvette models equipped with the 8L45 or 8L90 automatic transmission (RPOs M5N, M5T, M5U, M5X). (Fig. 12) The harsh shift conditions may be caused by one or more clutch fill times not completely learned in the Transmission Control Module (TCM).
