# 2014 - 2016 Corvette: Service Bulletin: #17-NA-278: Convertible Top Creak or Snap Noise While Driving

## #17-NA-278: Convertible Top Creak or Snap Noise While Driving - (Aug 29, 2017)

<b>Subject:</b>				Convertible Top Creak or Snap Noise While Driving			
Brand:	Model:	Model Year:		VIN:		Engine:	Transmission:
		from	to	from	to		
Chevrolet	Corvette Convertible	2014	2016			All	All

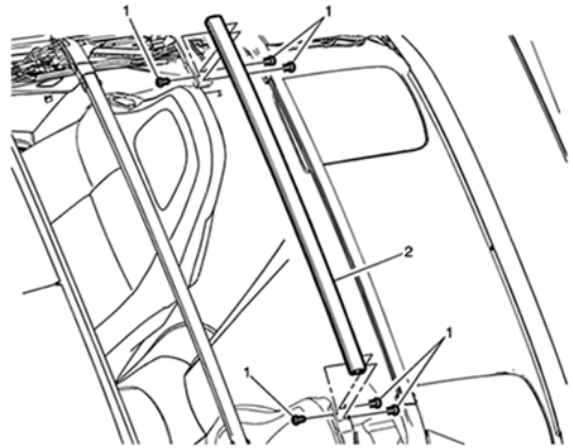
<i>Involved Region or Country</i>	North America, Japan, Europe, Middle East, Russia
<i>Condition</i>	Some customers may comment on hearing a creak or snapping noise from the convertible top while driving their vehicle. The noise may be loudest when the vehicle has sat in the sun for a length of time.
<i>Cause</i>

The cause of the condition may be that the fasteners (1) at the ends of the #3 Bow (2) may have lost torque.

Following the Service Procedure below, remove the original smaller screws and install the new larger M6 screws referenced in the Part Table.
