2016 - 2019 Corvette: GM TechLink: Setting the Timing on Gen 5 V6 and V8 Engines

Setting the Timing on Gen 5 V6 and V8 Engines

March 21, 2019 - GM TechLink

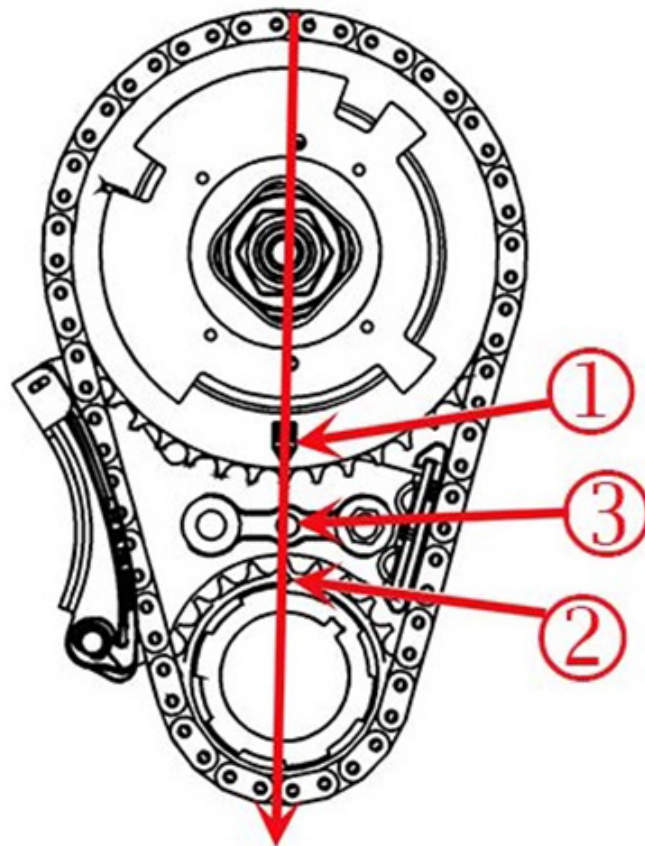
Fig. 12

In the illustration of the gear set (Fig. 12), the vertical red line travels through the links at the top and bottom. In this case, the chain was installed with the face links at the teeth that were 180 degrees from the proper timing marks. The mark on the camshaft position actuator sprocket (Fig. 12, #1) should be in the 6 o'clock position and the mark on the crankshaft sprocket (Fig. 12, #2)

should be located in the 12 o'clock position. Since the oil feed hole (Fig. 12, # 3) is not centered in the block, it may throw off your perception during alignment.

To set the timing, mark the tooth that is 180 degrees opposite of the timing marks on both gears. Next, count the links and fold the timing chain to mark the links at each end. Hang the chain on the two gears at the marks and verify that the gears are properly aligned.
