2015 - 2019 Corvette: TechLink: Low Oil Pressure Conditions

September 13, 2019

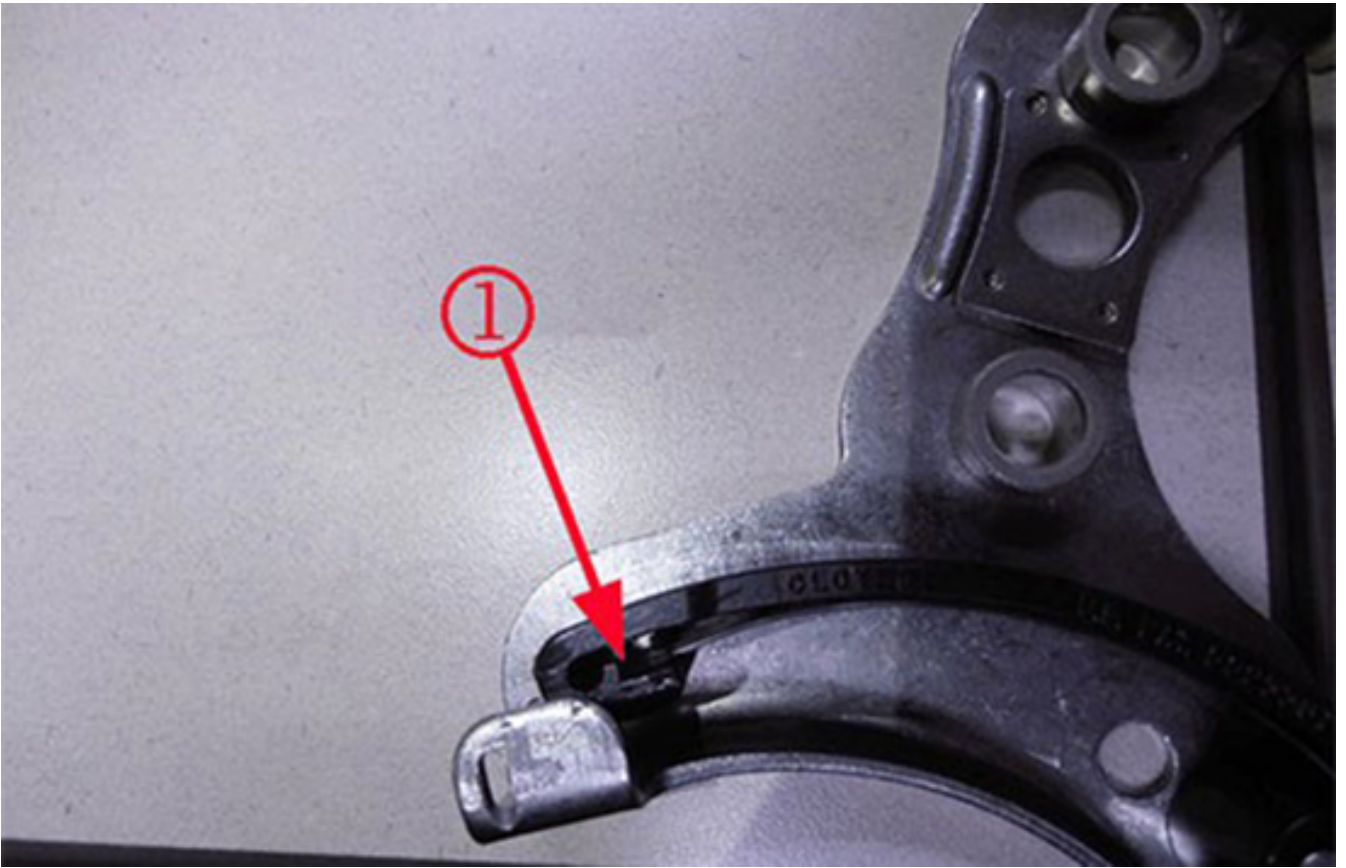
Fig. 19

If these conditions are found, the tensioner spring in the timing chain guide may be “short” and not fully seated into the guide pivot end. (Fig. 19) Cycling the oil pump control valve will not cause any changes in the oil pump response. Replace the timing chain tensioner guide.
