# 2020 Corvette: Service Bulletin: #N202302840: Service Update - Door Paint Chipping

**Subject:** N202302840 — Door  
Paint Chipping  
**Models:** 2020 Chevrolet Corvette

*Release Date:* April 2020

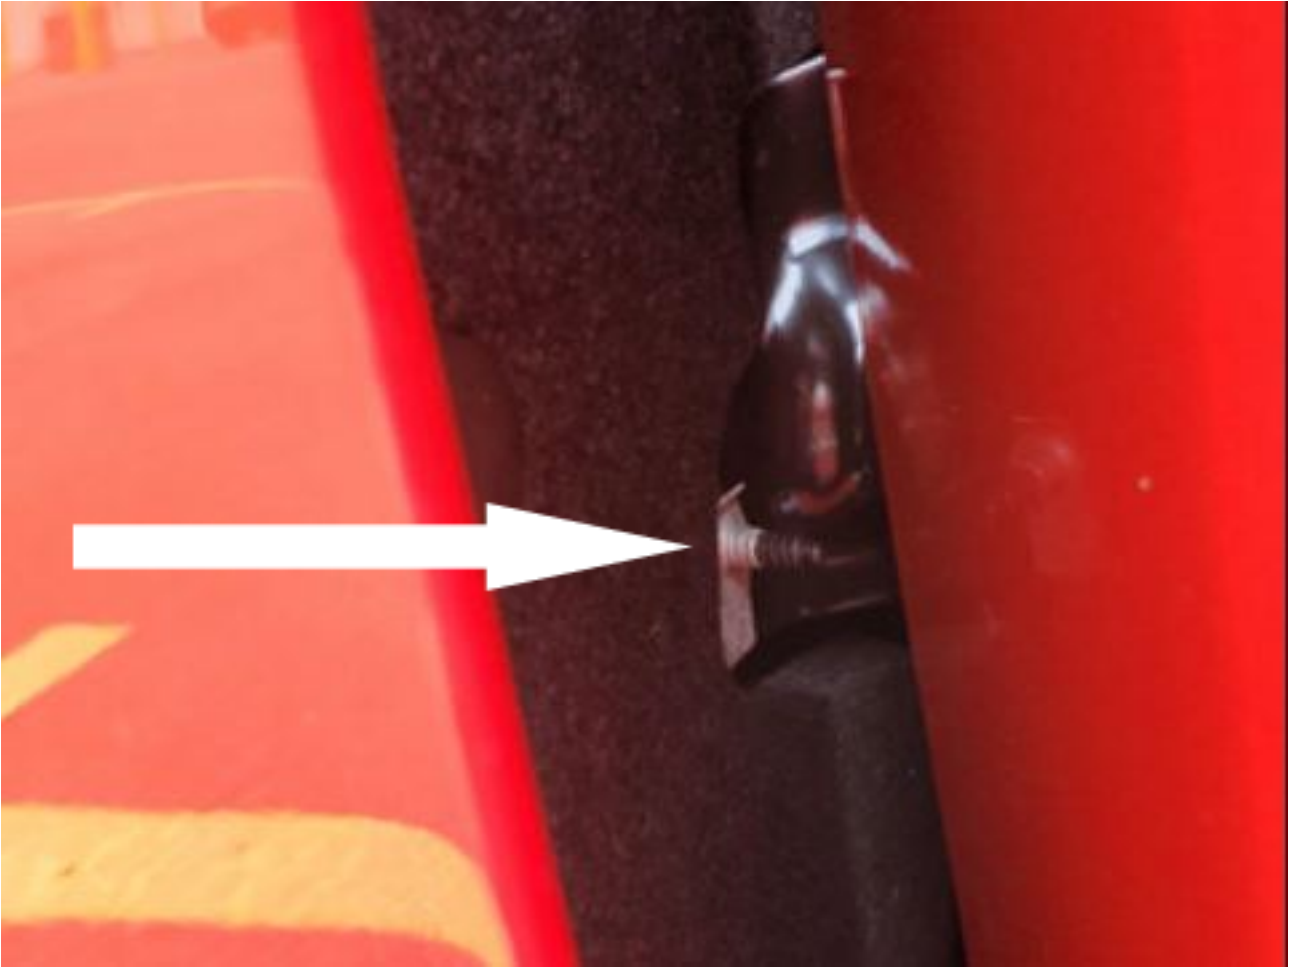
- If more than 2 threads are showing, proceed to step # 4.
- Partially remove the wheelhouse liner to access the rear fender mounting fasteners. Refer to *Front Wheelhouse Liner Replacement* in SI.
  1. Locate and remove the center fender to body fastener as shown.
  2. Install the shorter service fastener. Tighten  $9\text{ Nm}$  ( $80\text{ lb in}$ ).
  3. Reinstall the wheelhouse liner. Refer to *Front Wheelhouse Liner Replacement* in SI.
  4. Repeat steps 1-7 on the right side of the vehicle.
