2020 Corvette: GM TechLink: Corvette Competition Seat Bolster Pad Support

GM TechLink
April 30, 2020

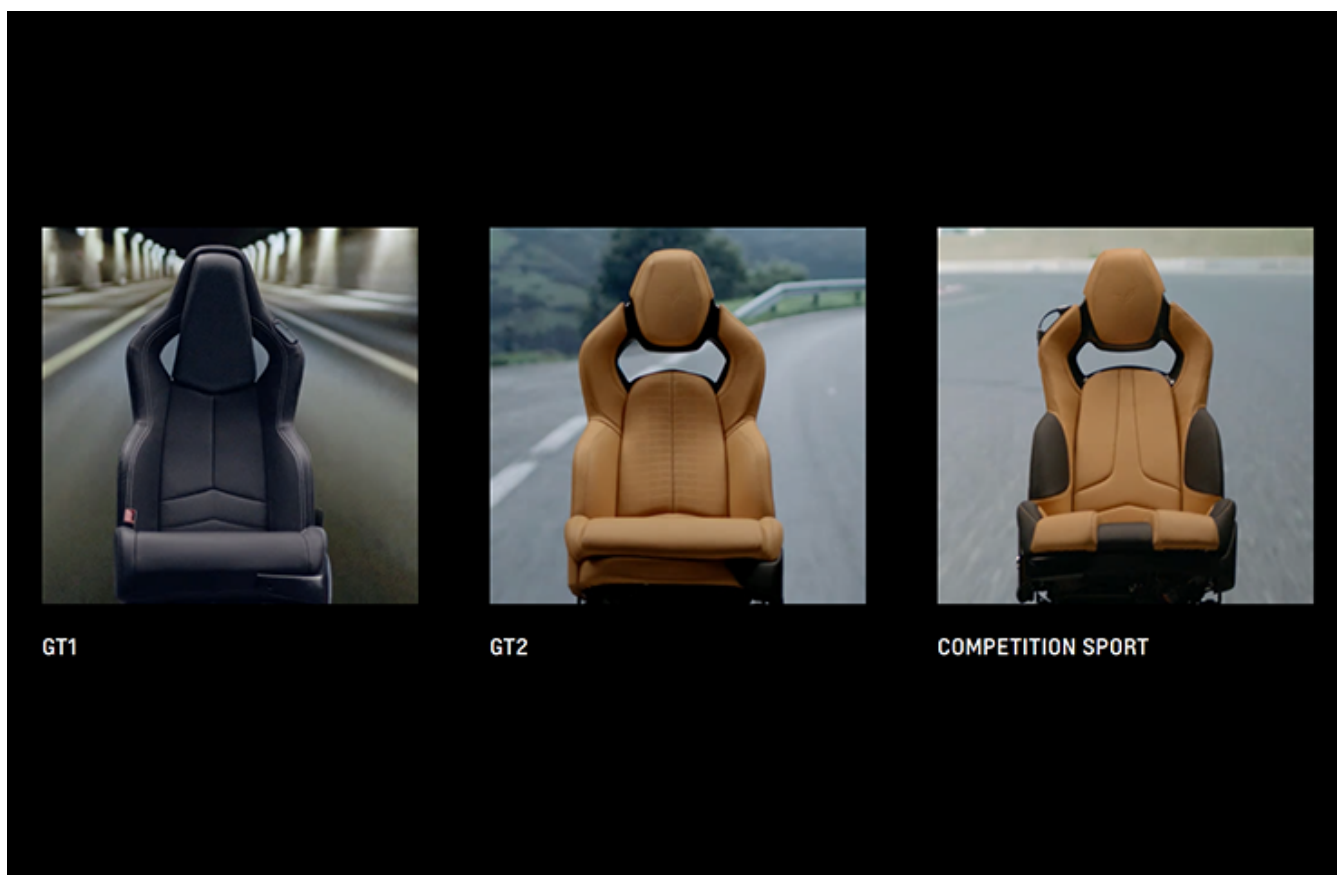
Fig. 1

The all-new 2020 Corvette Stingray features three available seats: GT1, GT2, and Competition Sport. (Fig. 1) On some models with the Competition Sport seats, the sides of the aggressive seat cushion bolsters may have a fit and appearance condition where the seat cushion pad folds under the cushion cover.

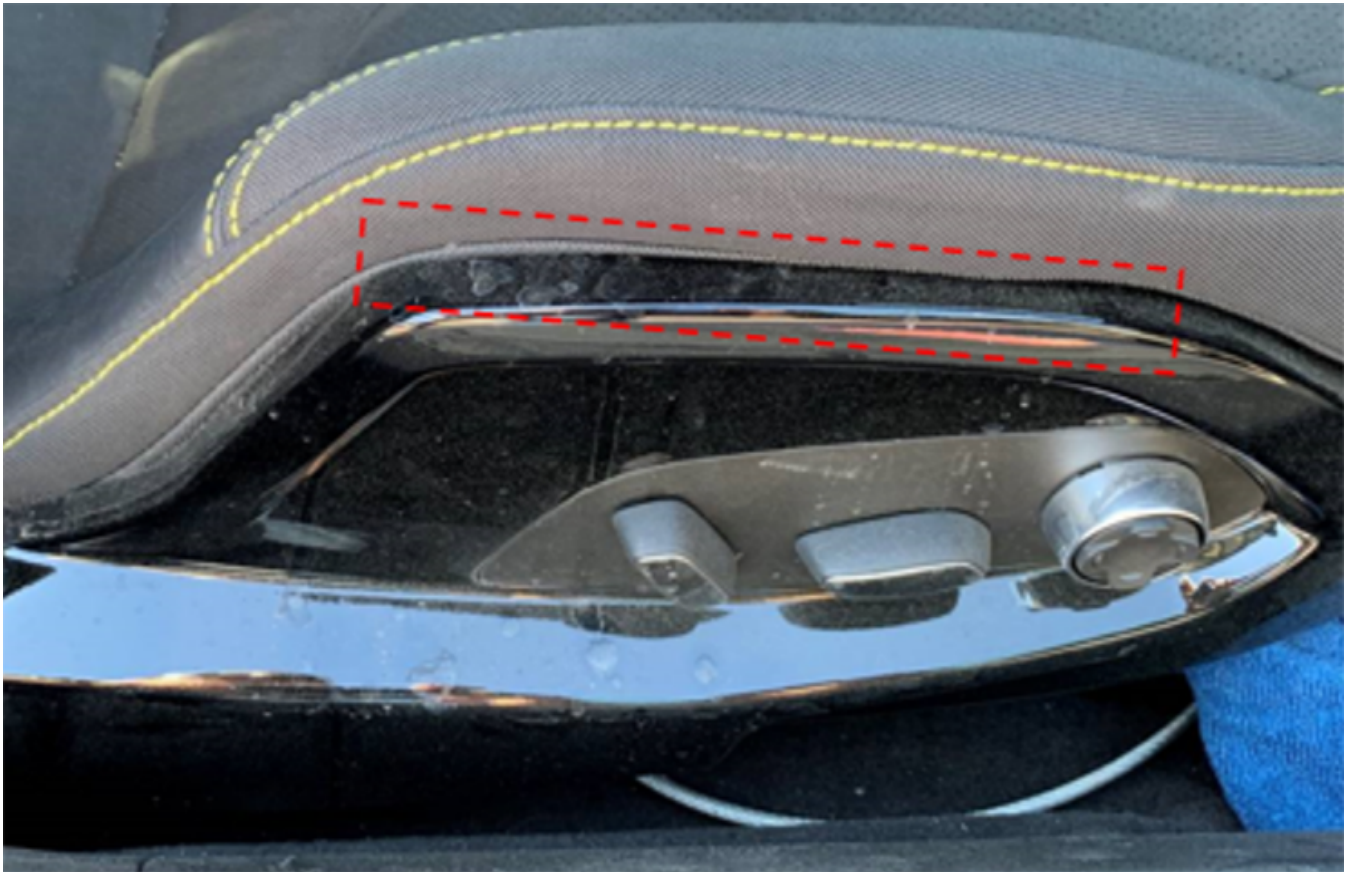
Fig. 2

The fit and appearance condition is due to an incorrect seat foam-to-side shield interface that causes the foam to be unsupported. (Fig. 2) As a result, the unsupported seat foam can create a poor appearance as the driver enters and exits the vehicle over time.
