# 2020 Corvette: GM TechLink: Corvette Competition Seat Bolster Pad Support

**GM TechLink**  
**April 30, 2020**

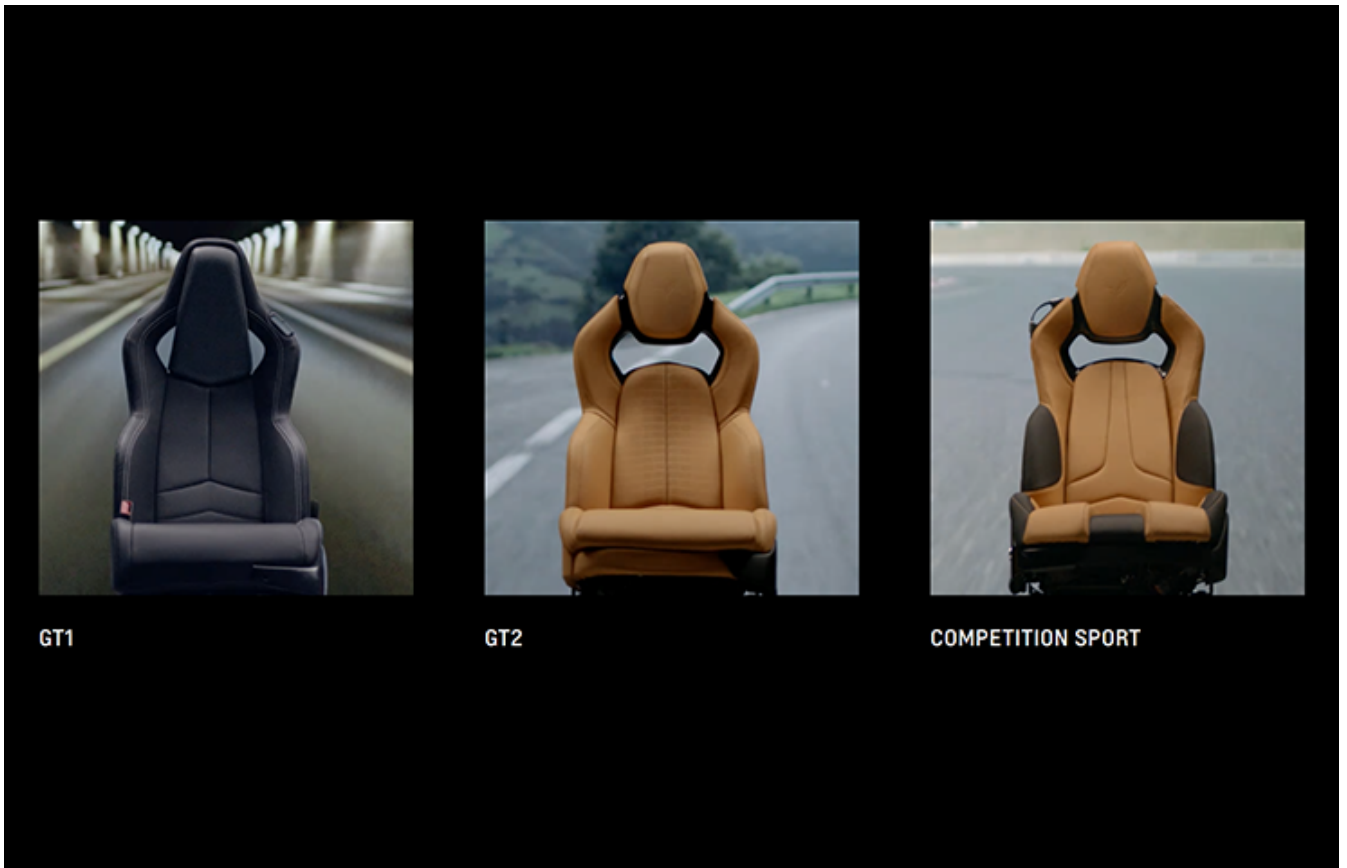
**Fig. 1**

The all-new 2020 Corvette Stingray features three available seats: GT1, GT2, and Competition Sport. (Fig. 1) On some models with the Competition Sport seats, the sides of the aggressive seat cushion bolsters may have a fit and appearance condition where the seat cushion pad folds under the cushion cover.

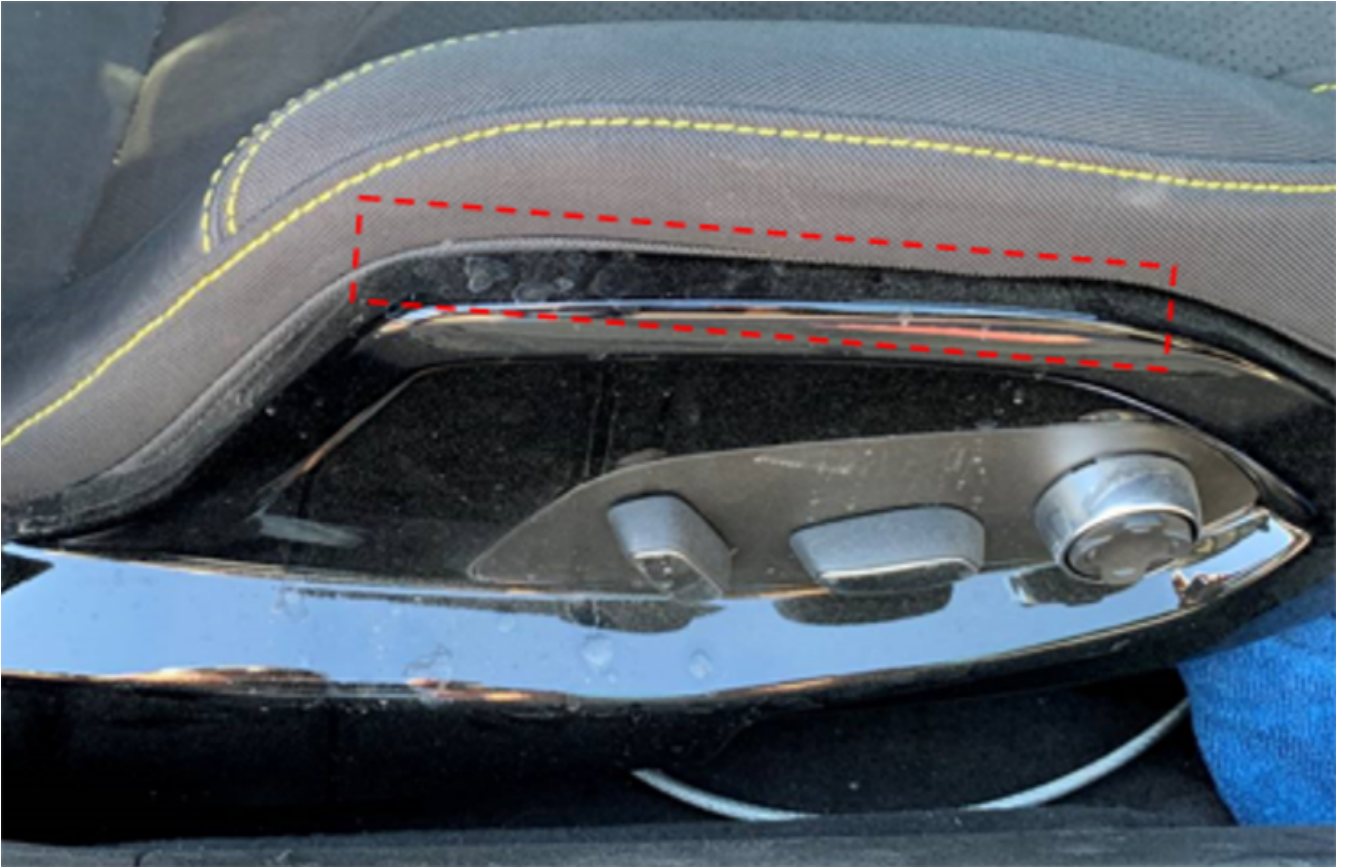
**Fig. 2**

The fit and appearance condition is due to an incorrect seat foam-to-side shield interface that causes the foam to be unsupported. (Fig. 2) As a result, the unsupported seat foam can create a poor appearance as the driver enters and exits the vehicle over time.

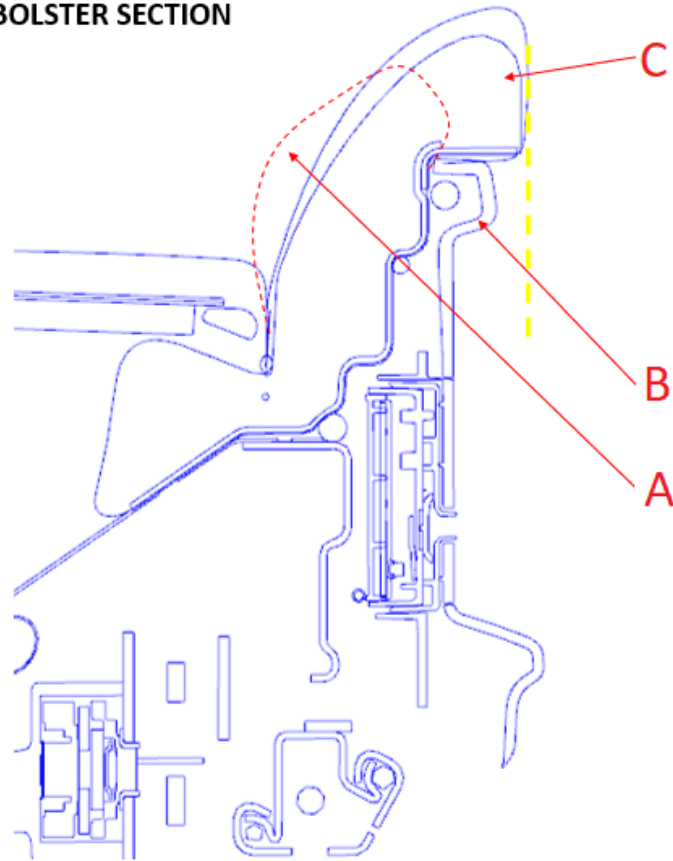
**Fig. 3**

If this condition is found, check that the foam and bottom felt of the foam pad (Fig. 3, A) are not caught on the edge of the side shield (Fig. 3, B), which may cause the poor trim appearance. The felt on the bottom of the foam pad should extend over the edge of the side shield, allowing the foam to be proud to the side shield. (Fig. 3, C)

When properly fitted, the bolster will be flush with the vertical surface of the side shield.
