2020 Corvette: GM TechLink: Corvette Competition Seat Bolster Pad Support

GM TechLink
April 30, 2020

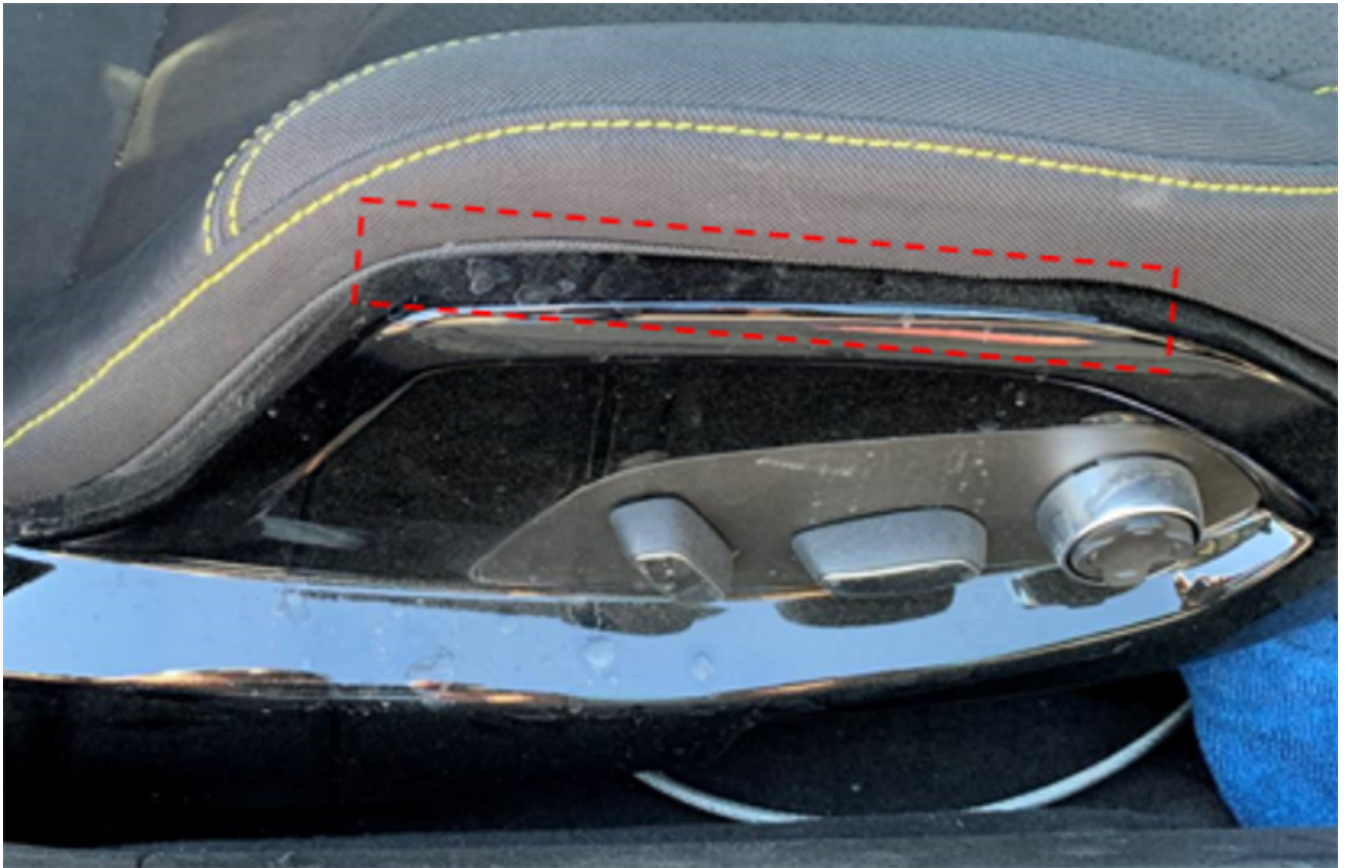
Fig. 2

The fit and appearance condition is due to an incorrect seat foam-to-side shield interface that causes the foam to be unsupported. (Fig. 2) As a result, the unsupported seat foam can create a poor appearance as the driver enters and exits the vehicle over time.

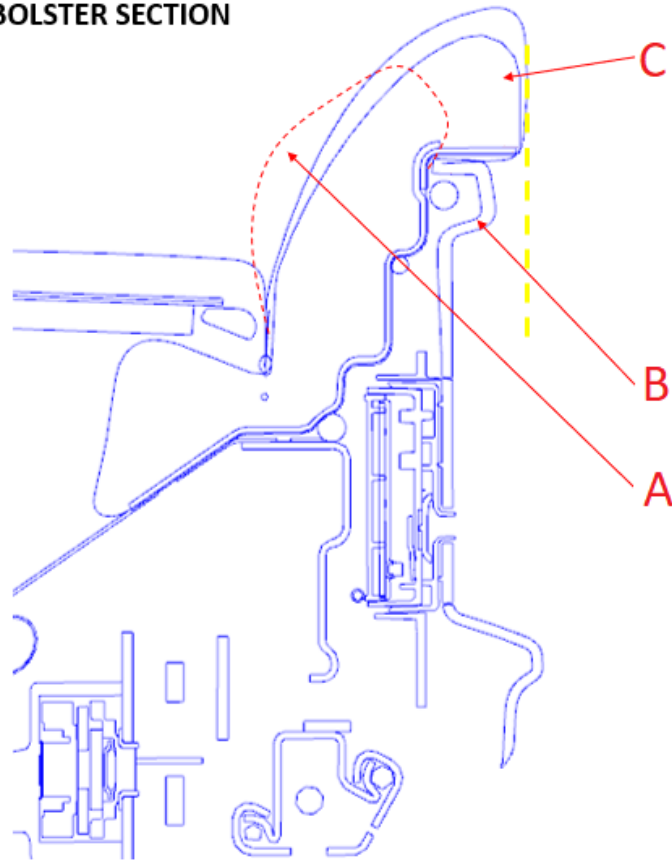
Fig. 3

If this condition is found, check that the foam and bottom felt of the foam pad (Fig. 3, A) are not caught on the edge of the side shield (Fig. 3, B), which may cause the poor trim appearance. The felt on the bottom of the foam pad should extend over the edge of the side shield, allowing the foam to be proud to the side shield. (Fig. 3, C)

When properly fitted, the bolster will be flush with the vertical surface of the side shield.

To correct the fit and appearance condition, remove side shield and massage the foam pad back into position. The pad must be pulled up vertically. Make sure it is not folded or collapsed.

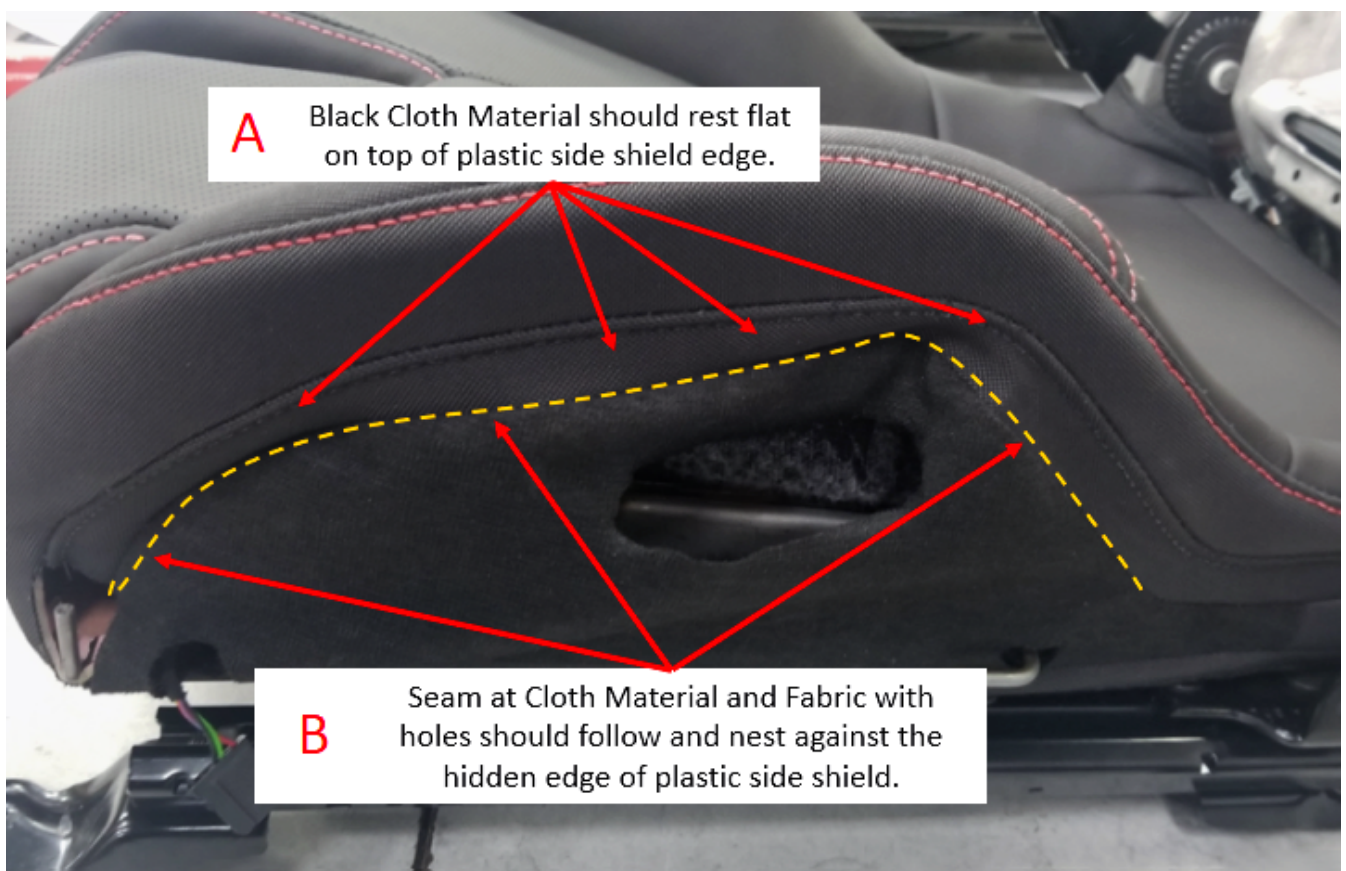
Fig. 4

When in proper position, the pad will fit into the cushion cover of the bolster with the black cloth material of the bolster cover resting flat on the top of the side shield edge. (Fig. 4, A) In addition, the seam of the cloth material and perforated fabric should follow along the hidden edge of the side shield. (Fig. 4, B)
