2020 Corvette: Rushing Air Sound in PCV Tube

GM TechLink

May 21, 2020

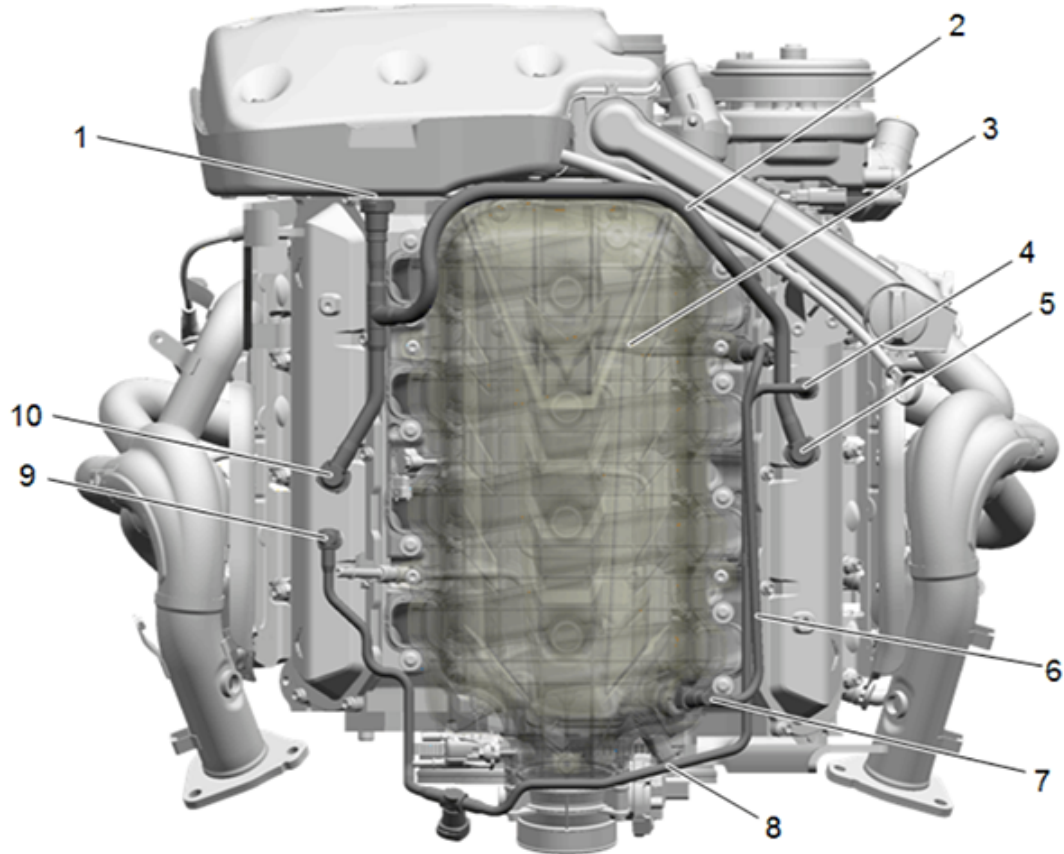
Fig. 3

In the LT2 engine, filtered fresh air is routed from upstream of the throttle plate through a formed nylon fresh air tube (8) to a PCV fitting (9) in the left-side rocker arm cover and a PCV fitting (4) in the right-side rocker arm cover. The design of the rocker arm covers shields rocker arm oil spray, reducing the potential for oil being drawn back into the fresh air PCV tube during any backflow of the ventilation system. Separated foul vapor from the engine oil tank (1) is routed to a PCV fitting (10) in the left-side rocker arm cover and a PCV fitting (5) in the right-side rocker arm cover via a formed nylon recirculation tube (2). Foul crankcase vapor is routed through a formed nylon foul air tube (6) from a PCV connection (3) on the engine oil separator in the engine valley to right side rear of the intake manifold (7). (Fig. 3)
