2018 - 2019 Corvette: GM TechLink: Intermittent Parasitic Battery Draw Below 40° F/4° C

Intermittent Parasitic Battery Draw Below 40° F/4° C

June 16, 2020
GM TechLink

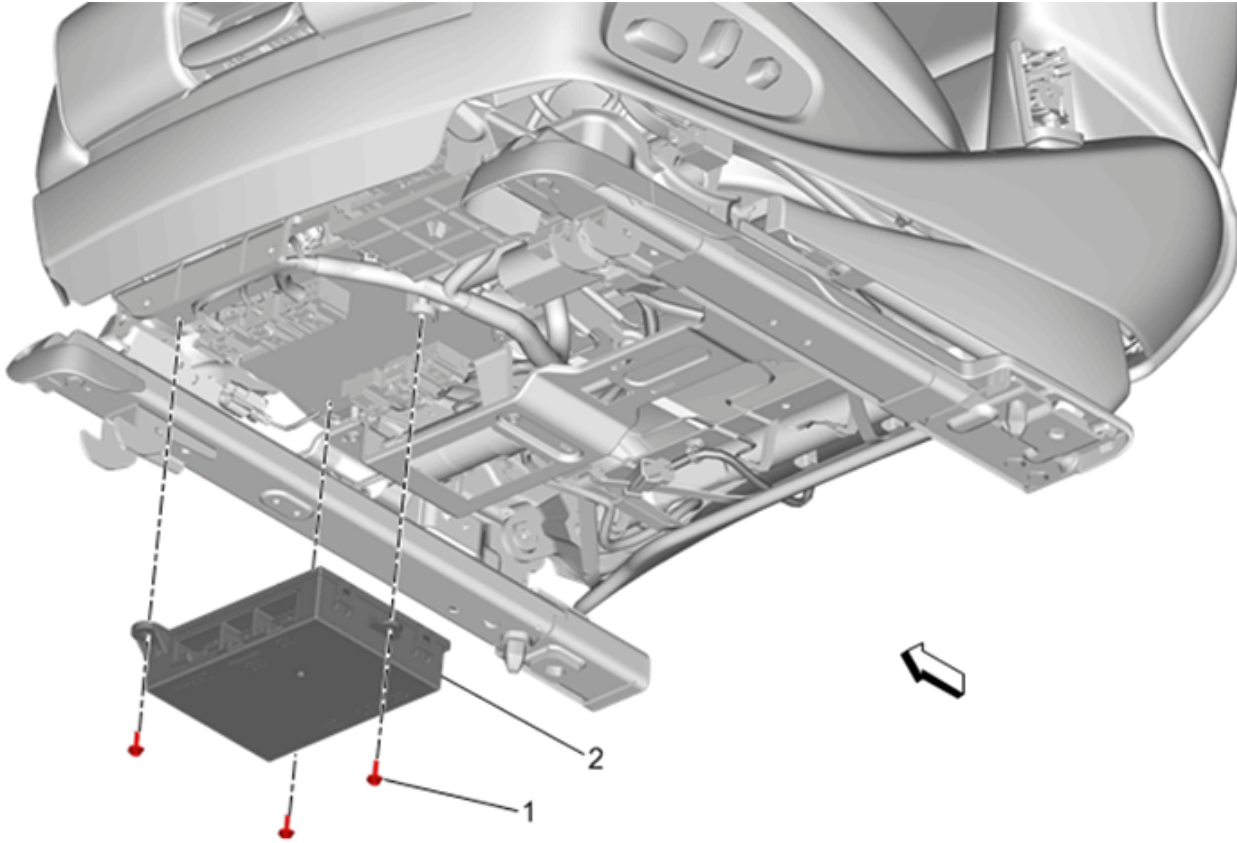
Fig. 9

These conditions may be due to a low battery state of charge that is being caused by one or more modules waking up the Low Speed GM LAN Bus. When the ambient air temperature is below 40° F/4° C, the Seat Memory Control Module (SMCM) could inadvertently wake up the Low Speed GM

LAN Bus. All SMCM's on a vehicle, including the Driver K40 (Fig. 9), Passenger K40P, Left Rear K40LR and/or Right Rear K40RR module, may apply.

Follow the Battery Electrical Drain/Parasitic Load Test procedure in the appropriate Service Information. If an excessive battery draw is duplicated, as part of the Circuit/System Testing procedure, remove the fuse(s) that powers the SMCM. The SMCM may be powered by more than one fuse. Wait several minutes to see if the vehicle will return to an acceptable battery draw level. If so, replace the appropriate SMCM.
