# 2018 - 2019 Corvette: GM TechLink: Intermittent Parasitic Battery Draw Below 40° F/4° C

## Intermittent Parasitic Battery Draw Below 40° F/4° C

June 16, 2020  
GM TechLink

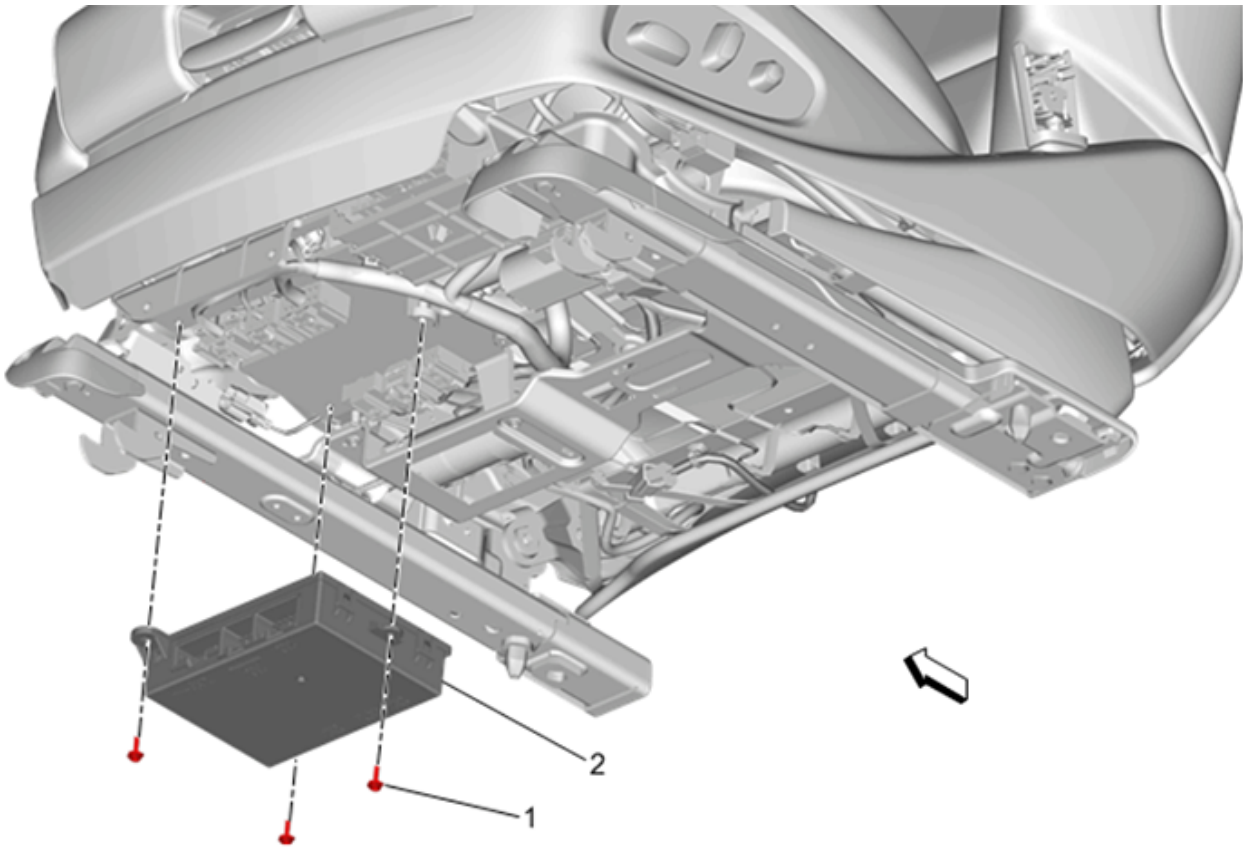
**Fig. 9**

These conditions may be due to a low battery state of charge that is being caused by one or more modules waking up the Low Speed GM LAN Bus. When the ambient air temperature is below 40° F/4° C, the Seat Memory Control Module (SMCM) could inadvertently wake up the Low Speed GM LAN Bus. All SMCM's on a vehicle, including the Driver K40 (Fig. 9), Passenger K40P, Left Rear K40LR and/or Right Rear K40RR module, may apply.

Follow the Battery Electrical Drain/Parasitic Load Test procedure in the appropriate Service Information. If an excessive battery draw is duplicated, as part of the Circuit/System Testing procedure, remove the fuse(s) that powers the SMCM. The SMCM may be powered by more than one fuse. Wait several minutes to see if the vehicle will return to an acceptable battery draw level. If so, replace the appropriate SMCM.
