# 2020 Corvette: GM TechLink: Front Fender and Fascia Realignment

## 2020 Corvette: Front Fender and Fascia Realignment

June 16, 2020  
GM TechLink

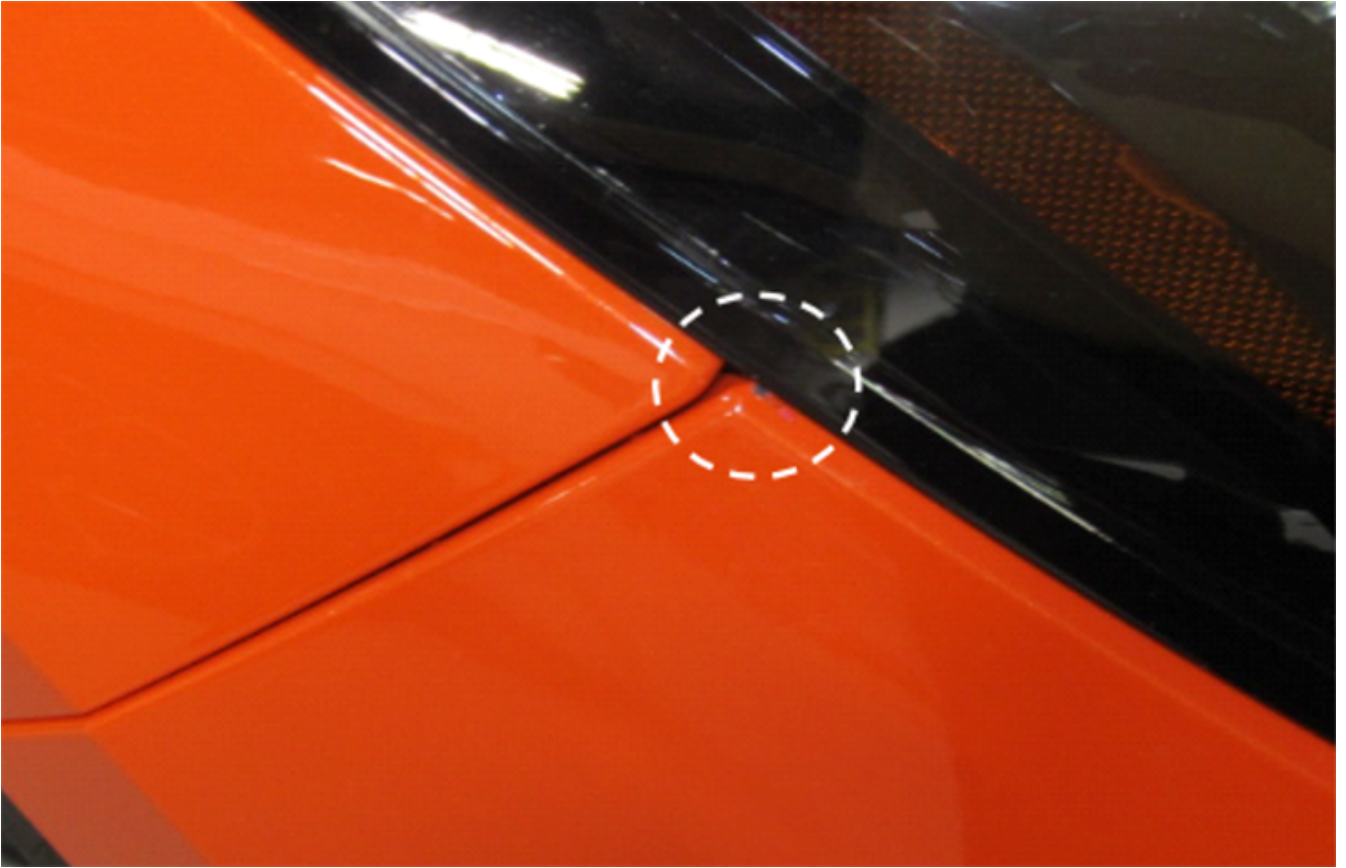
**Fig. 10**

Some 2020 Corvettes may have a small paint chip in the front fascia below the headlamp on one or both sides of the vehicle. (Fig. 10) The paint chip may be caused by a mis-positioned fender-to-fascia gap joint.

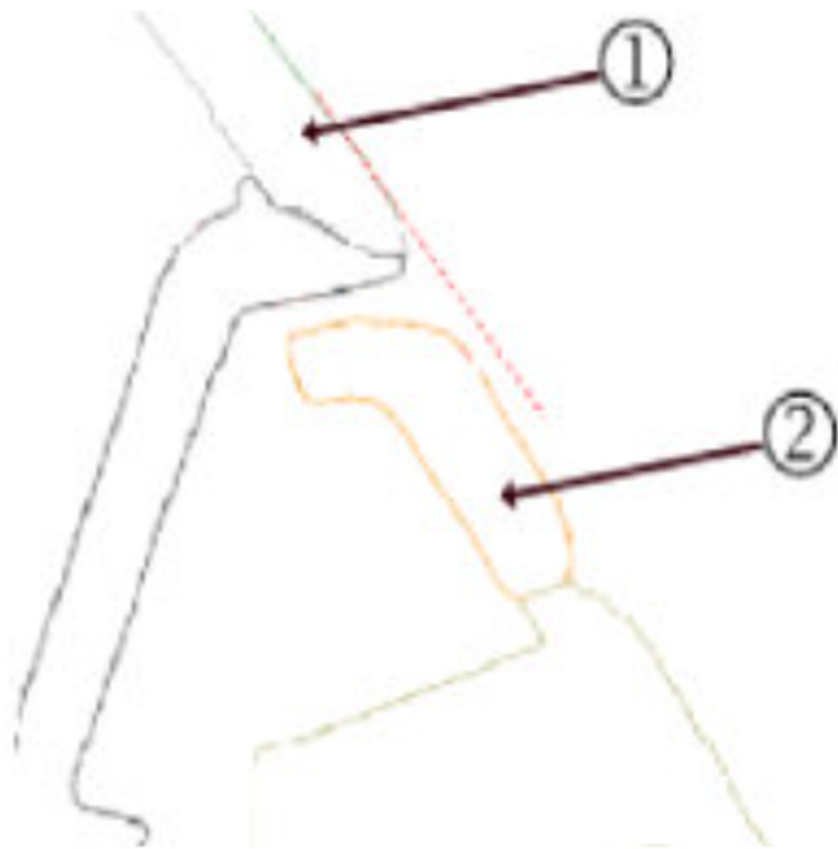
Fig. 12

After adjusting the fender inboard, the headlamp lens (Fig. 12, #1) will be proud of the fender (Fig. 12, #2) and the fascia tip will install below the headlamp lens. (Fig. 13)
