# 2020 Corvette: GM TechLink: Front Fender and Fascia Realignment

## 2020 Corvette: Front Fender and Fascia Realignment

June 16, 2020  
GM TechLink

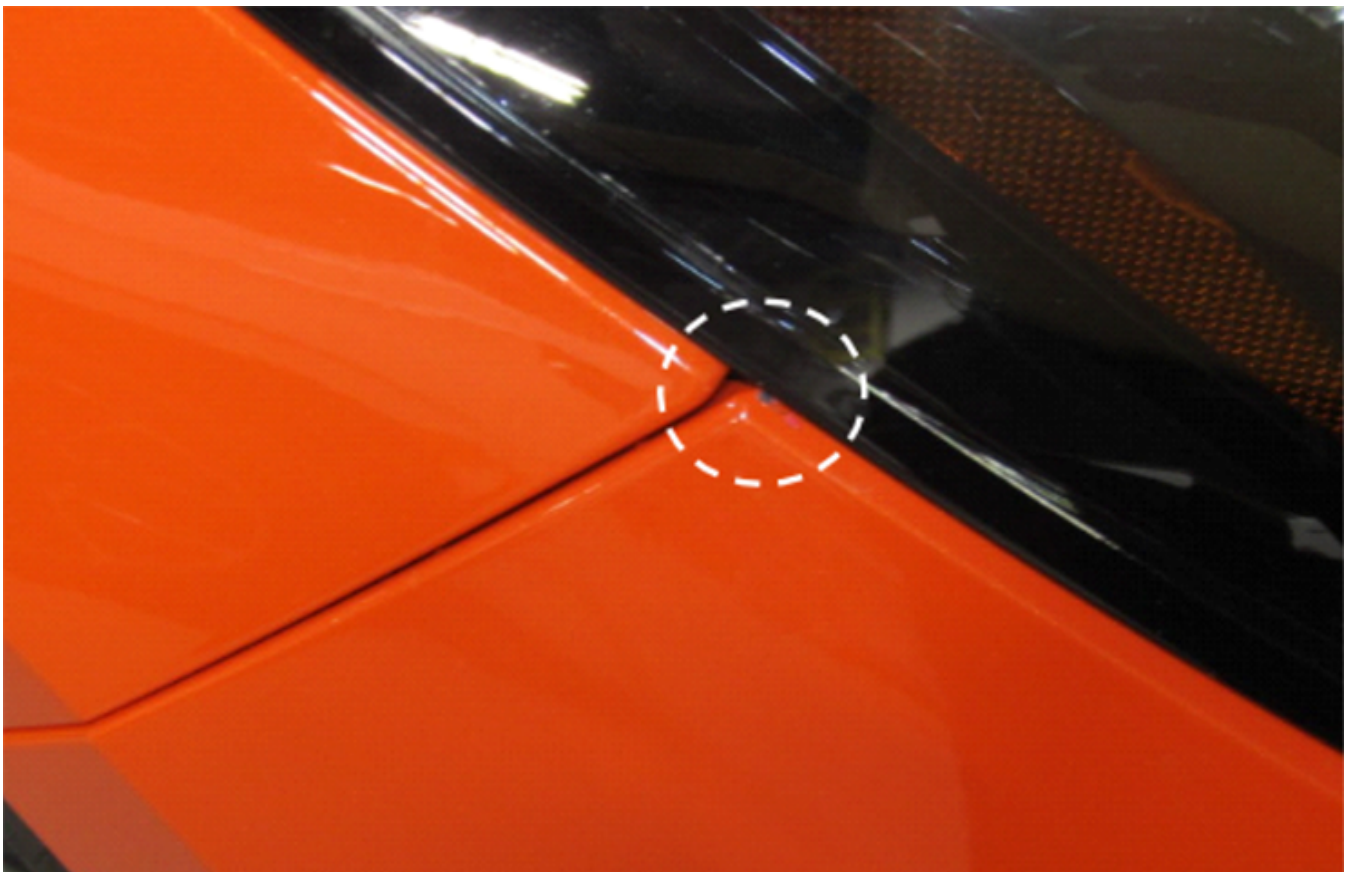
**Fig. 10**

Some 2020 Corvettes may have a small paint chip in the front fascia below the headlamp on one or both sides of the vehicle. (Fig. 10) The paint chip may be caused by a mis-positioned fender-to-fascia gap joint.
