2020 Corvette: Recall Notice: #N202309350: Non-Compliance - Interior Trunk Release Button Inoperative Ten Minutes After Power Off

Subject: N202309350 — Interior
Trunk Release Button
Inoperative Ten Minutes
After Power Off

Models: 2020 Chevrolet Corvette

Release Date: August 2020

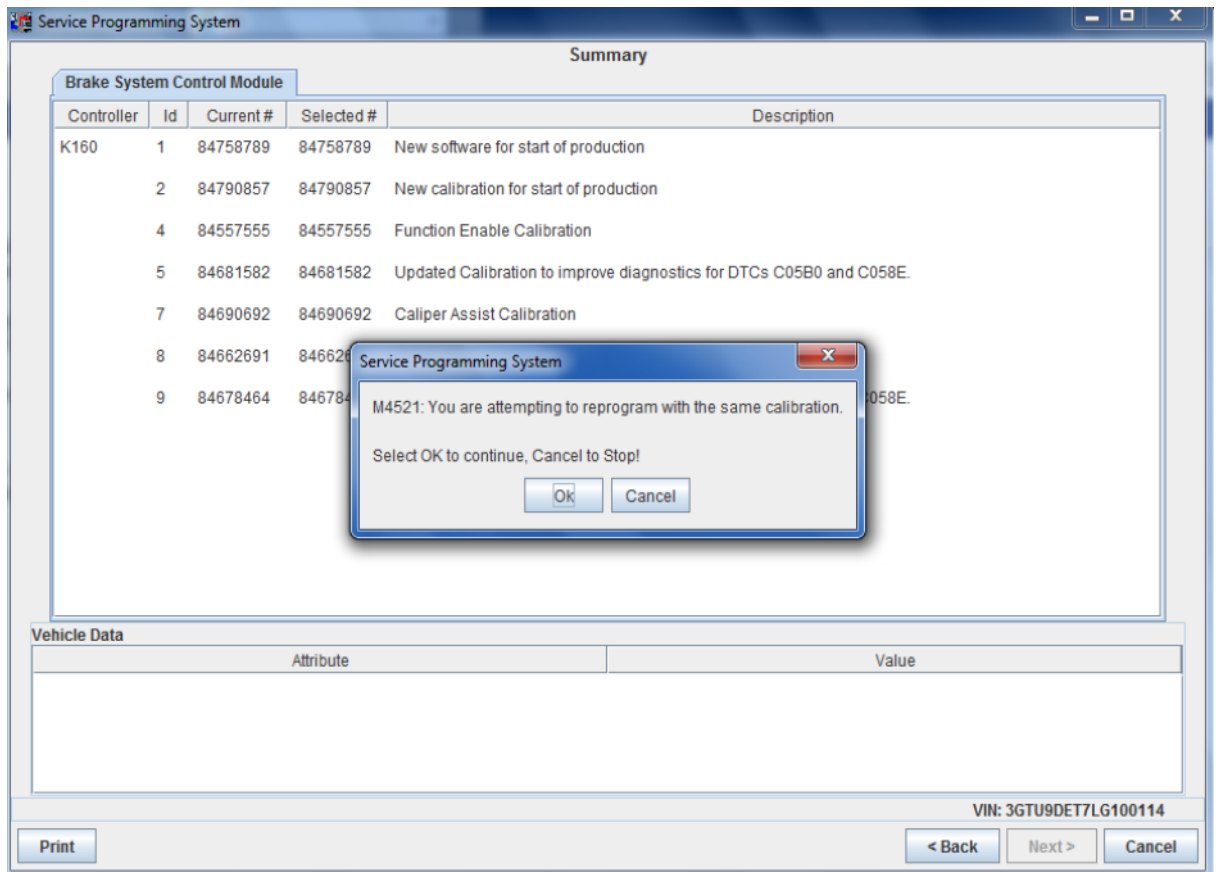
Important: TIS2WEB screen shown. Techline Connect screen is similar and will be included in the near future.

Important: If the Same Calibration/Software Warning is noted on the SPS Summary screen, record the warranty claim code (WCC) and select OK and follow screen instructions. After a successful programming event, the WCC is located in the Service Programming System dialogue box of the SPS Summary screen. No further action is required. Refer to the Warranty section of the bulletin.

1. Reprogram the body control module. Refer to *K9 Body Control Module: Programming and Setup* in SI.
