# 2018 - 2019 Corvette: GM TechLink: Delayed Transmission Engagement

## Delayed Transmission Engagement

September 30, 2020

GM TechLink

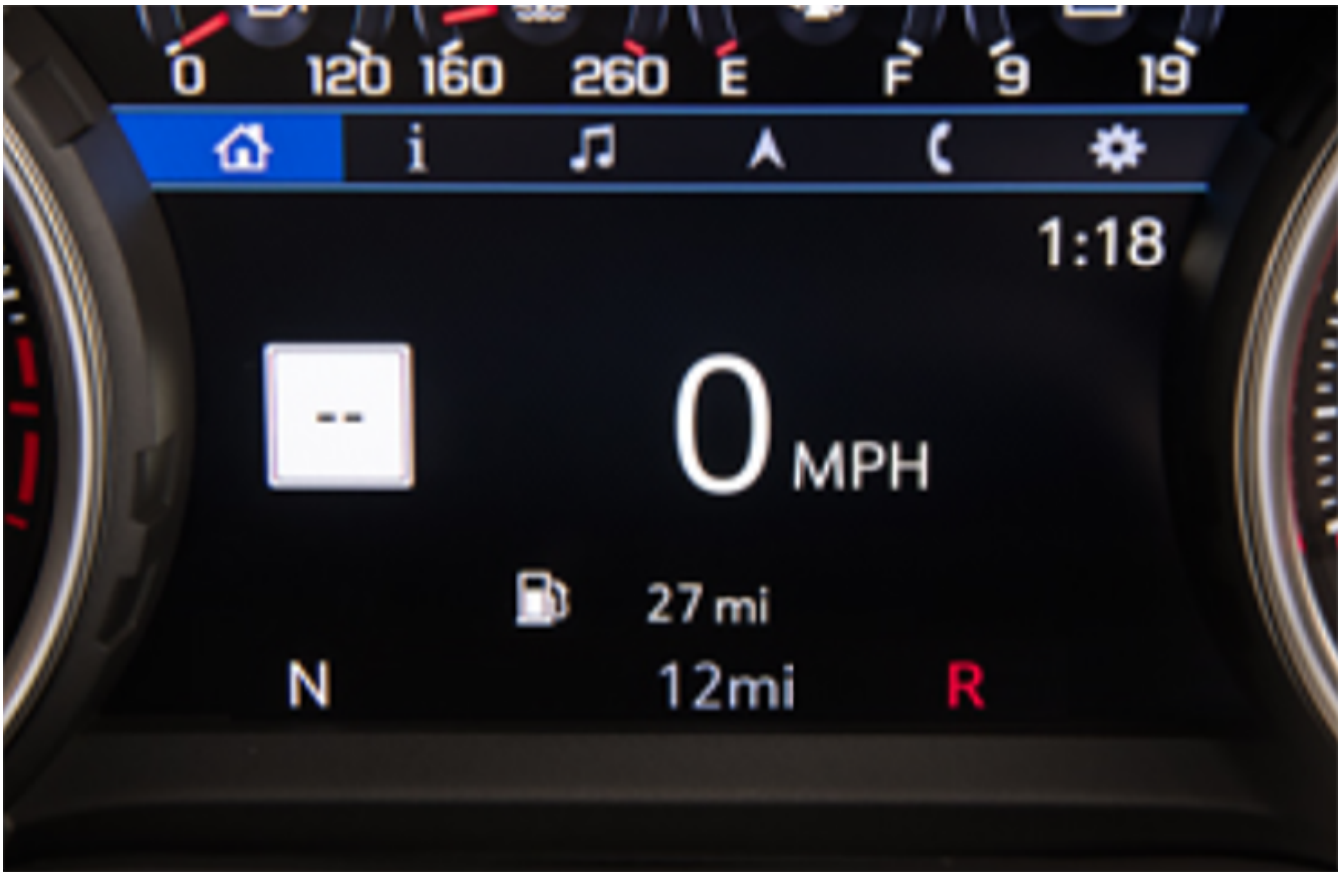
**Fig. 12**

Some **2018 - 2019 ATS, CTS, CT6, Corvette**; 2018 - 2020 Express; 2018 - 2021 Camaro, Colorado, Silverado, Canyon, Savana, Sierra; and 2021 CT4 models equipped with the 8L45 or 8L90 8-speed automatic transmission (RPO M5T, M5N, M5U, M5X, MQD, MQE) may have a delayed engagement condition when the transmission is shifted from Park to Reverse or Park to Drive after the vehicle has been sitting with the engine off. (Fig. 12) The delayed engagement typically occurs after several hours or, more commonly, overnight.

The condition may seem to be delayed gear engagement, a slipping transmission, or delayed engagement followed by a harsh engagement.

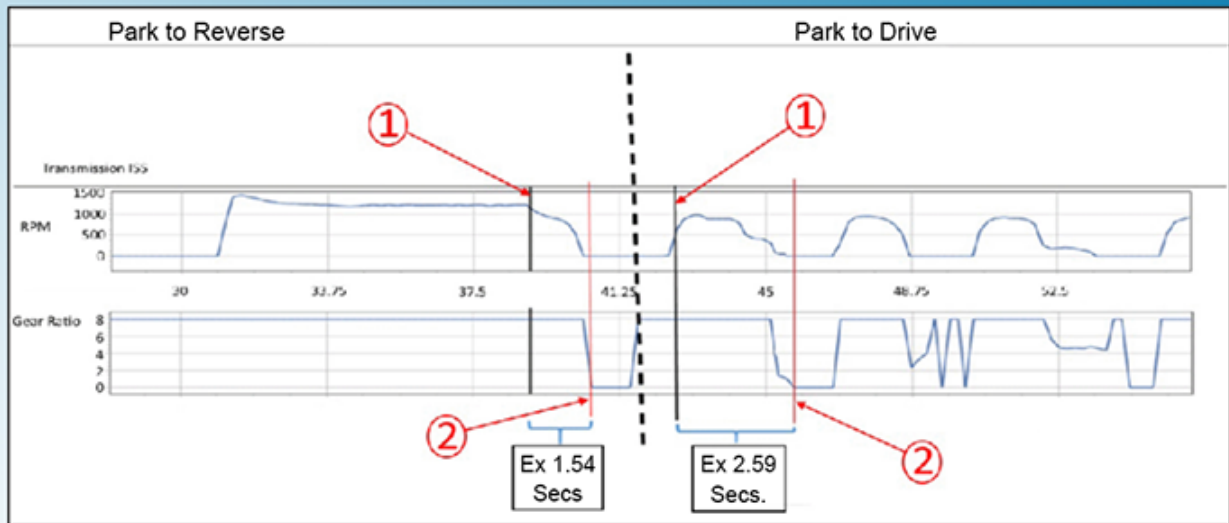
**Fig. 13**

Use GDS2 to monitor engine RPM and the transmission input speed sensor (ISS) prior to starting the engine. Start the engine with the transmission in Park and shift the vehicle from Park to Drive or Park to Reverse with the service brake applied. The ISS should drop to zero within three seconds, which is the clutch engagement time. Recording the GDS session log can be useful in diagnosing the condition.

Delayed engagement of Park to Reverse or Park to Drive is present if the time difference between the gear selected (Pt. 1) and the transmission input shaft speed reaching 0 RPMs (Pt. 2) exceeds three seconds. (Fig 13)

If engagement time exceeds three seconds, attempt to learn the C3 – Drive and C5 Reverse – Clutch using the following steps:

1. Allow the transmission sump temperature to rise between 20° and 30°C (68° and 86°F). Do not apply the accelerator pedal.
2. Perform 20 Park to Reverse shifts or 20 Park to Drive shifts releasing the brake pedal with each shift, allowing the vehicle to roll 5-10 feet (1.5-3.0 m) per engagement into gear.

If the learn procedure does not correct the condition, disassemble the transmission and inspect the 1-3-5-6-7 Clutch (C3) for a delay into Drive condition and inspect the 4-5-6-7-8 Reverse Clutch (C5) for a delay into Reverse condition. The respective clutch plates and seals should be inspected for wear and or damage and repaired accordingly.
