2018 - 2019 Corvette: GM TechLink: Delayed Transmission Engagement

Delayed Transmission Engagement

GM TechLink

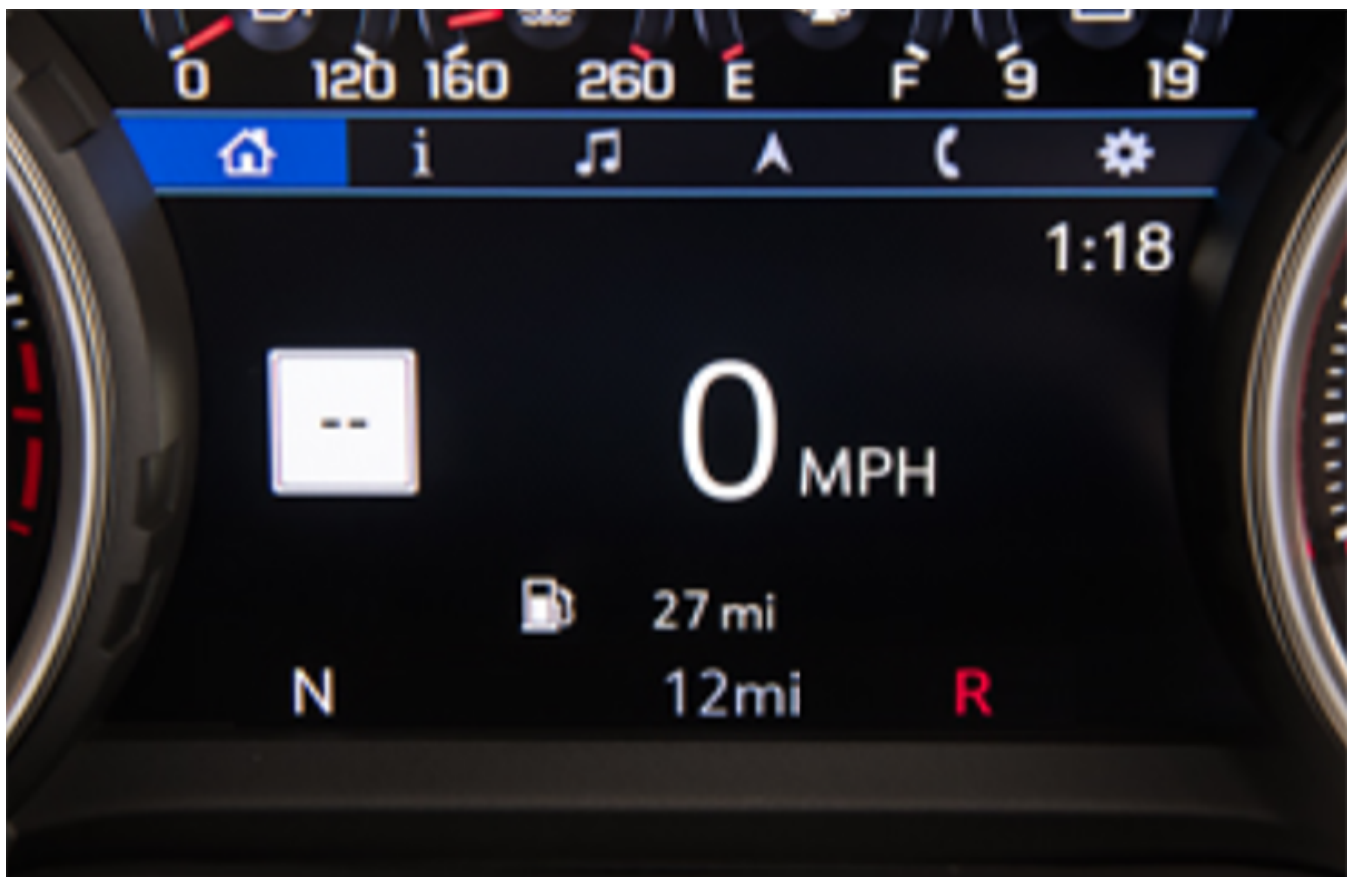
Fig. 12

Some **2018 - 2019 ATS, CTS, CT6, Corvette**; 2018 - 2020 Express; 2018 - 2021 Camaro, Colorado, Silverado, Canyon, Savana, Sierra; and 2021 CT4 models equipped with the 8L45 or 8L90 8-speed automatic transmission (RPO M5T, M5N, M5U, M5X, MQD, MQE) may have a delayed engagement condition when the transmission is shifted from Park to Reverse or Park to Drive after the vehicle has been sitting with the engine off. (Fig. 12) The delayed engagement typically occurs after several hours or, more commonly, overnight.

The condition may seem to be delayed gear engagement, a slipping transmission, or delayed engagement followed by a harsh engagement.

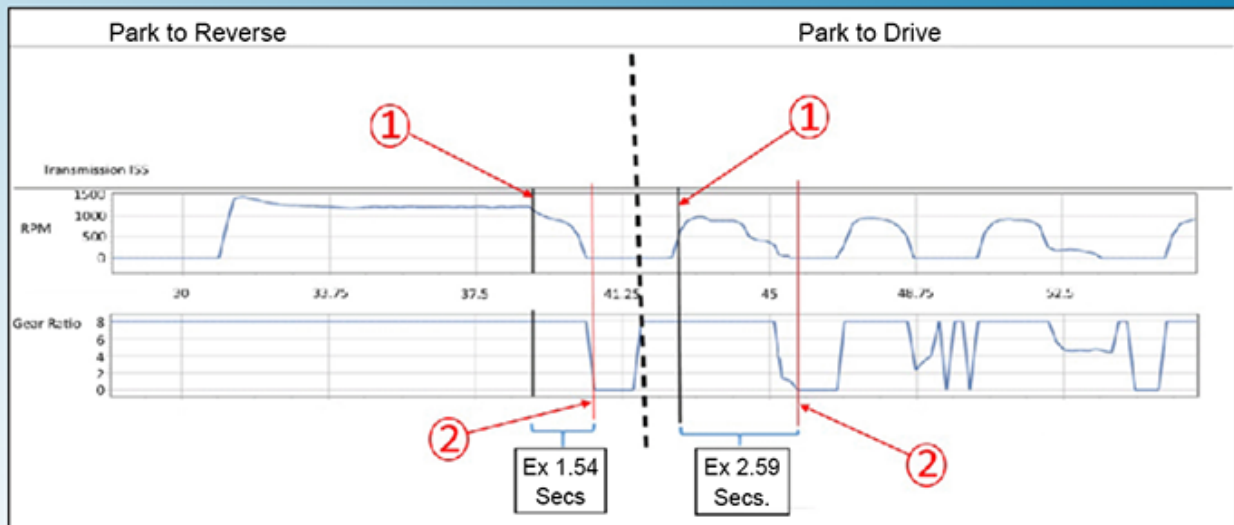
Fig. 13

Delayed engagement of Park to Reverse or Park to Drive is present if the time difference between the gear selected (Pt. 1) and the transmission input shaft speed reaching 0 RPMs (Pt. 2) exceeds three seconds. (Fig 13)

In most cases, the transmission will engage in three seconds or less, which is considered an acceptable engagement time and no repairs should be attempted.

If engagement time exceeds three seconds, attempt to learn the C3 – Drive and C5 Reverse – Clutch using the following steps:

1. Allow the transmission sump temperature to rise between 20° and 30°C (68° and 86°F). Do not apply the accelerator pedal.
2. Perform 20 Park to Reverse shifts or 20 Park to Drive shifts releasing the brake pedal with each shift, allowing the vehicle to roll 5-10 feet (1.5-3.0 m) per engagement into gear.

If the learn procedure does not correct the condition, disassemble the transmission and inspect the 1-3-5-6-7 Clutch (C3) for a delay into Drive condition and inspect the 4-5-6-7-8 Reverse Clutch (C5) for a delay into Reverse condition. The respective clutch plates and seals should be inspected

for wear and or damage and repaired accordingly.
