2020 Corvette: Service Bulletin:: #20-NA-179: Malfunction Indicator Lamp (MIL) Illuminated - DTCs P0521 and/or P06DD Set - (Oct 23, 2020)

Subject: Malfunction Indicator Lamp (MIL) Illuminated
– DTCs P0521 and/or P06DD Set

Brand:	Model:	Model Year:		VIN Breakpoint:		Engine:	Transmission:
		from	to	from	to		
Chevrolet	Corvette	2020	2020	SORP	September 10, 2020	6.2L (LT2)	—

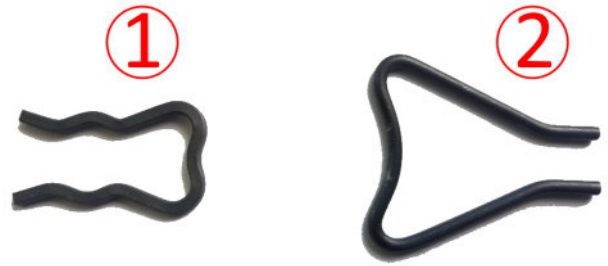
This condition may be caused by an unseated engine oil pressure control valve (OCV).

If P0521 and P06DD DTCs are present, then a redesigned oil pressure control valve retainer clip (1) may be necessary. Refer to the Service Procedure section below.

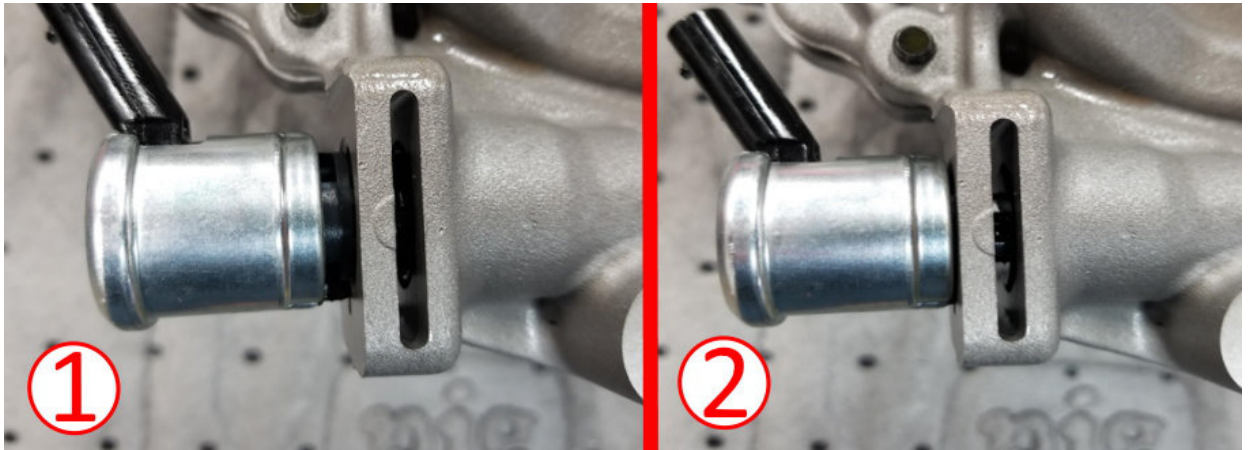
1. Inspect the OCV:
 - If you find this oil pressure control valve dislodged (1), it will be necessary to install a redesigned oil control valve retainer.
- Disconnect the oil pressure control valve electrical connector and position aside.
