2020 Corvette: Service Bulletin:: #20-NA-179: Malfunction Indicator Lamp (MIL) Illuminated - DTCs P0521 and/or P06DD Set - (Oct 23, 2020)

Subject: Malfunction Indicator Lamp (MIL) Illuminated – DTCs P0521 and/or P06DD Set

Brand:	Model:	Model Year:		VIN Breakpoint:		Engine:	Transmission:
		from	to	from	to		
Chevrolet	Corvette	2020	2020	SORP	September 10, 2020	6.2L (LT2)	—

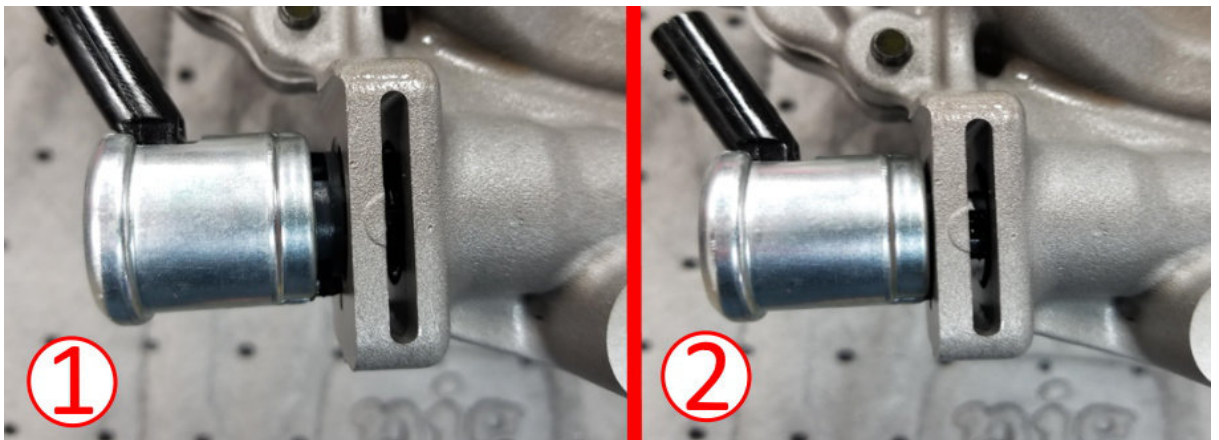
1. Inspect the OCV:
 - If you find this oil pressure control valve dislodged (1), it will be necessary to install a redesigned oil control valve retainer.
- Disconnect the oil pressure control valve electrical connector and position aside.
