2005 - 2020 Corvette: Service Bulletin: #PIC6378A: Diagnosing Various Concerns On A Power Folding Top - (Oct 29, 2020)

Subject: Diagnosing Various Concerns On A
Power Folding Top

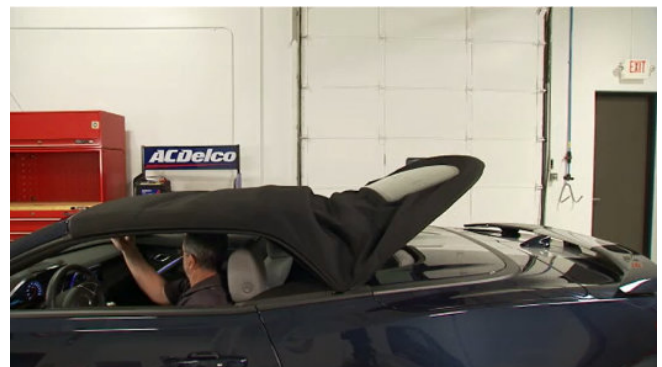
Example Case: Let's take a 2018 Chevrolet Camaro for instance, with a basic folding top concern. The customer states that the top will open fine, but it will not close all the way. A preliminary check will indicate that there is a "Top Not Secure" message in the DIC, but no DTCs are set. The tech is able to duplicate the concern each and every time. When closing, the top will lift up out of the stowage compartment, latch tightly to the windshield header, and the tension bow will lift up to a 45° angle. The Rear Stowage Compartment Lid will lower and lock into position, but the tension bow will not lower. It simply remains suspended in the air as seen in the photo below. The folding top pump quits working and the top stops moving at that point.

On a correctly working car, the stowage compartment lid must close completely before the tension bow is commanded down. Because the steps or phases must be completed in order, the technician must go to the point where the failure occurs, and then go back one step to look at the scan tool data.

Looking at the scan tool sensor data below, we can see that only one of the two Stowage Compartment Lid Closed Position Sensors read "On". Because the Folding Top Control Module will not command the tension bow to lower if both Stowage Compartment Lid Closed Position Sensors are not showing that they are closed, the module thinks that the stowage lid is still raised. As a matter of operation, it will not continue the top cycle. In this instance, the technician must further inspect the Right Folding Top Stowage Compartment Lid Closed Position Sensor to determine what the fault is.
