**2014 - 2019 Corvette: Service Bulletin:
 #19-NA-217: Manual Transmission Stalling,
 Clutch Chatter and/or Hard Shifting into 1st
 Gear or Reverse; Automatic Transmission
 Vibration on Launch and/or Engine Noise - (Dec
 21, 2020)**

Subject: Manual Transmission Stalling, Clutch Chatter and/or Hard Shifting into 1st Gear or Reverse; Automatic Transmission Vibration on Launch and/or Engine Noise

Brand:	Model:	Model Year:		VIN Breakpoint		Engine:	Transmission:
		from	to	from	to		
Chevrolet	Corvette	2014	2019	—	—	6.2L (LT1, LT4)	6L80 Automatic (MYC), 8L90 Automatic (M5U) or Manual

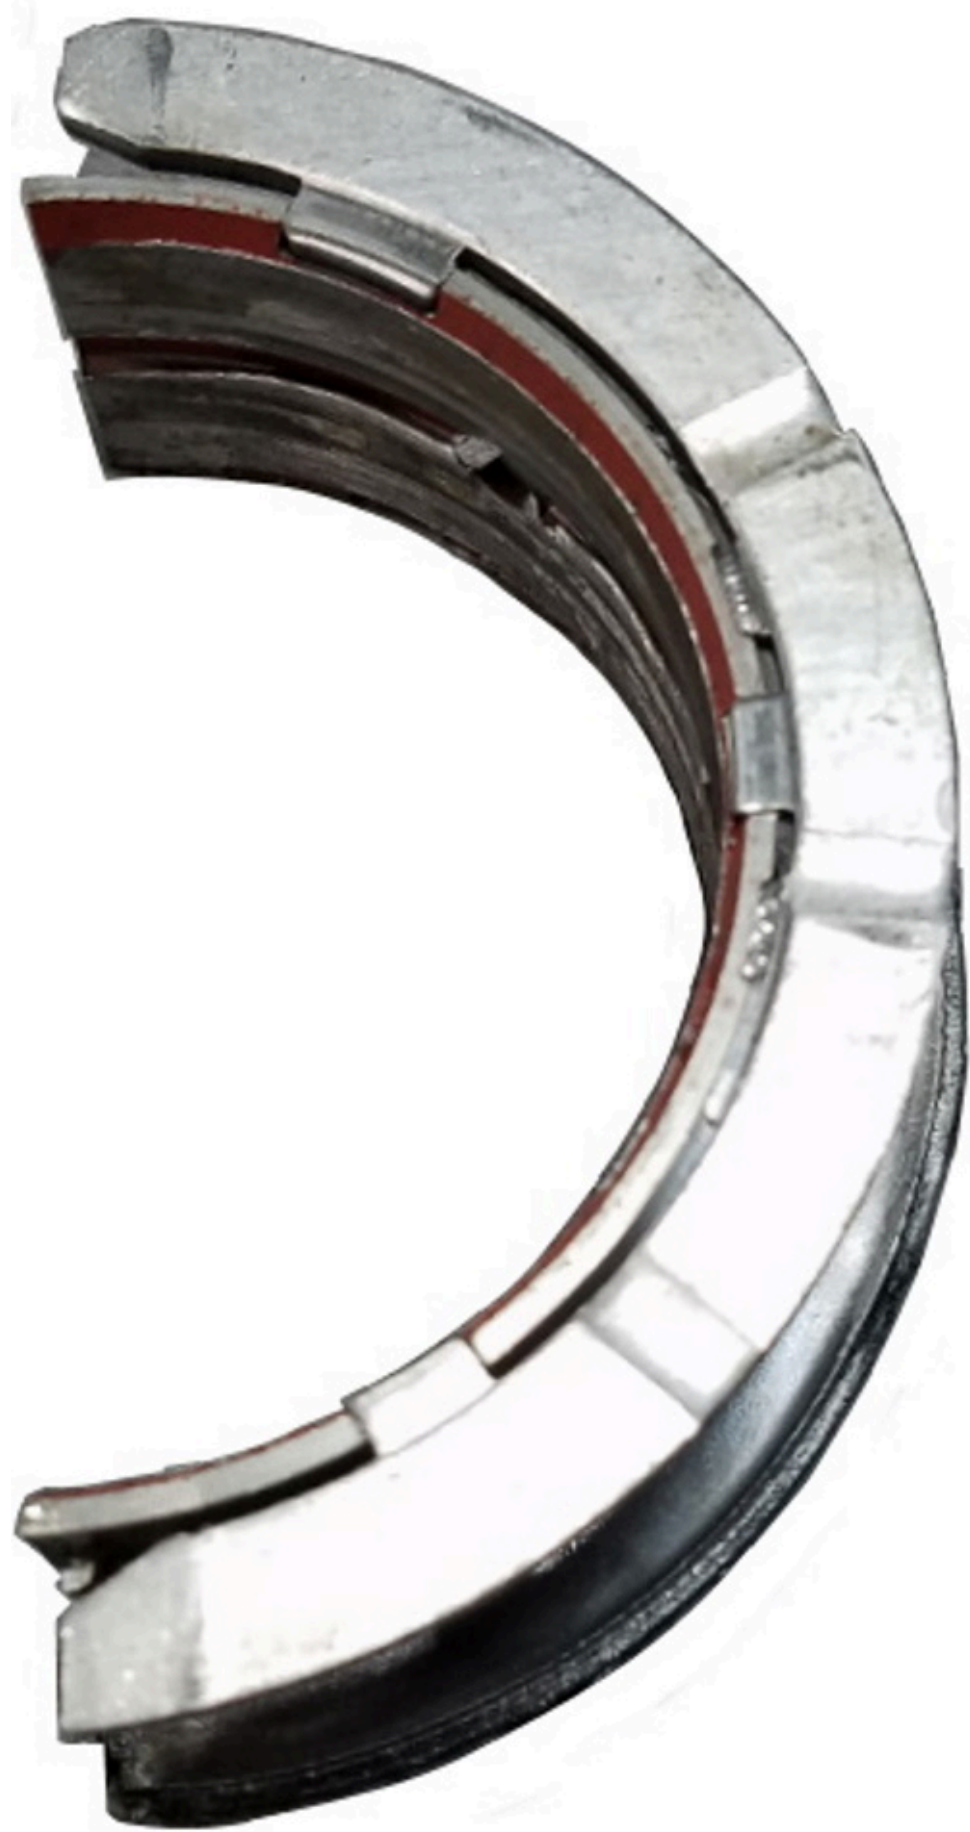
Example of a good thrust bearing face.

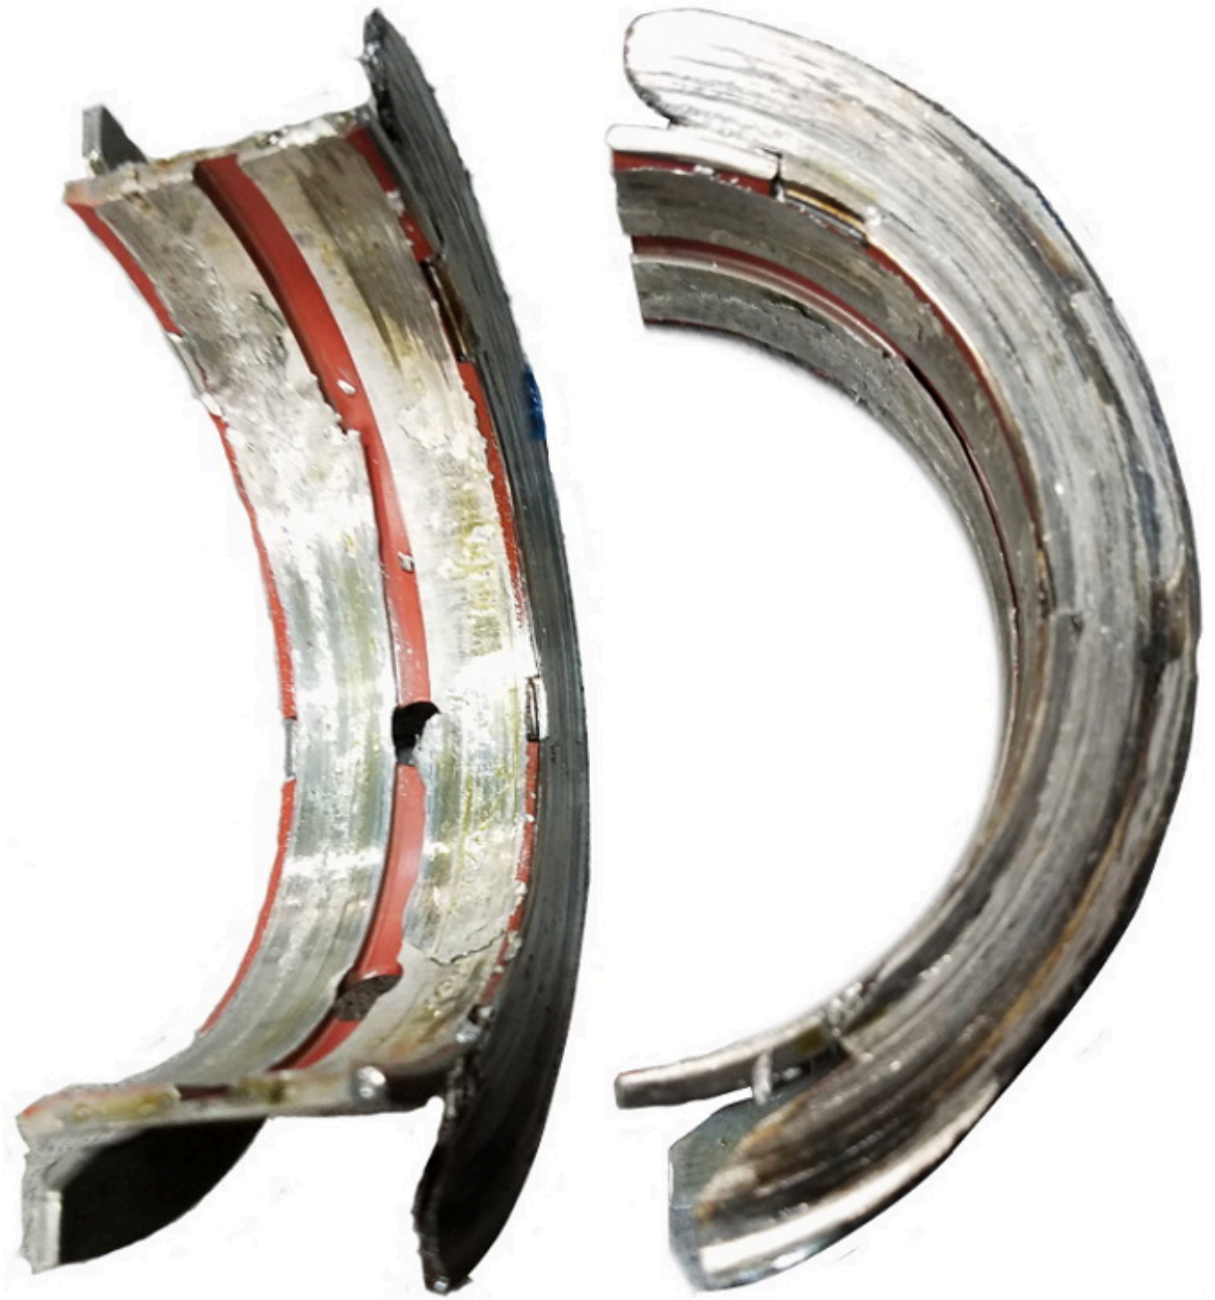
This condition may be caused by excessive crankshaft endplay associated with a damaged thrust bearing.

1. Inspect the thrust bearing for wear on one side and crankshaft on the corresponding mating surface. The

graphic above shows an example of a damaged thrust bearing.

- If wear is evident (3 vertical channels worn off), it will be necessary to replace the crankshaft, connecting rods and main bearings.
- Refer to *Crankshaft and Bearing Removal* in SI.

If bearing damage is found and if the vehicle is equipped with a dry sump system, it will be necessary to replace the oil tank with lines and oil cooler.
