2014 - 2019 Corvette: Service Bulletin: #19-NA-217: Manual Transmission Stalling, Clutch Chatter and/or Hard Shifting into 1st Gear or Reverse; Automatic Transmission Vibration on Launch and/or Engine Noise - (Dec 21, 2020)

Subject: Manual Transmission Stalling, Clutch Chatter and/or Hard Shifting into 1st Gear or Reverse; Automatic Transmission Vibration on Launch and/or Engine Noise

Brand:	Model:	Model Year:		VIN Breakpoint		Engine:	Transmission:
		from	to	from	to		
Chevrolet	Corvette	2014	2019	—	—	6.2L (LT1, LT4)	6L80 Automatic (MYC), 8L90 Automatic (M5U) or Manual

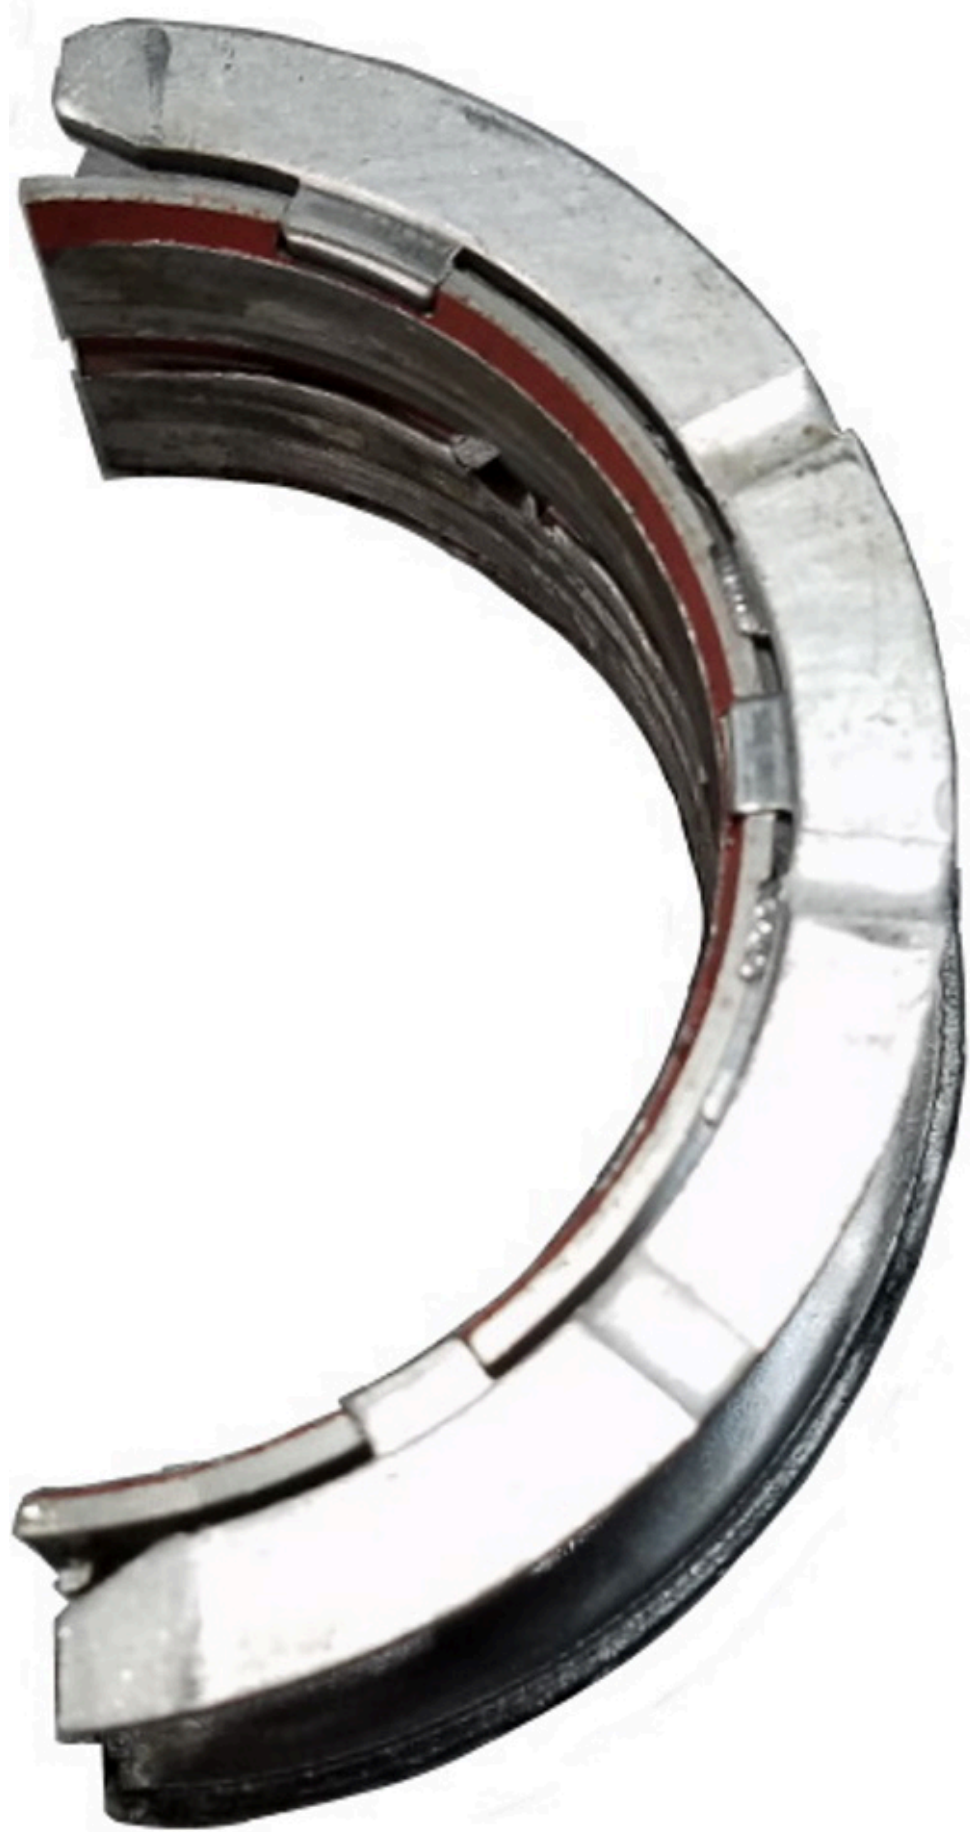
Example of a good thrust bearing face.

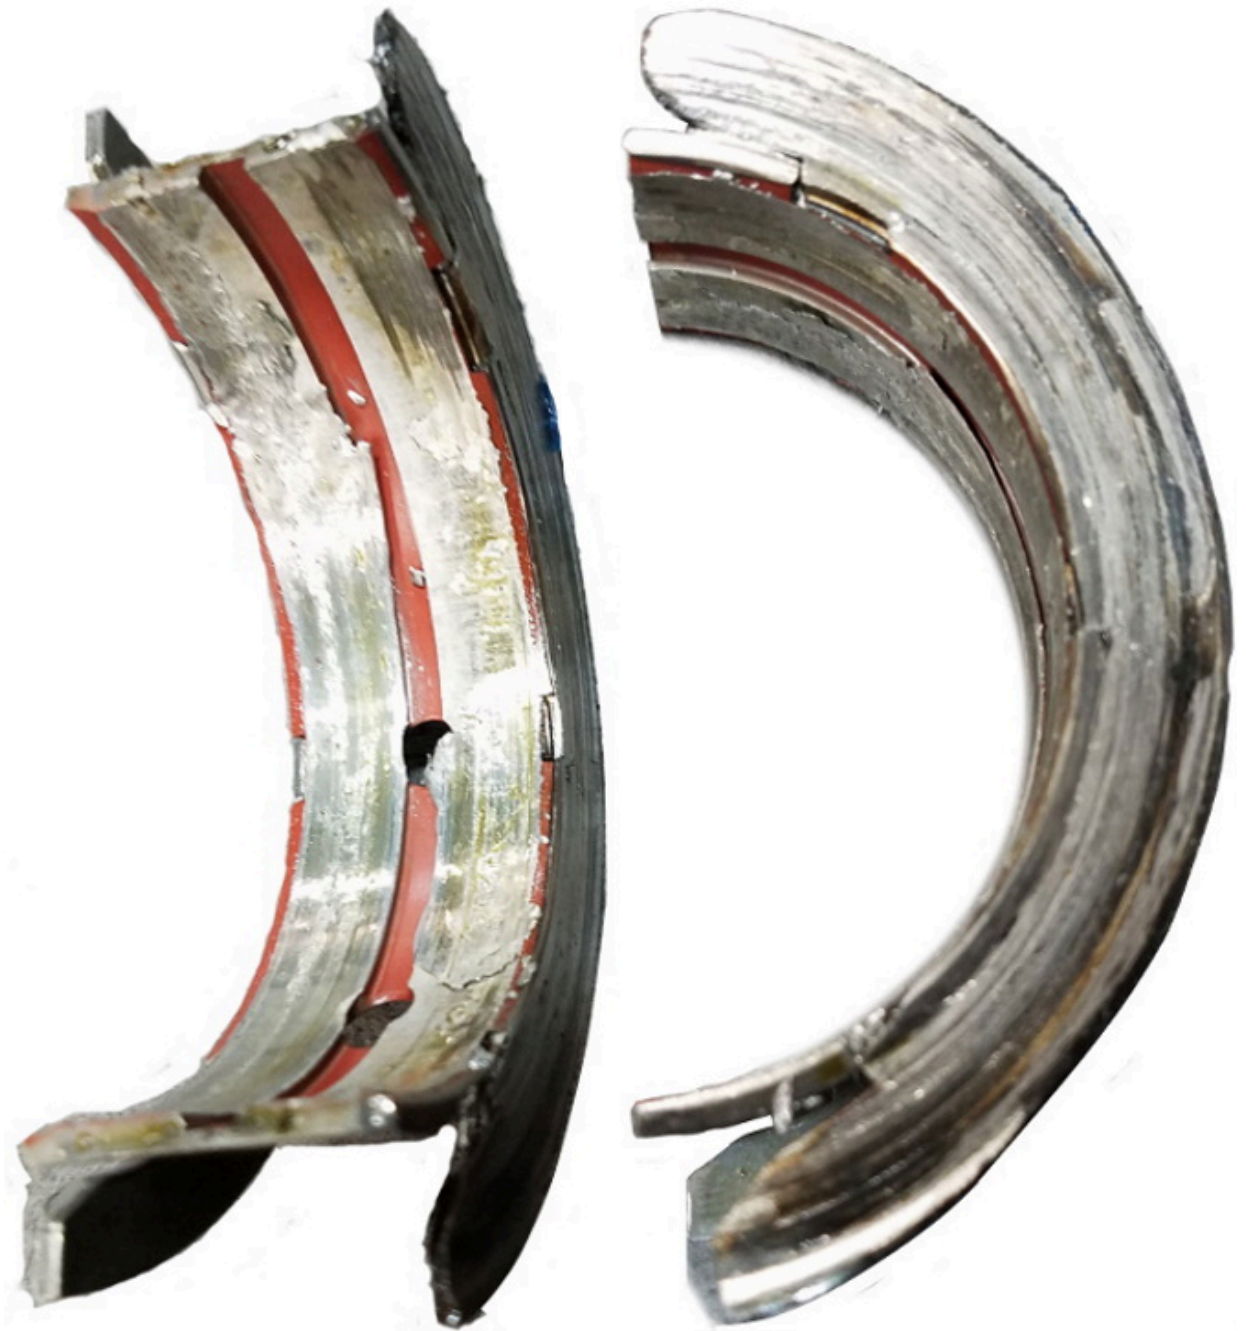
This condition may be caused by excessive crankshaft endplay associated with a damaged thrust bearing.

1. Inspect the thrust bearing for wear on one side and crankshaft on the corresponding mating surface. The graphic above shows an example of a damaged thrust bearing.

- If wear is evident (3 vertical channels worn off), it will be necessary to replace the crankshaft, connecting rods and main bearings.
- Refer to *Crankshaft and Bearing Removal* in SI.

If bearing damage is found and if the vehicle is equipped with a dry sump system, it will be necessary to replace the oil tank with lines and oil cooler.
