2014 - 2021 Corvette: Service Buletin: #PIP5212C: Concern Of An Engine Thermostat Tick Noise And/Or Running Hot - (Mar 30, 2021)

#PIP5212C: Concern Of An Engine Thermostat Tick Noise And/Or Running Hot - (Mar 30, 2021)

Subject:	Concern Of An Engine Thermostat
	Tick Noise And/Or Running Hot

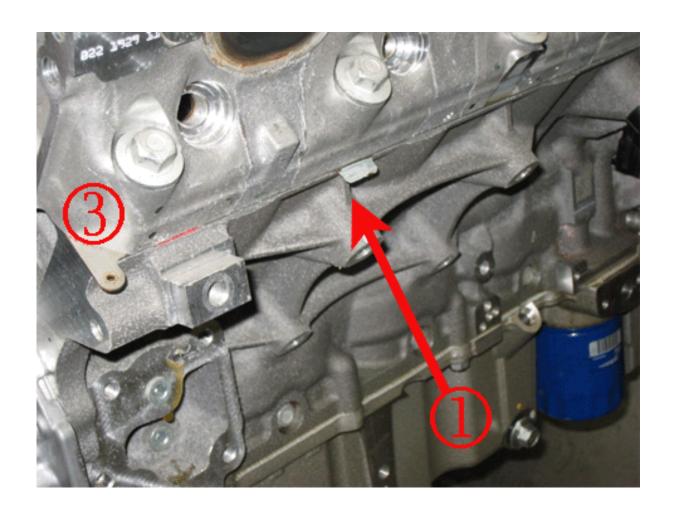
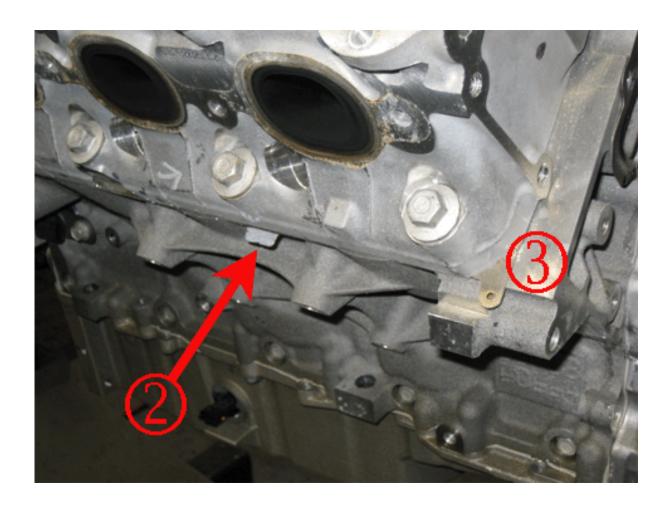
A vehicle may have a concern of the engine running hot and/or has a tick noise from the thermostat.

Per the attached pictures, the head gasket locating tabs for both of the engine cylinder banks should be toward the front of the engine.

- 1. Bank 1 tab near cylinder 3
- 2. Bank 2 tab near cylinder 4
- 3. Is the front of the engine

If the head gasket locating tabs are found to be closer to cylinders 5 or 6, this indicates the head gaskets were installed incorrectly restricting the engine coolant flow.

Replace the head gasket to repair for this concern.
