2014 - 2021 Corvette: Service Buletin: #PIP5212C: Concern Of An Engine Thermostat Tick Noise And/Or Running Hot - (Mar 30, 2021)

#PIP5212C: Concern Of An Engine Thermostat Tick Noise And/Or Running Hot - (Mar 30, 2021)

Subject: Concern Of An Engine Thermostat
Tick Noise And/Or Running Hot

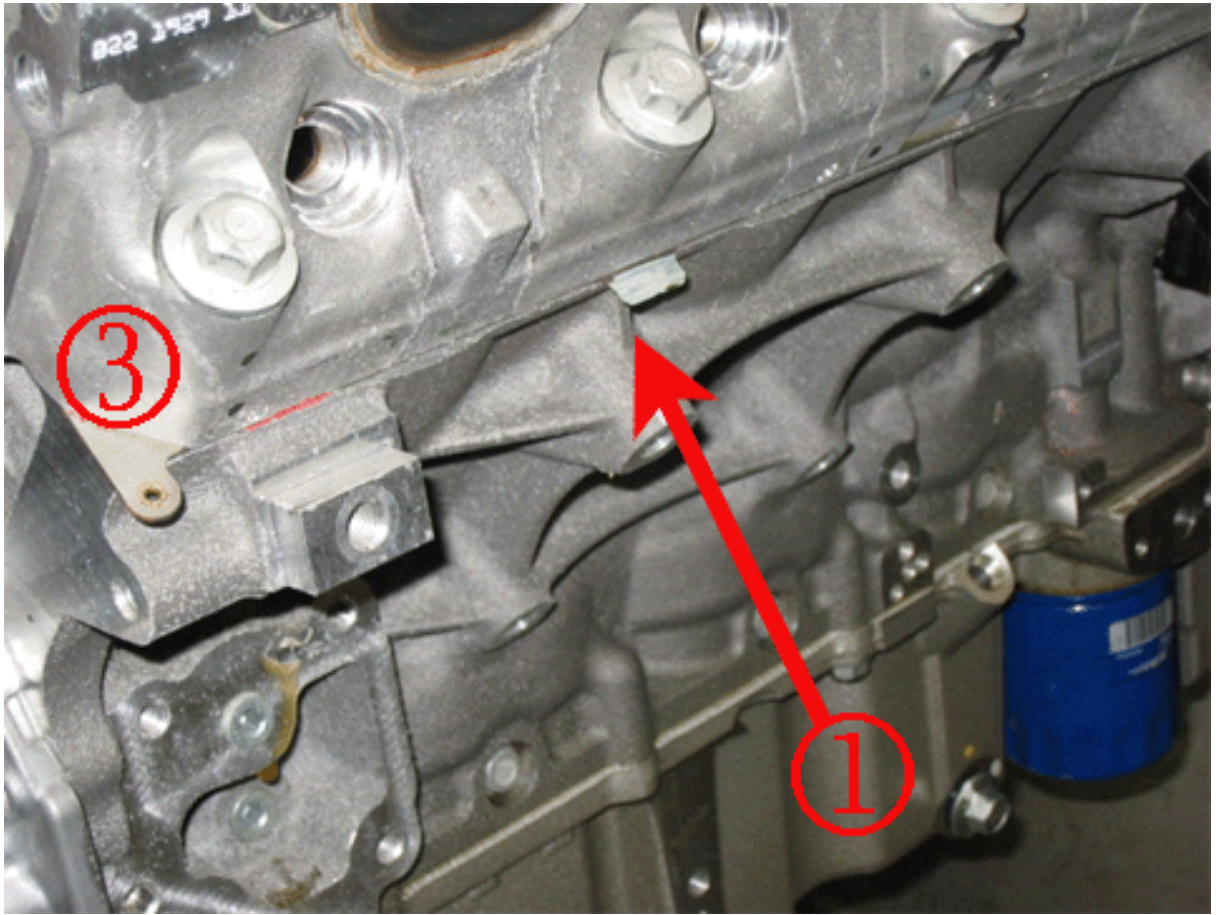
Per the attached pictures, the head gasket locating tabs for both of the engine cylinder banks should be toward the front of the engine.

1. Bank 1 tab near cylinder 3
2. Bank 2 tab near cylinder 4
3. Is the front of the engine

If the head gasket locating tabs are found to be closer to cylinders 5 or 6, this indicates the head gaskets were installed incorrectly restricting the engine coolant flow.

Replace the head gasket to repair for this concern.
