2020 - 2021 Corvette: Service Bulletin: #21-NA-091: Information on Normal Rearview Camera Display Operation - Flashing Diamond - Spot - or UFO like image on Rear View Camera Display - (Apr 13, 2021)

Subject: Information on Normal Rear View
Camera Display Operation - Flashing
Diamond - Spot - or UFO like image
on Rear View Camera Display

This bulletin replaces PIT5799A. Please discard PIT5799A.

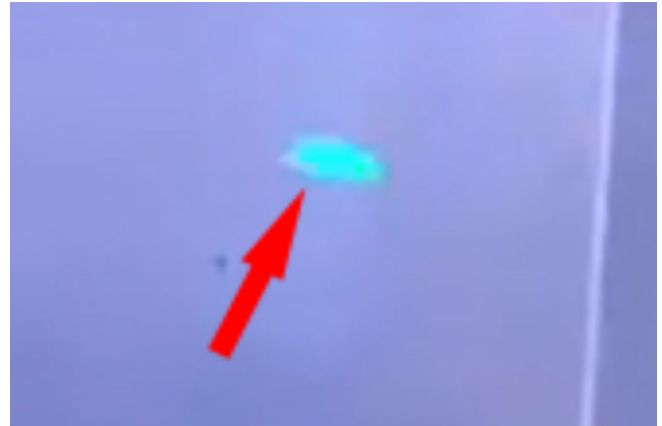
Some customers may comment on a flashing light present on the radio display when in Reverse and with the rear view camera on, usually is

corrected by an ignition cycle.

Please communicate to the customer that the rear view camera system and radio display are functioning as designed and this is a normal condition of their vehicle. Please share this information with the customer, including a copy of this bulletin.

Technicians should verify that no other conditions are present and return the vehicle to the customer.
