# **2020 - 2021 Corvette: GM TechLink: Internal Transmission Faults Not Serviceable at the Dealership**

## **Internal Transmission Faults Not Serviceable at the Dealership**

April 13, 2021

### **GM TechLink**

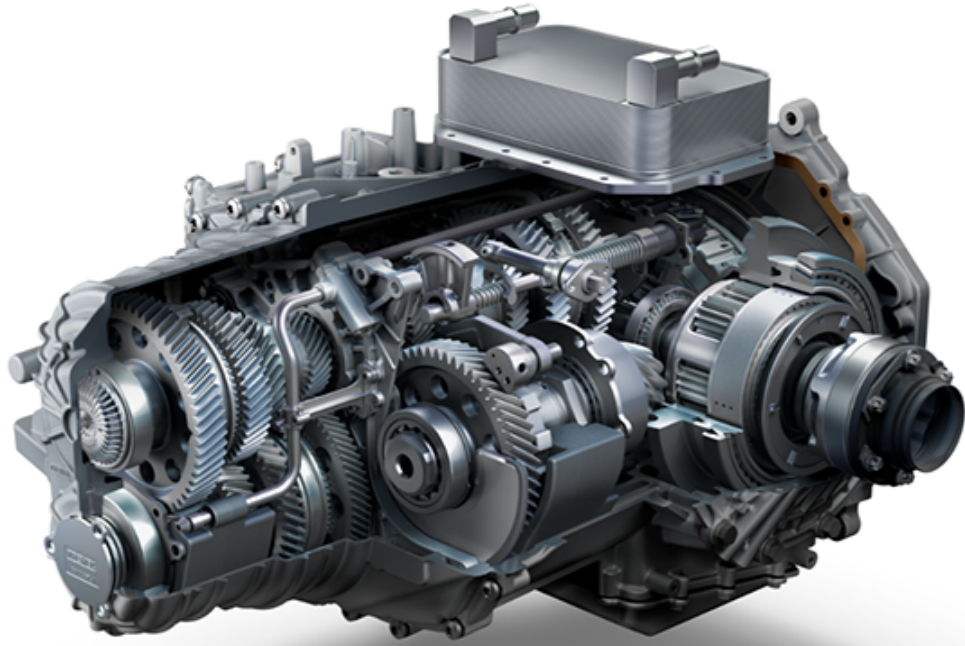
**Fig. 18**

A Service Transmission message or a Service Engine Soon message may be displayed on the Driver Information Center of some 2020-2021 Corvettes equipped with the DCT TR9080 transmission (RPO M1L) (Fig. 18) along with DTCs P2838 (Shift Fork 2 Position Sensor Circuit Low), P2839 (Shift Fork 2 Position Sensor Circuit High) or P283A (Shift Fork 2 Position Sensor Circuit Intermittent).

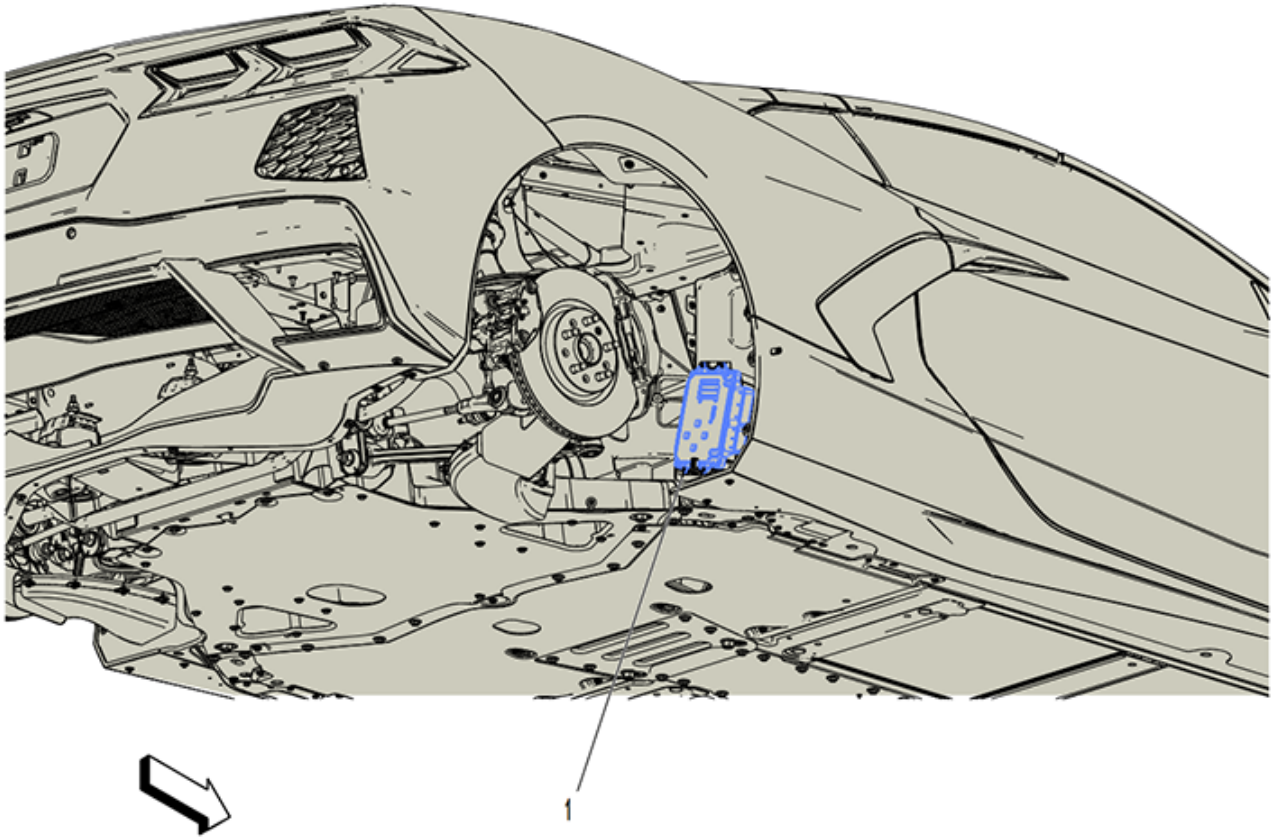
**Fig. 19**

If any combination of these DTCs have set (current or in history), check circuit integrity on circuit 7812 between the Transmission Control Module (TCM) (Fig. 19, #1) and the transmission. Check the terminal tension as well as for a possible short to ground.

If any issues are found, repair as needed and verify proper vehicle operation. If no issues are noted, the transmission would need to be replaced as anything related to the Odd Sensor Module (OSM) is not serviced.

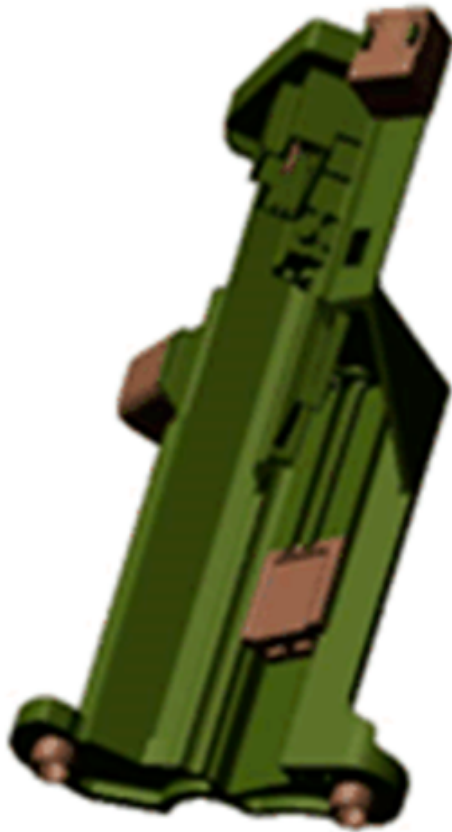
**Fig. 20**

The Odd Sensor Module (Fig. 20) is located in the shift fork assembly and contains the transmission input shaft speed sensor – odd gears and the shift fork 1 position sensor and shift fork 2 position sensor. The TCM uses the output speed sensor signal along with the even and odd input shaft speed sensor signals to determine transmission line pressure, shift patterns, and the correct gear ratio.
