2020 - 2024 Corvette: Noise From the Transmission Area

July 23, 2024

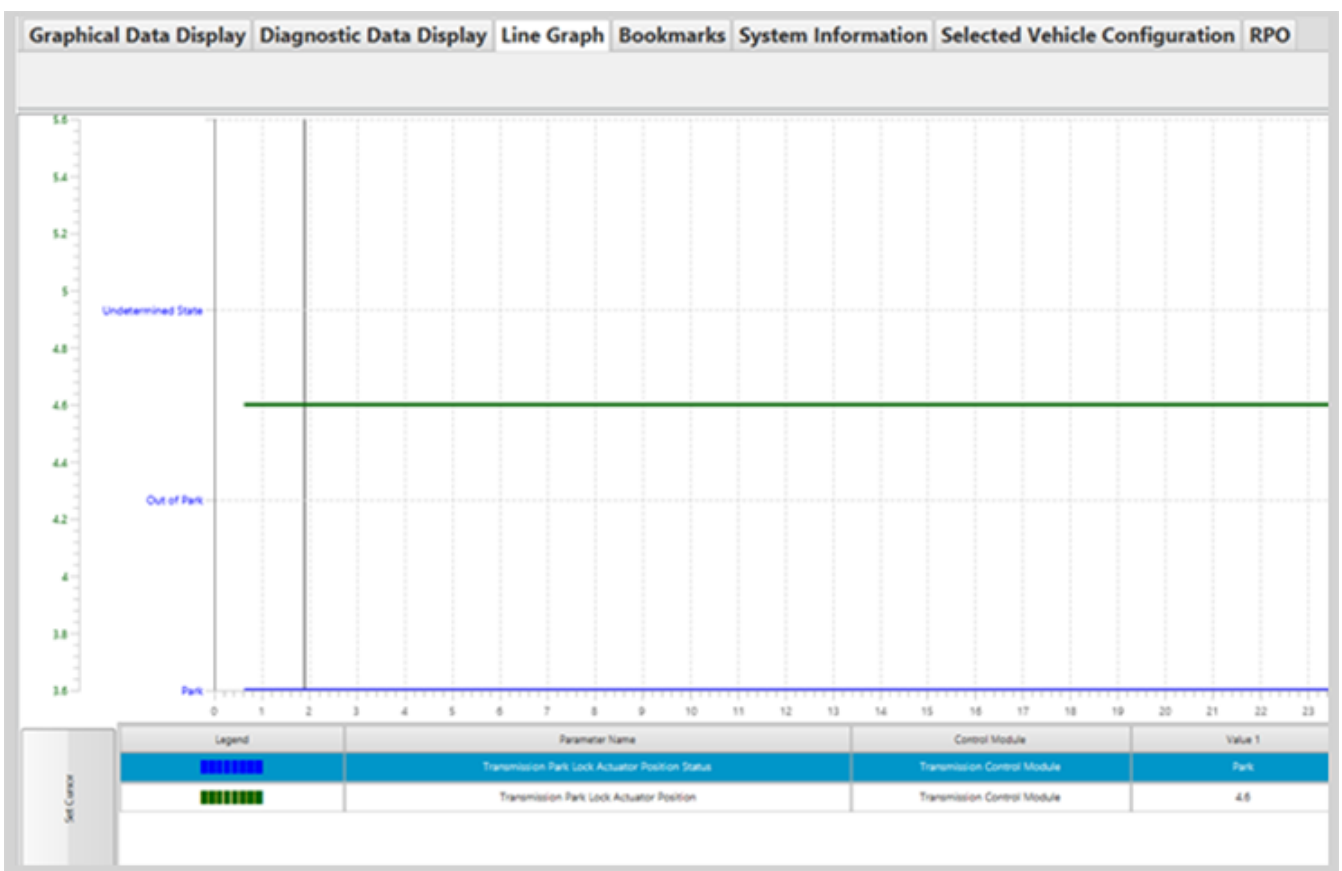
Fig. 16

If the noise from the bell housing area follows engine RPM and can be duplicated without moving the vehicle, verify that the vehicle has the latest TCM calibrations, set up a TAC case and attach the PicoScope sound files (refer to Bulletin #21-NA-049), and verify the park sensor measurement in the GDS transmission data for Park Lock Valve (PLV) drift (refer to Bulletin #23-NA-176). (Fig. 16)

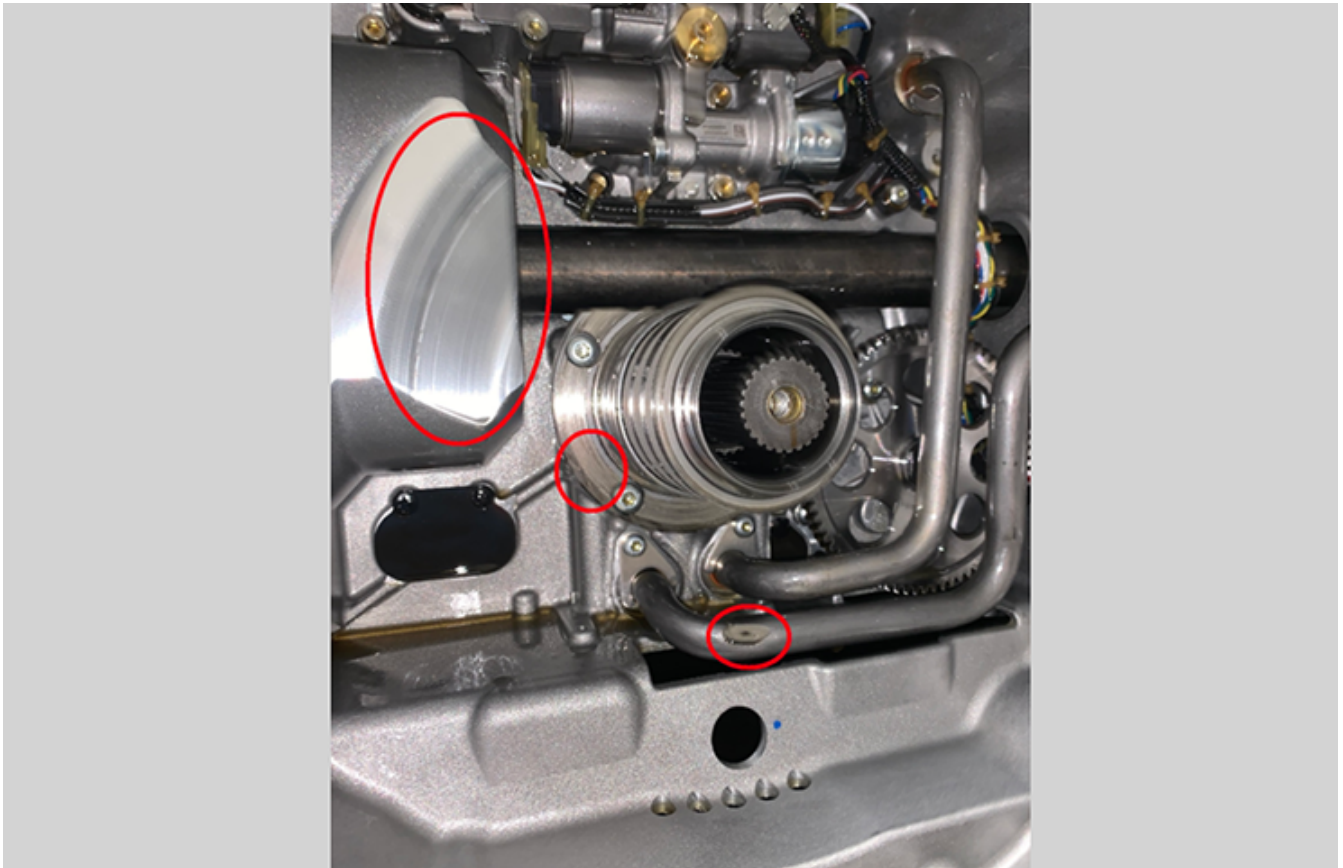
Fig. 18

While inspecting the pump gear for damage, if the direct clutch can be removed easily but there is contact with the pipe and stator, replace parts as needed. Light damage to the housing caused by direct clutch contact will not require replacement. (Fig. 18)
