2020 - 2024 Corvette: Noise From the Transmission Area

July 23, 2024

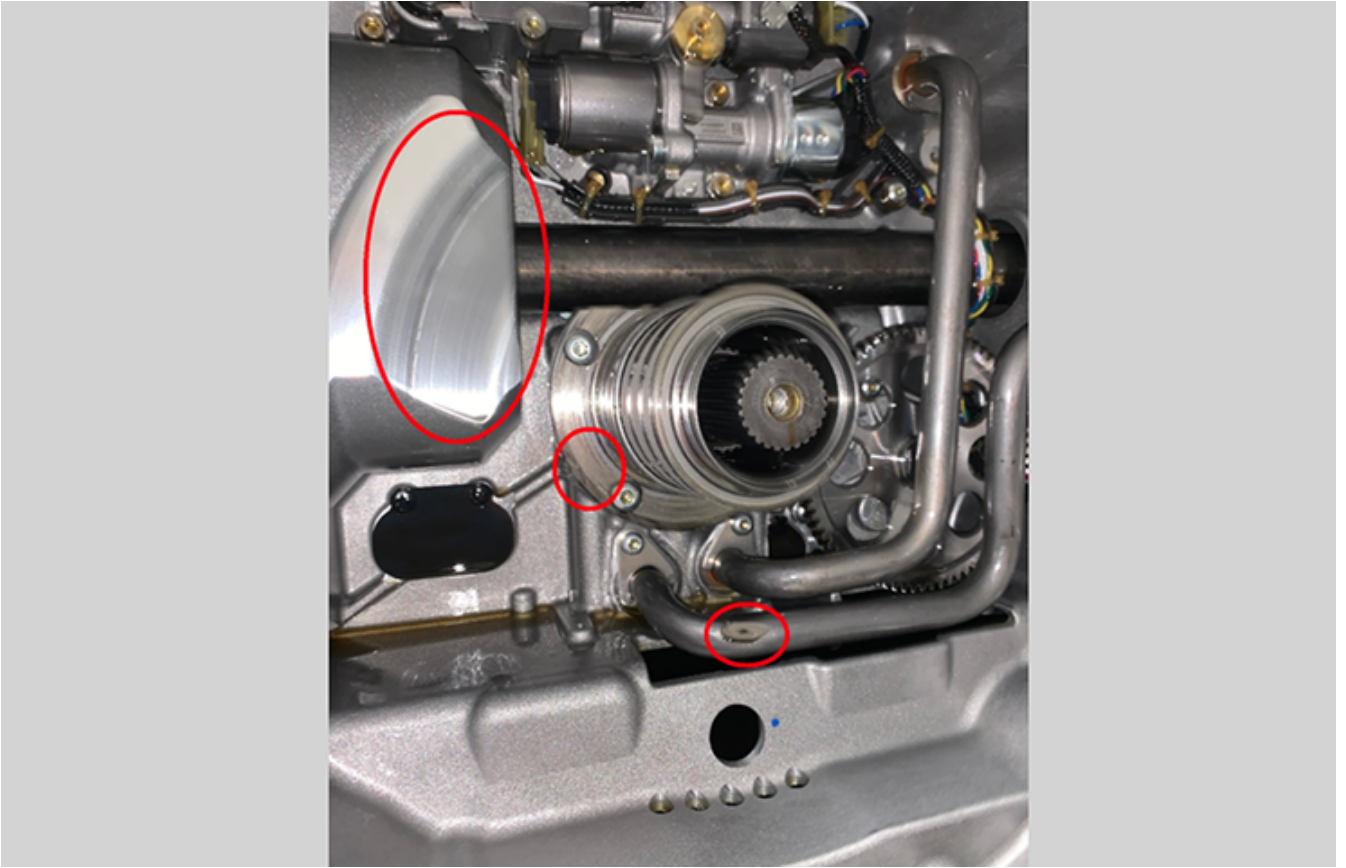
Fig. 18

While inspecting the pump gear for damage, if the direct clutch can be removed easily but there is contact with the pipe and stator, replace parts as needed. Light damage to the housing caused by direct clutch contact will not require replacement. (Fig. 18)
