# 2019 - 2024 Corvette: Crankshaft Bearing Diagnosis

March 21, 2024

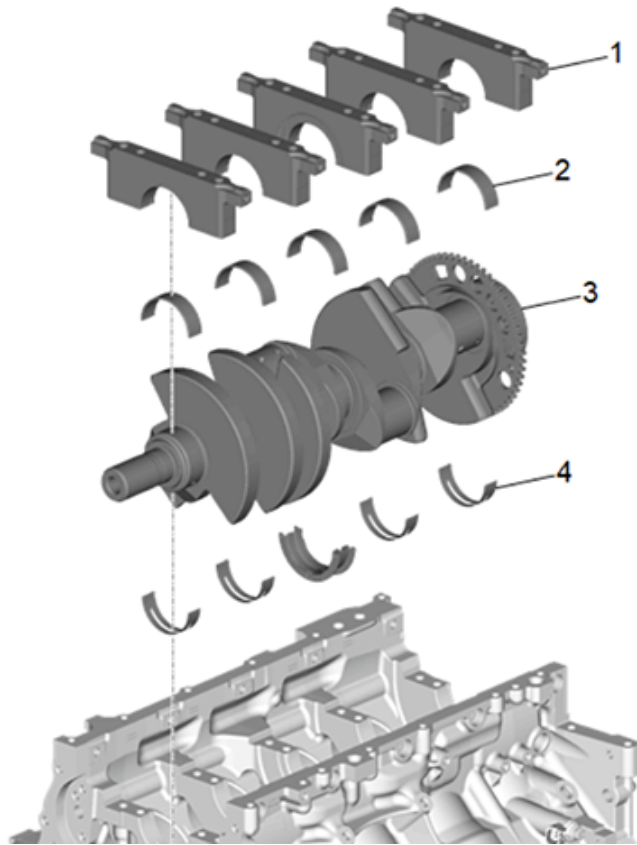
**Fig. 8**

If these engine conditions are present, check for crankshaft bearing failure or a damaged thrust bearing. (Fig. 8) There are several items to inspect to determine if bearing failure has occurred.

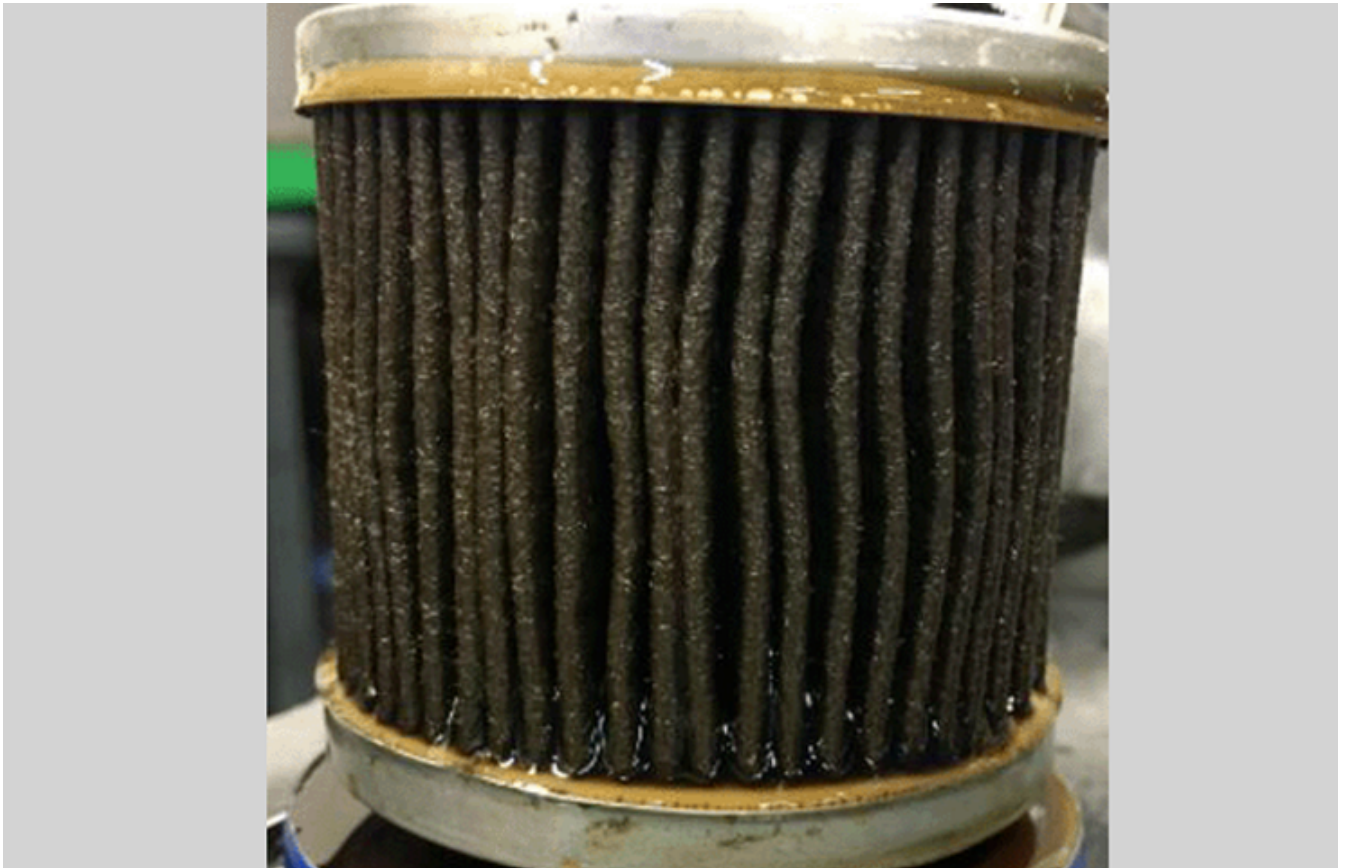
**Fig. 9.**

Begin diagnosis by inspecting the engine oil and filter for bearing material or excessive metal debris. (Fig. 9) Pouring the oil through a white shop towel may be helpful.

Remove the engine oil pan for further inspection of the crankshaft rod and main bearings if bearing debris has been identified.

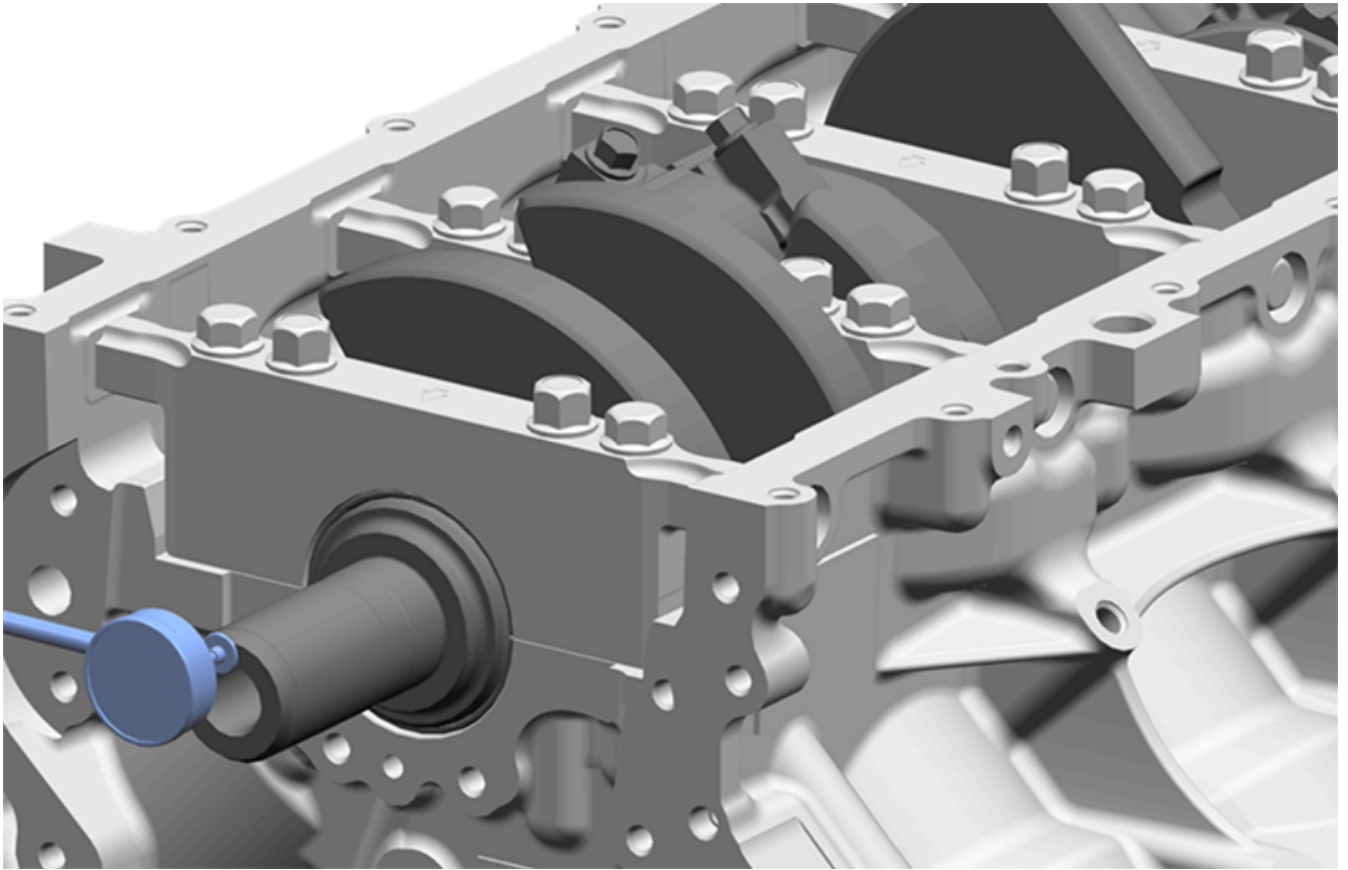
**Fig. 10**

In addition, if material is found in the engine oil, measure crankshaft end play following the appropriate Service Information. (Fig. 10) If there is not excessive crankshaft end play, remove the engine accessory drive belt and run the engine again. If the noise is eliminated, check the accessory drive belt-driven components for possible issues.
