# 2020 - 2024 Corvette: Convertible Top Water Leak

March 21, 2024

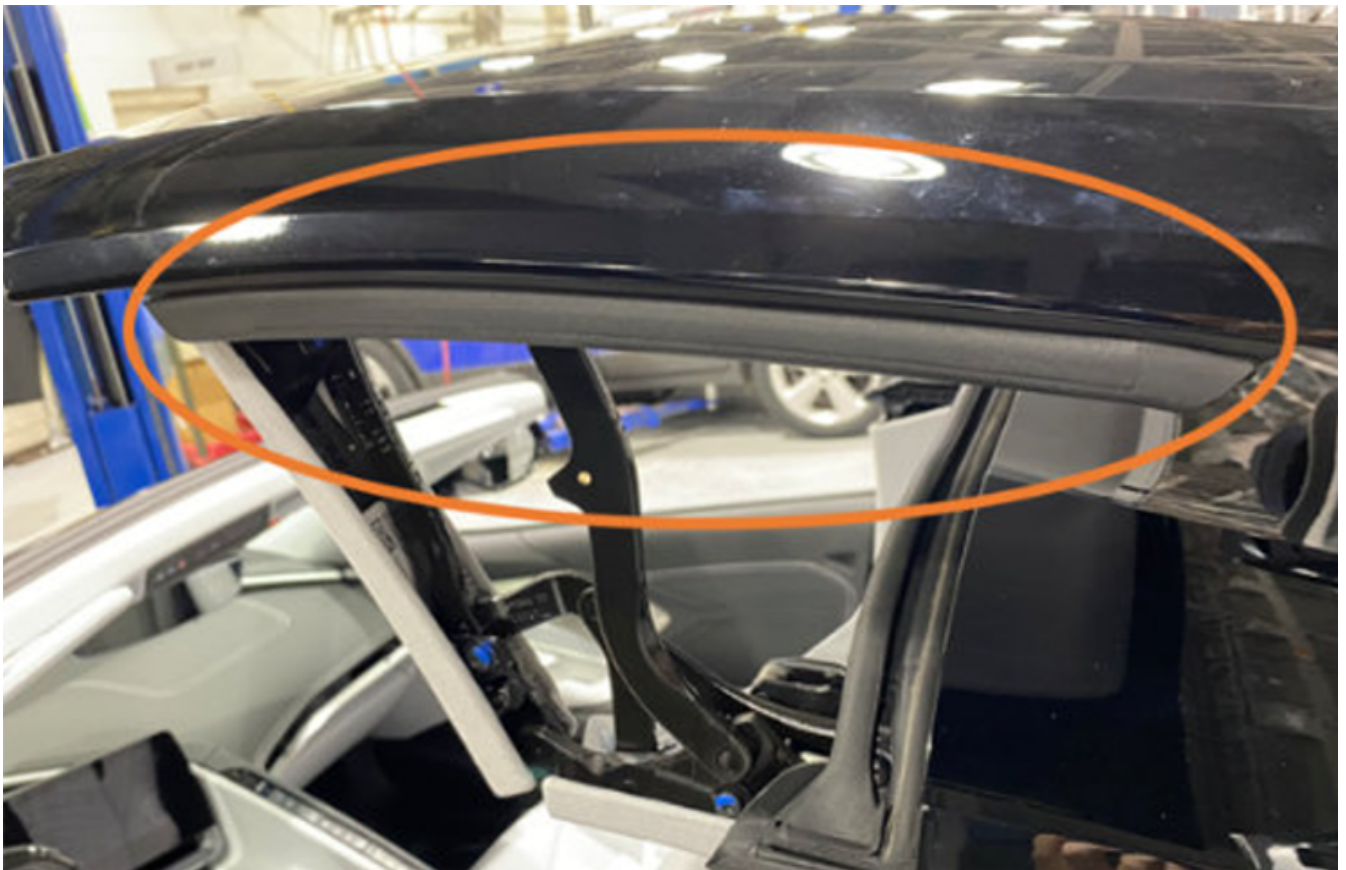
**Fig. 11**

Some 2020-2024 Corvette convertible models may have a water leak around the side glass. The leak, which is found at approximately the middle rear of the side glass area (Fig. 11), may be noticed when the vehicle is exposed to a high-pressure car wash.

The side glass leak may be due to slight variations in sealing between the roof panel seals. To correct this condition, a piece of semi-closed EPDM foam should be installed at the edge of the top panel.
