# 2015 - 2018 Corvette: Shift Concerns on 8-Speed Transmissions

November 29, 2023

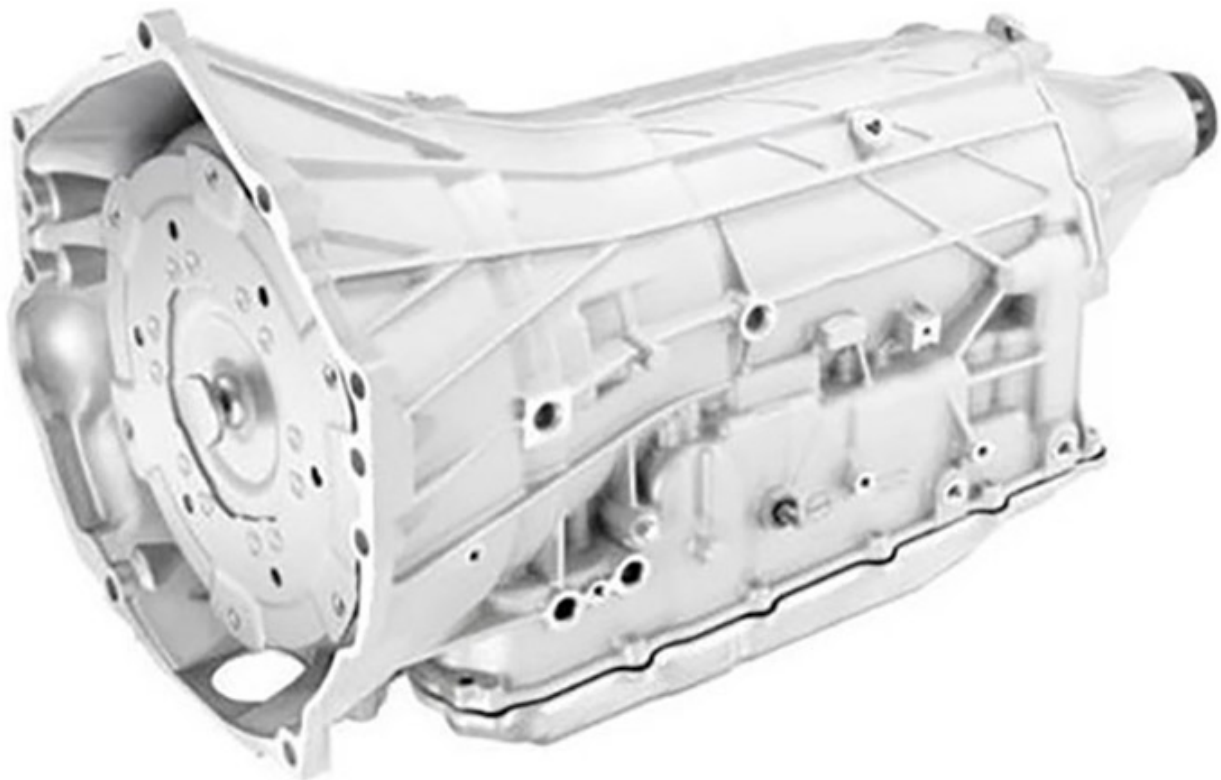
**Fig. 5**

The 8-speed automatic transmissions (RPO M5N, MNU, M5U, M5X, MHA, M5T, MQE, MQD) in some 2015-2018 Corvette; 2015-2020 Escalade, Yukon; 2015-2023 Silverado 1500, Sierra 1500; 2016-2018 CTS; 2016-2019 ATS, CTS; 2016-2023 Camaro; 2017-2023 Colorado, Canyon; 2017-2024 Express, Savana; and 2020-2024 CT4 models (Fig. 5) may exhibit hard or harsh shifts.

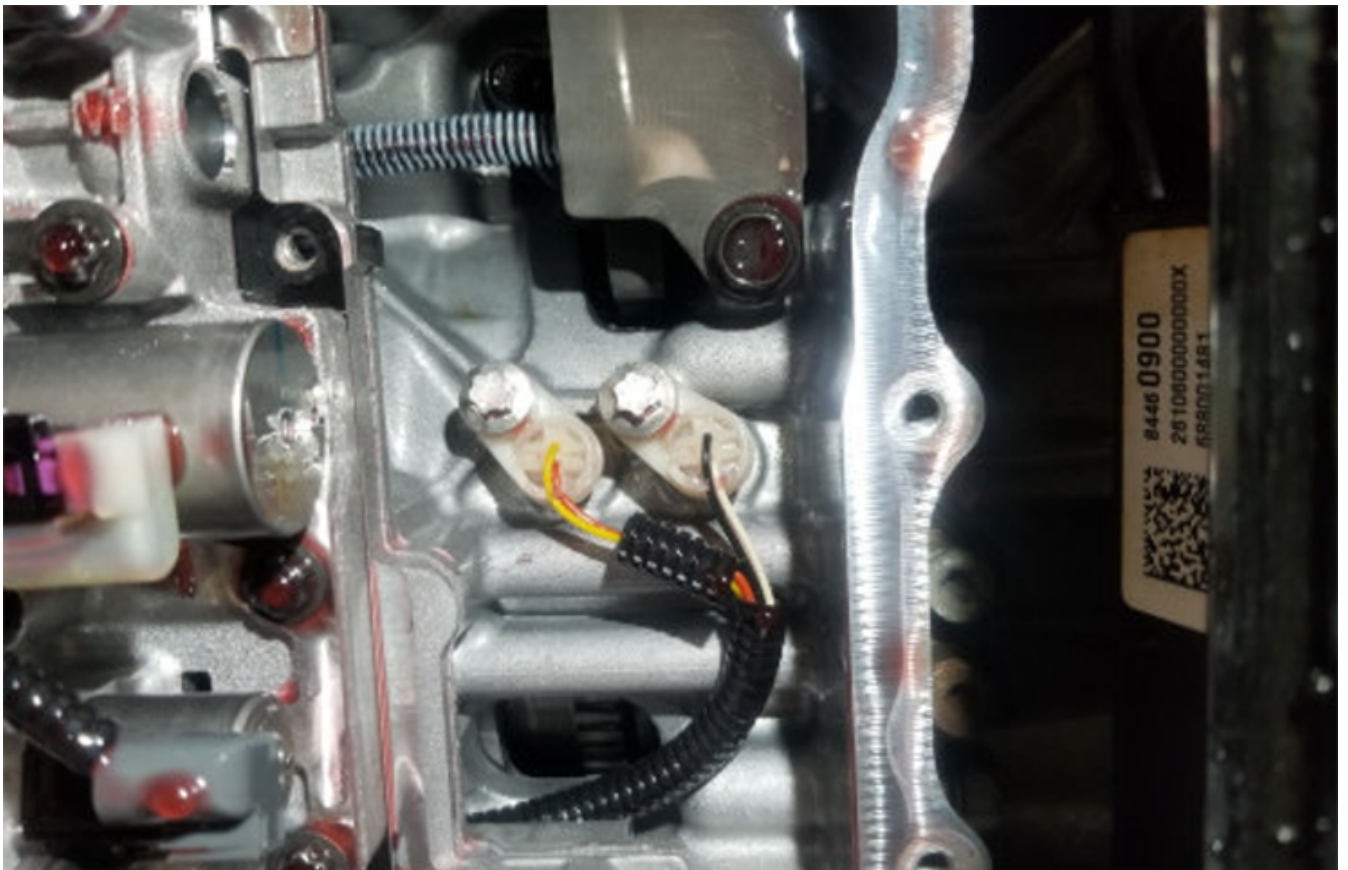
Fig. 7

In addition, if the speed sensors were recently replaced and the Transmission Service Fast Learn fails for excessive vehicle speed, or if DTCs P0717, P0722, P0746 and/or P0796 also set, inspect the speed sensors for the proper orientation. When correctly installed, the smaller portion of the sensor conduit should be facing the rear of the unit. (Fig. 7, Incorrect; Fig. 8, Correct)
